Post- HANDOVER INSPECTION REPORT

Property Address: Greenvale 3059

Stage of Works: Post Handover

Date of this Report: 11/11/2023

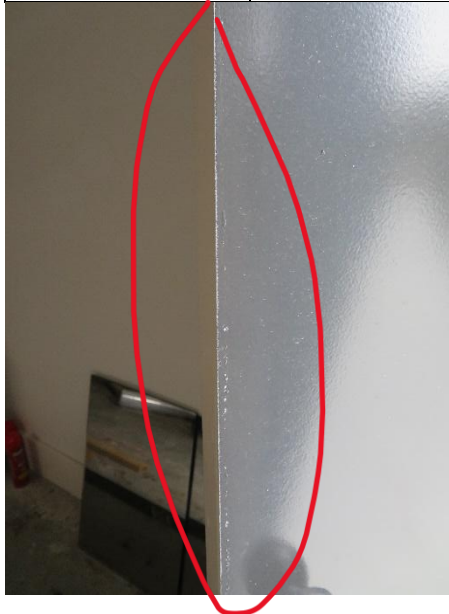
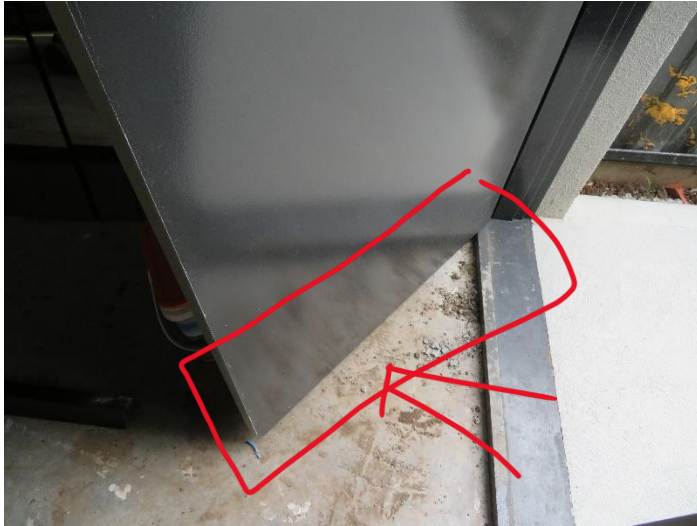
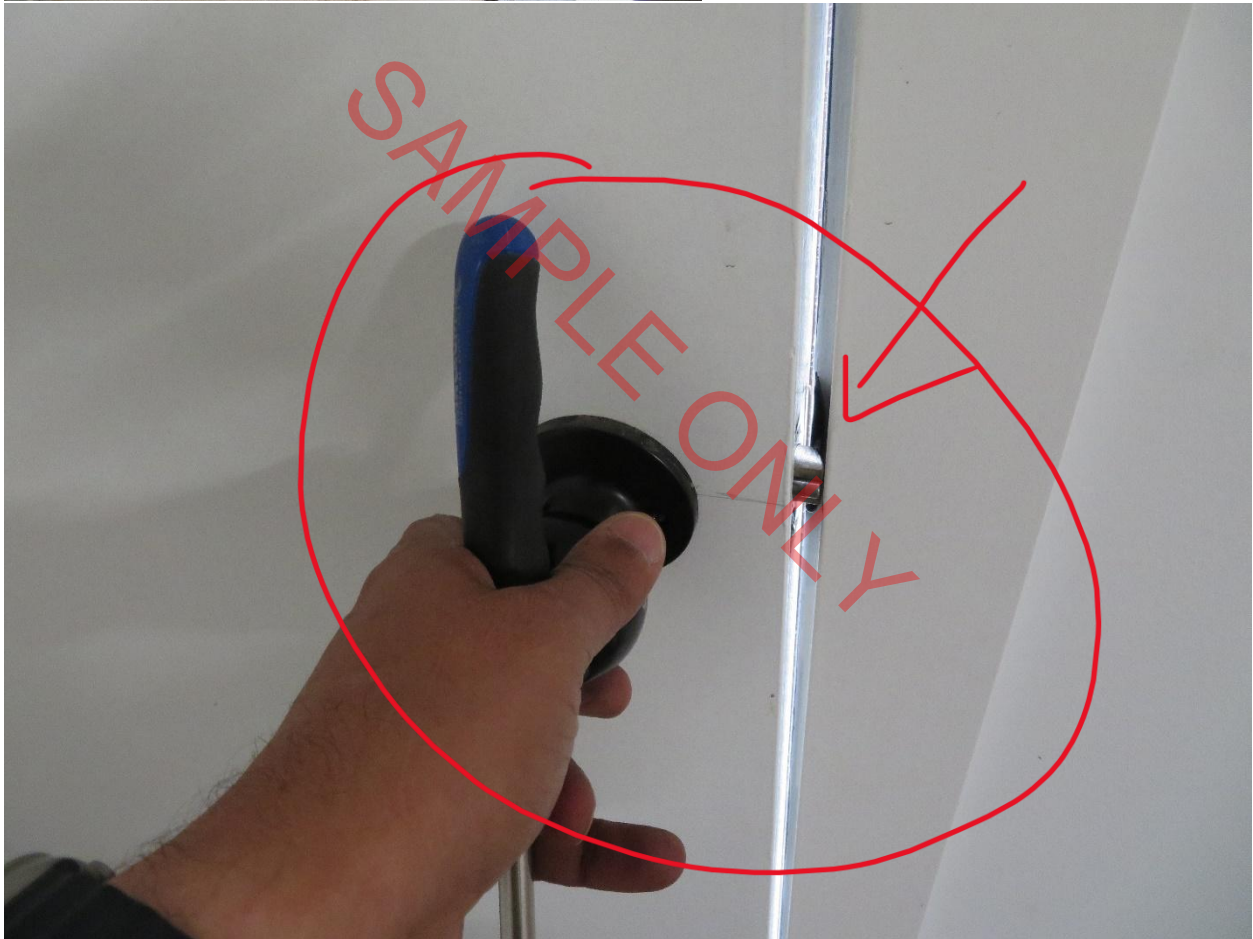
Location:	Pedestrian Garage Door
Finding: Information:	<ul style="list-style-type: none">• Door is not latching (Due to faulty striker plate)• Automatic door seal is not installed to prevent water ingress (Automatic door bottom seals are mechanically spring-loaded seals that lift clear of the floor as the door opens and seal tight when the door is closed).• Defective surface paintwork <p>As per VBA GUIDE TO STANDARDS AND TOLERANCES 2015 8 WINDOWS AND DOORS</p> <p>8.01 Installation of external windows and doors Unless documented otherwise, external windows and doors are defective if they are not installed and flashed in accordance with the manufacturer's installation instructions.</p> <p>8.02 Weather-tightness of windows, doors, and window and door frames Window frame and door frame installations are defective if, due to the builder's workmanship, they leak or cause unhealthy or dangerous conditions, loss of amenity for occupants, undue dampness or deterioration of building elements. Windows and doors are defective if, when closed, they allow the entry of water.</p> <p>Water entry through doors is not defective if they are not intended to prevent water entry. For example, vehicle access doors.</p> <p>8.03 Door furniture: During the documented maintenance period after completion, handles, locks and latches are defective if they do not operate as intended by the manufacturer. If the maintenance period is not documented; three months is the assumed time period after completion.</p> <p>After the end of the maintenance period, failure is not a defect unless it is caused by the builder's workmanship or a faulty product supplied by the builder.</p>

<p>12.02 Surface finish of paintwork</p> <p>Paintwork is defective if the application has blemishes such as paint runs, paint sags, wrinkling, dust, bare or starved painted areas, colour variations, surface cracks, irregular and coarse brush marks, sanding marks, blistering, non-uniformity of gloss level and other irregularities in the surface that are visible from a normal viewing position.</p> <p>Paintwork is defective if the application results in excessive over-painting of fittings, trims, skirtings, architraves, glazing and other finished edges.</p> <p>In accordance with section 8(a) of the Act, the builder warrants that the work will be carried out in a proper and workmanlike manner and specified in the contract.</p> <p>Therefore, this item is defective and attributable to the builder.</p>
Is this item defective?	YES
Is this item incomplete?	Yes
Recommendation	The builder to rectify this finding in accordance with section 8(a) of the Act.

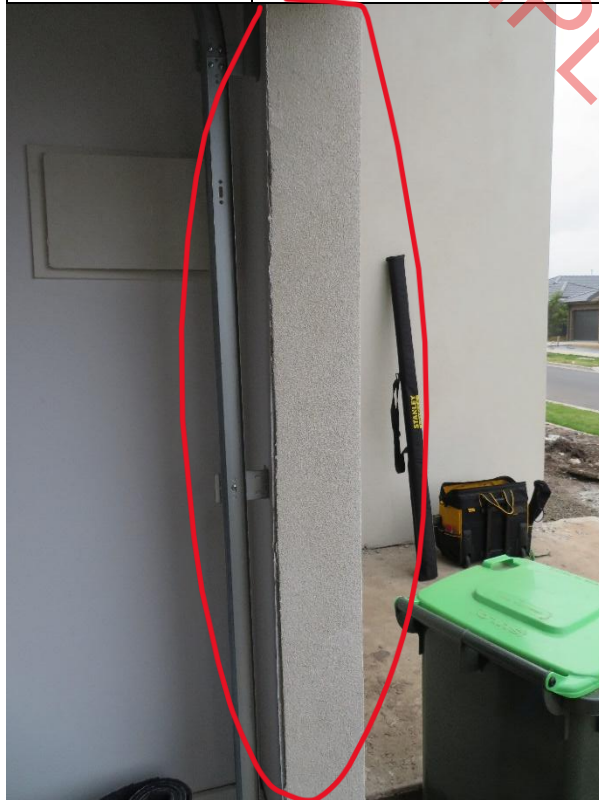
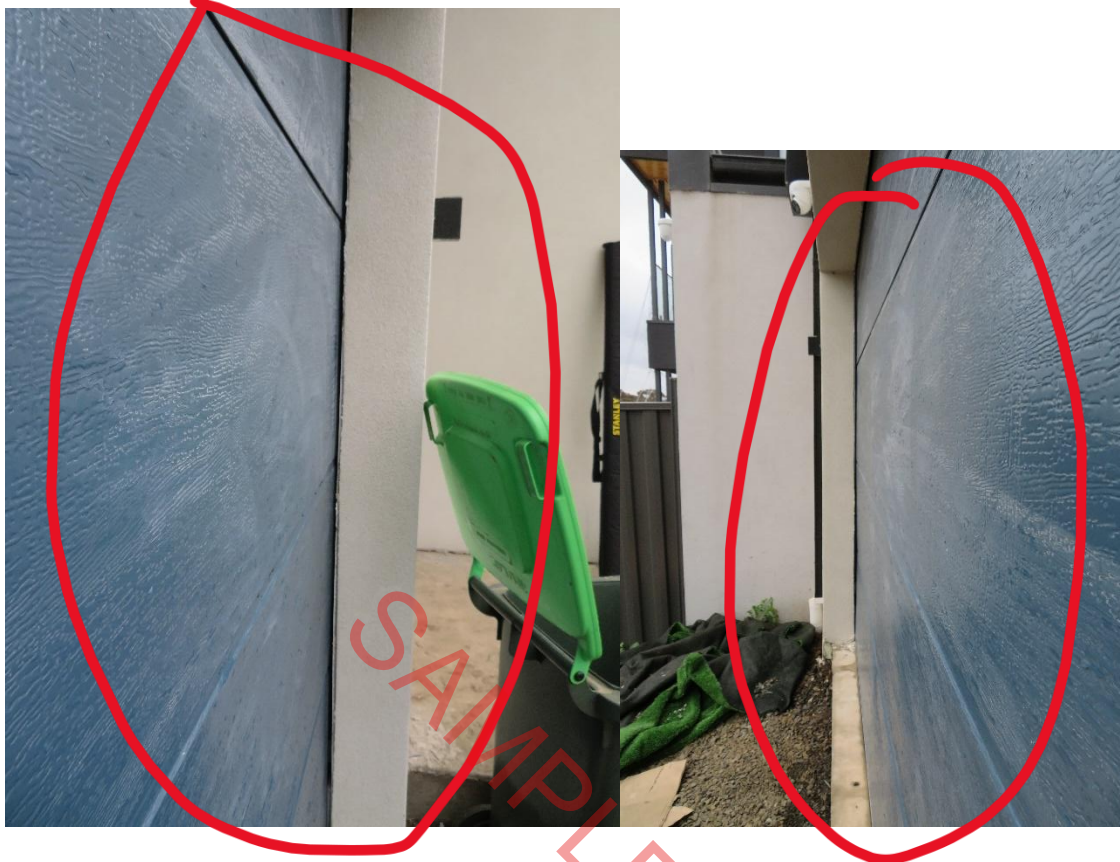
Findings: 2:

Location:	Sectional Garage Door wall frame
Finding: Information:	<ul style="list-style-type: none">• Cladding is faulty & uneven around the sectional garage door. Uneven gaps are causing water and potential for vermin entry. <p>As per VBA GUIDE TO STANDARDS AND TOLERANCES 2015</p> <p>9.01 Verticality or plumbness of internal and external wall surfaces Wall surfaces are defective if they deviate from vertical by more than 5 mm over a 1.8 m straight edge.</p>
Is this item defective?	YES
Is this item incomplete?	No
Recommendation	The builder to rectify this finding in accordance with section 8(a) of the Act.

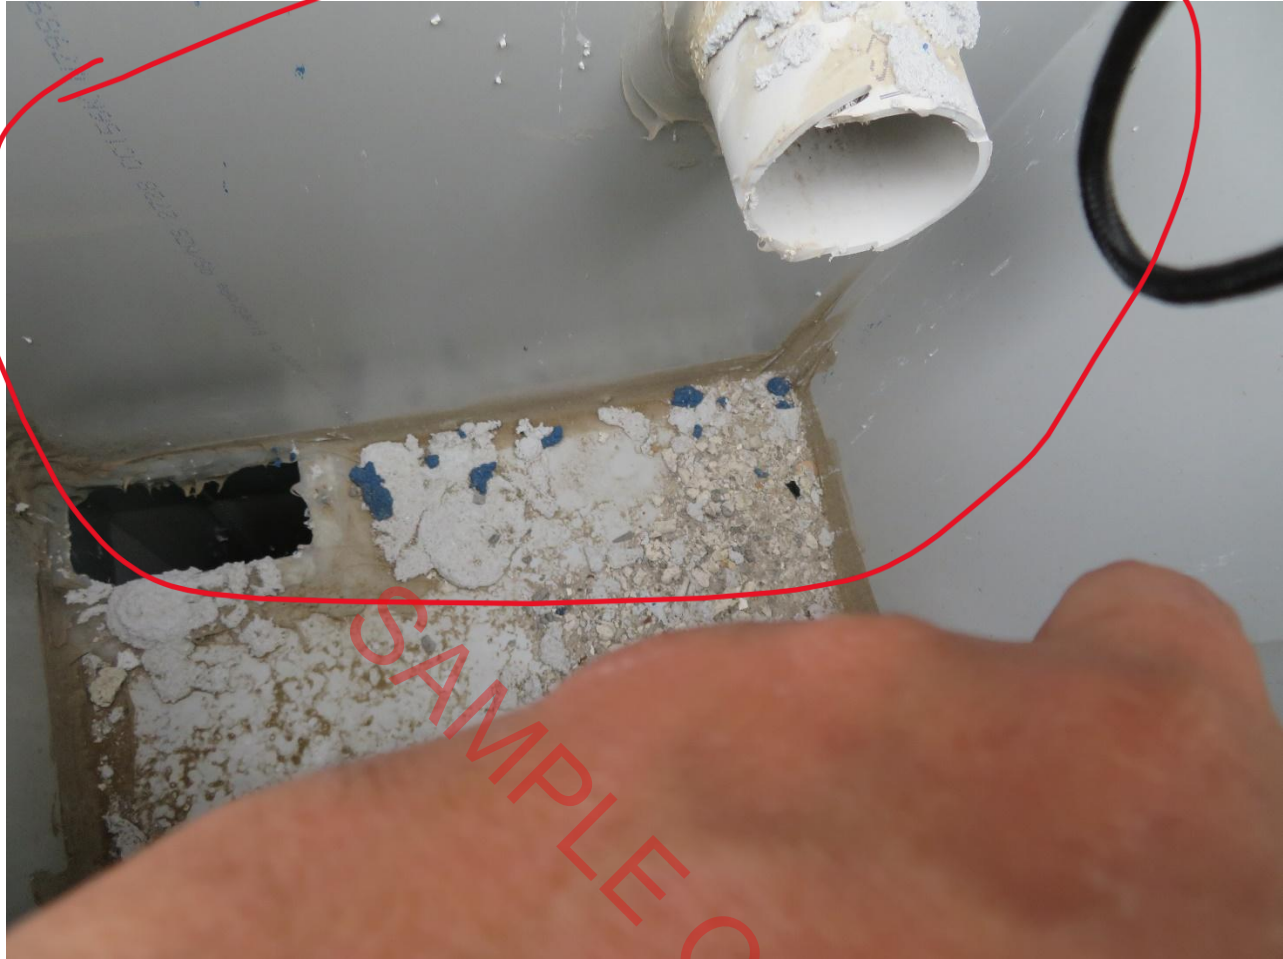
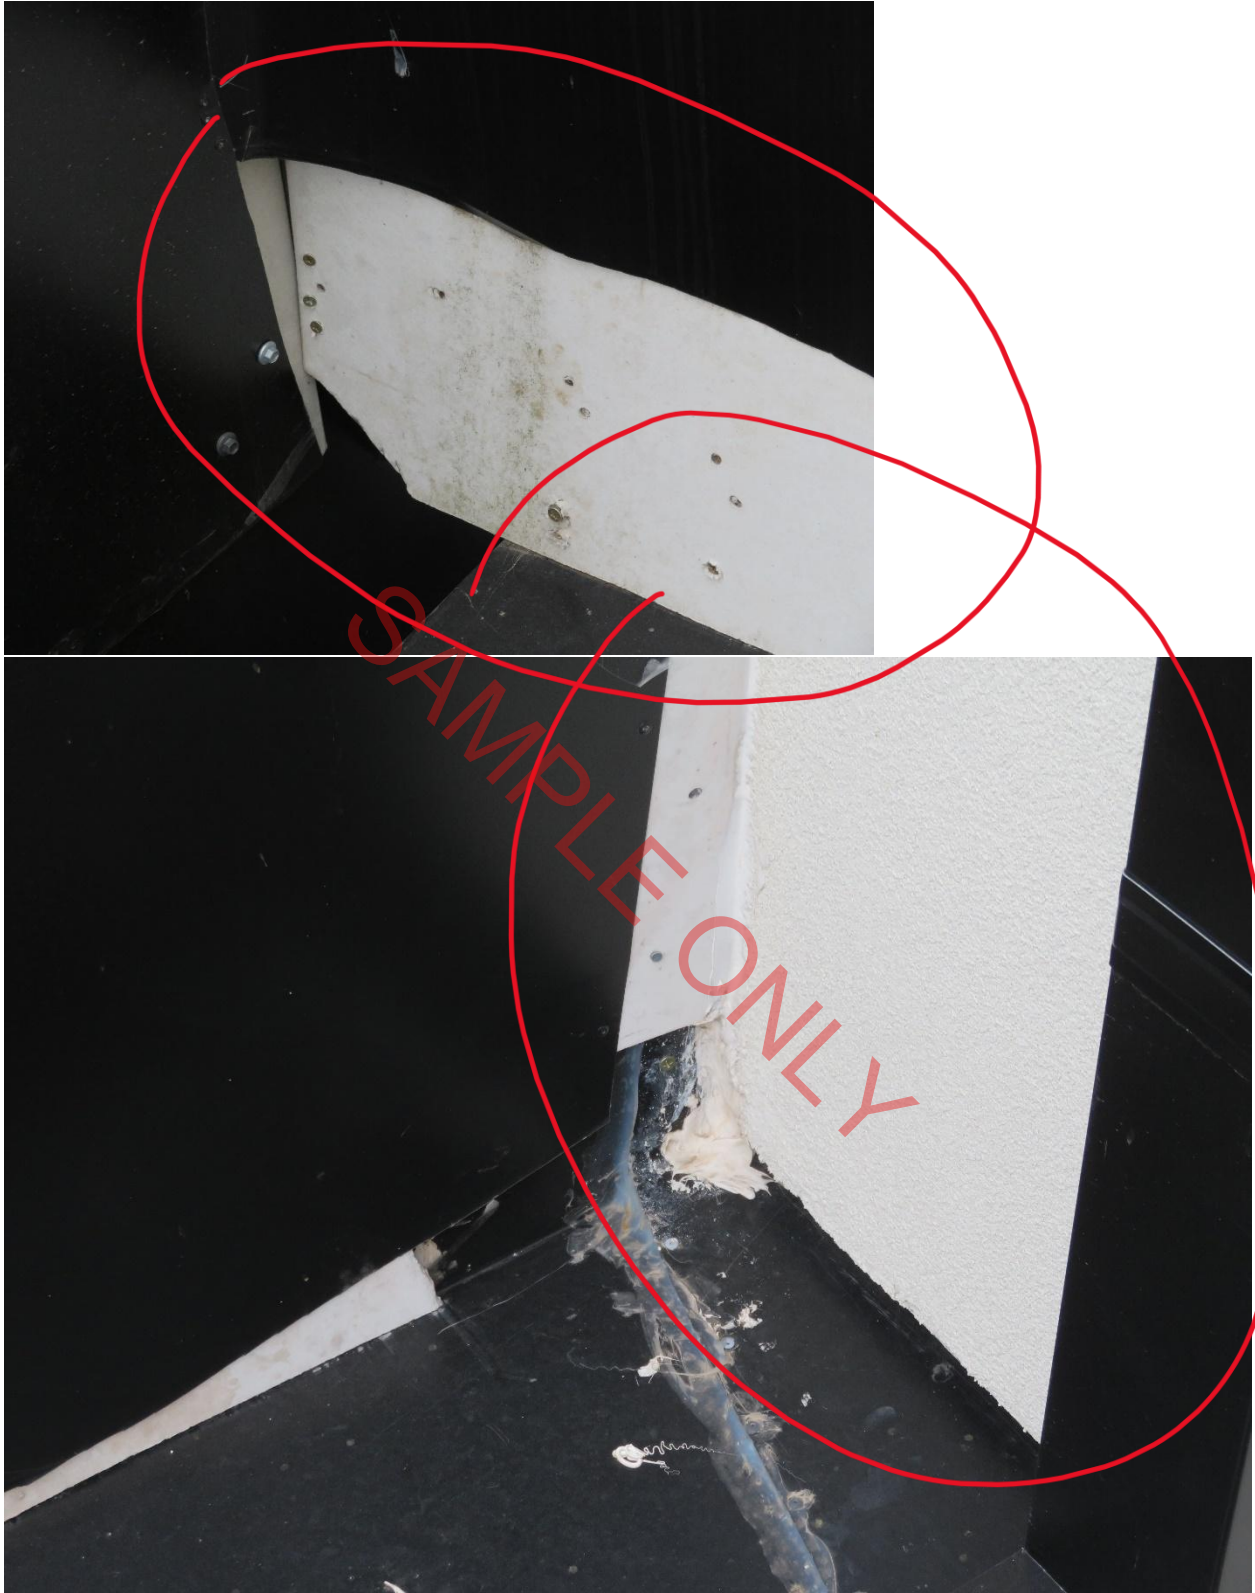
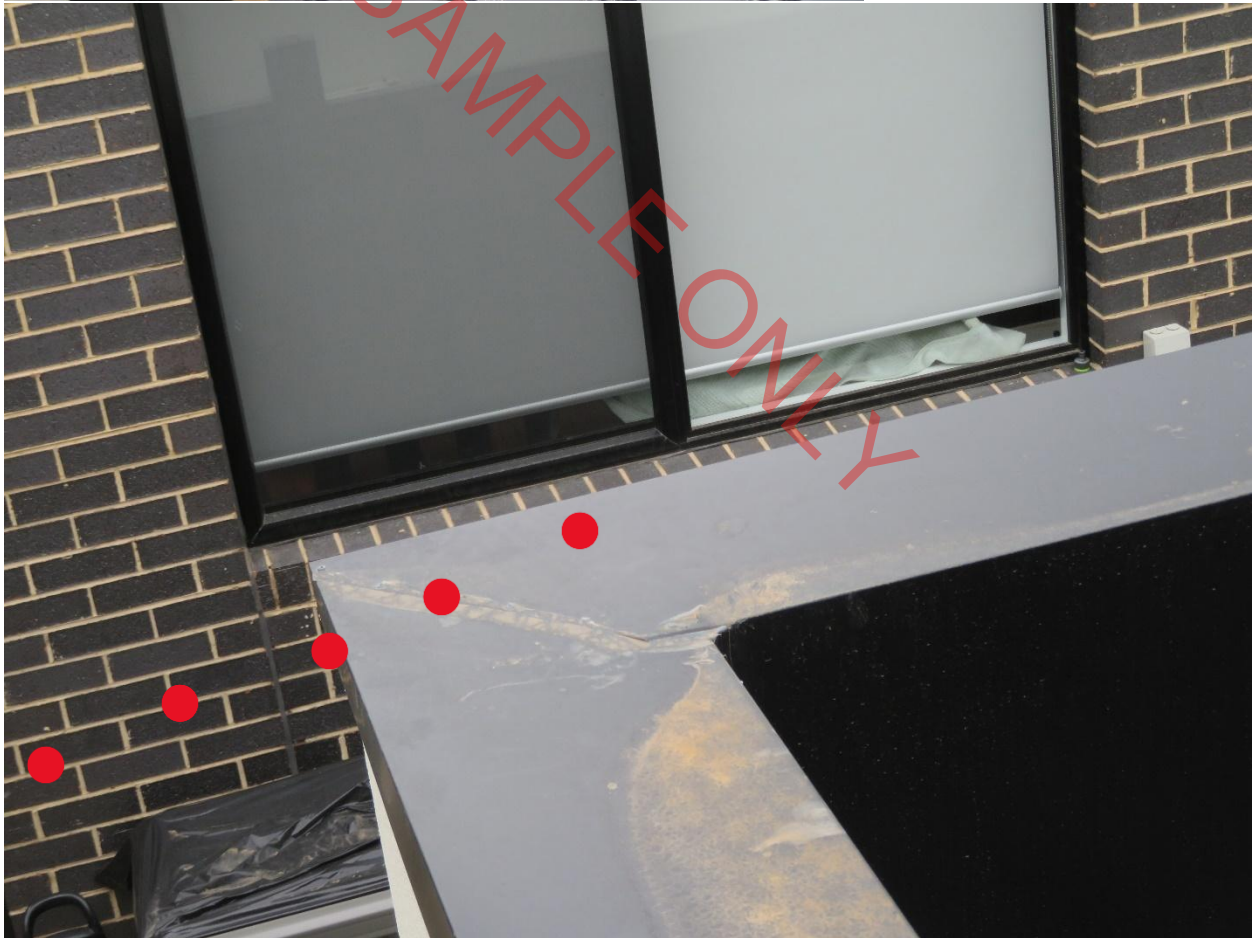
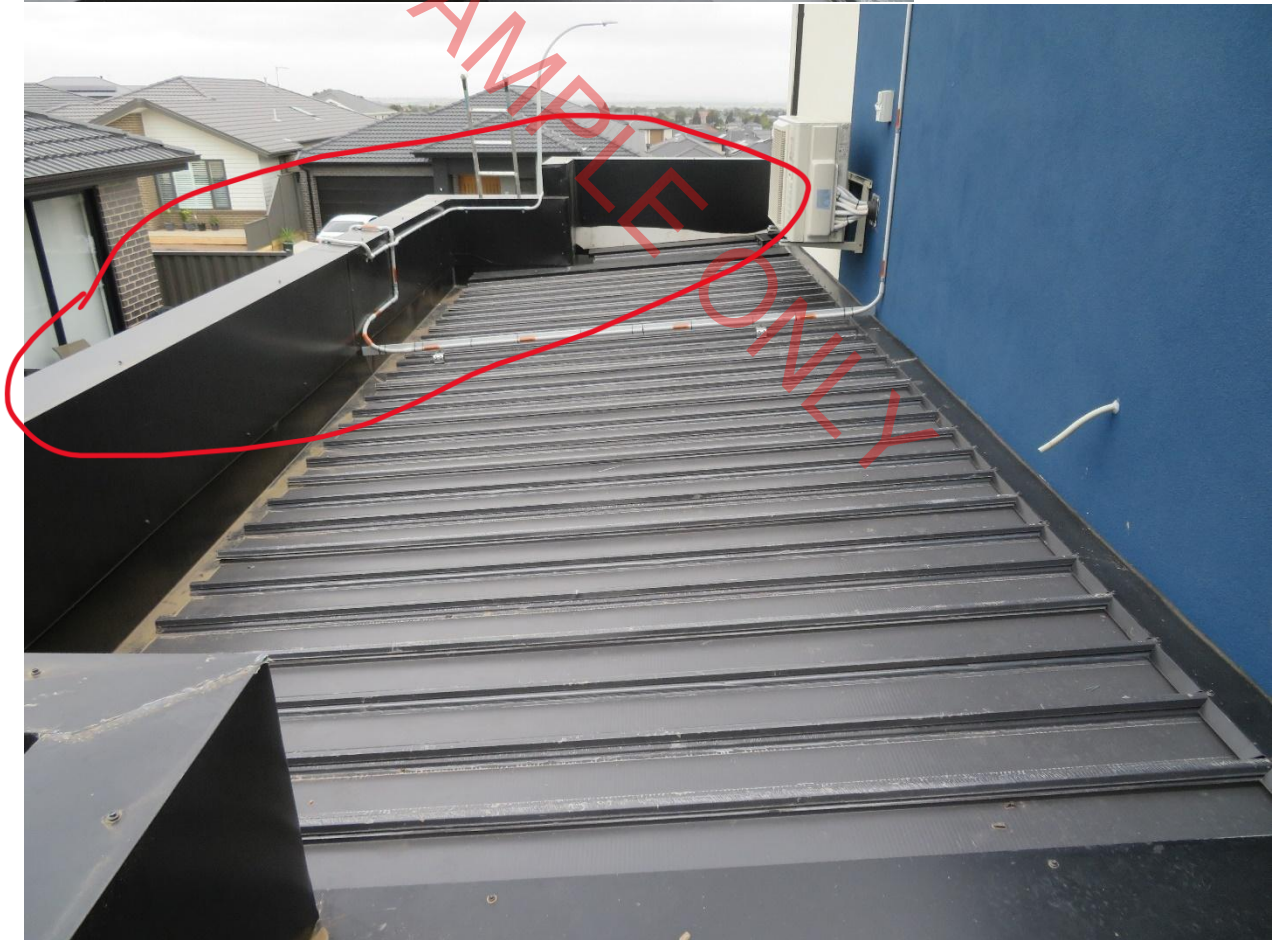
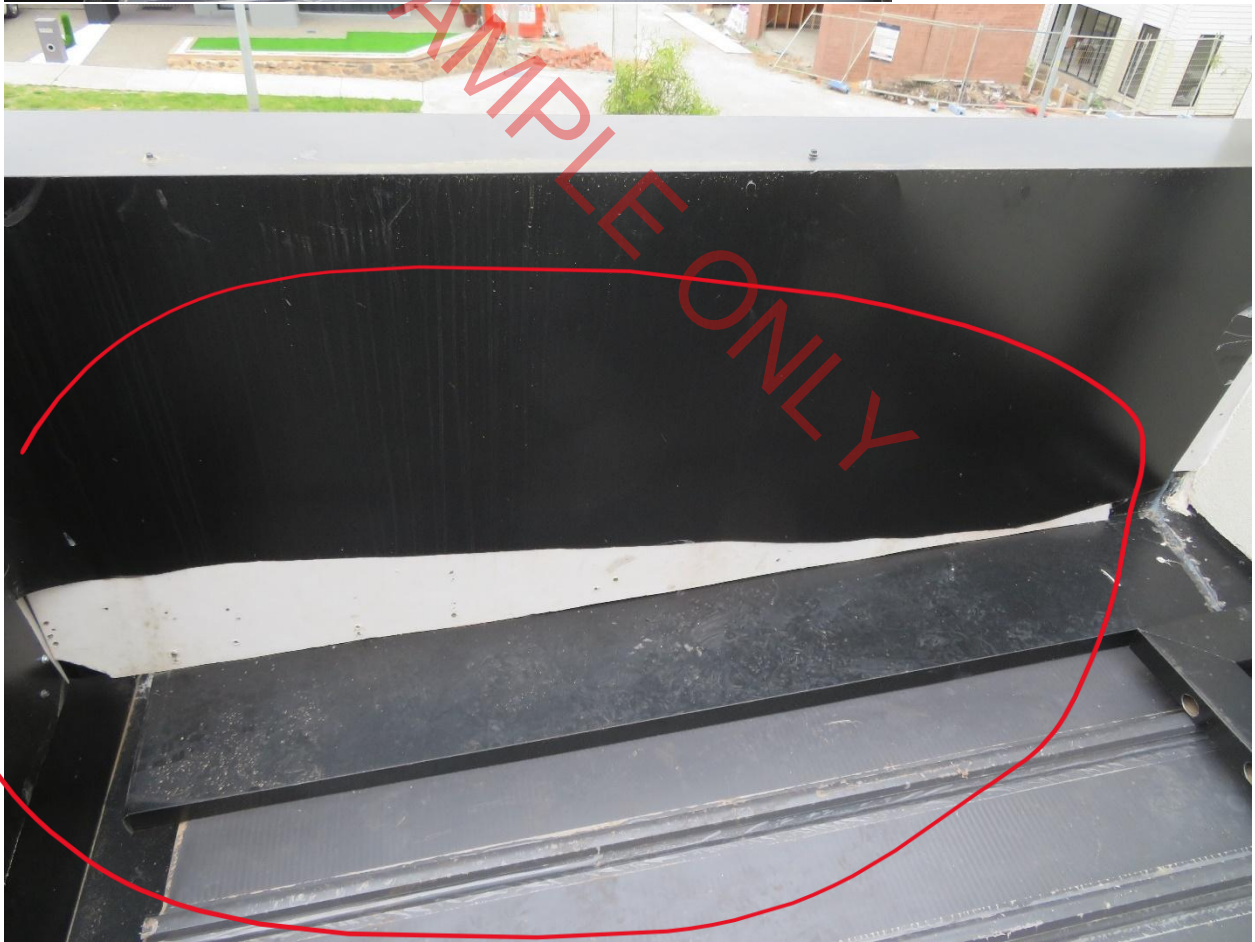
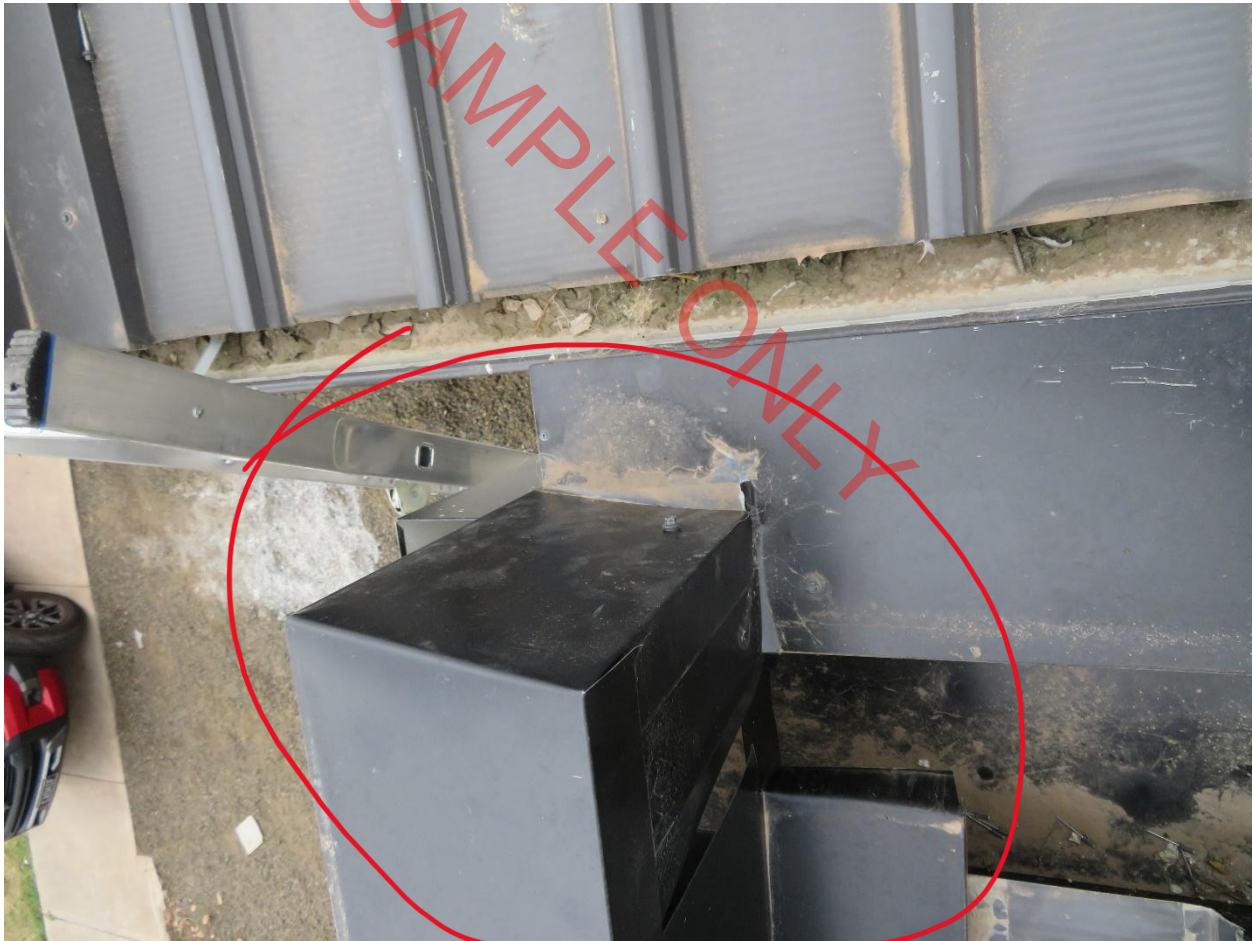
Findings: 3

Location:	Roof (Capping, flashing and protective film)
Finding: Information:	<ul style="list-style-type: none">• Protective film is not removed• Capping is defective & missing• Flashings are defective• Joints are not sealed as per the requirement• Downpipes are not secured properly• Downpipe is damaged and incorrectly installed• Building material is left behind in gutters and roof• Poor rectification worked carried out by a handyman organised by the builder.• Inadequate screws on capping and flashing <p>As per VBA GUIDE TO STANDARDS AND TOLERANCES 2015</p> <p>7.01 Plumbing: Plumbing work is defective if it does not comply with the relevant plumbing regulations and the contract documents. The builder shall provide the owner with a compliance certificate from the plumber when a certificate is required to be issued.</p> <p>7.02 Positioning of gutters: Unless documented otherwise, installation of gutters is defective if the fascia, when viewed from a normal viewing position, is:</p> <ul style="list-style-type: none">a) visible above a gutterb) not concealed by a flashing finished to match the gutter. <p>7.03 Water retention in gutters: Gutters are defective if they retain a depth of more than 10 mm of water.</p> <p>7.04 Joints in gutters: Unless documented otherwise, gutters are defective if they have joints lapped less than 25 mm. Laps that are not in the direction of flow to the outlet are defective. Joints that leak are defective.</p> <p>7.05 Fixing of gutters and downpipes: Gutters and downpipes are defective if they are not securely fixed.</p> <p>7.06 Flashings: Flashings are defective if they are not provided in accordance with the requirements of the Building Code of Australia.</p> <p>Wall and step flashings, and sloping flashings cut into walls are defective if they do not incorporate weathering folds, anti-capillary breaks and sealing, or do not enter the</p>

masonry walls by at least 15 mm as shown in Diagram 7.06(A) and Diagram 7.06(B).
Pressure flashings are defective if they are not fixed on appropriate surfaces, or are not fixed in accordance with Diagram 7.06(C).

Is this item defective?	YES
Is this item incomplete?	Yes
Recommendation	The builder to rectify this finding in accordance with section 8(a) of the Act.

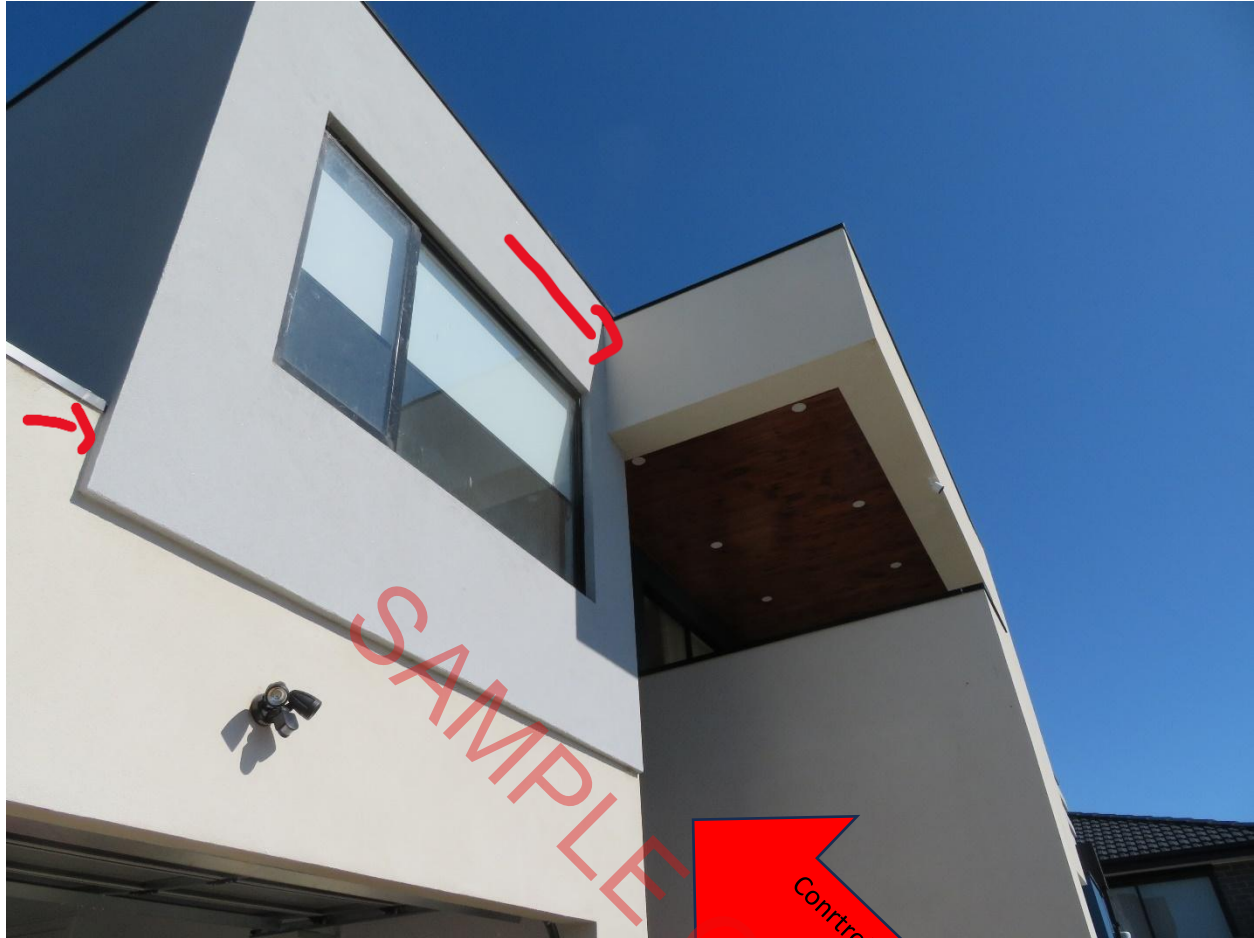
Control joints are not
sealed

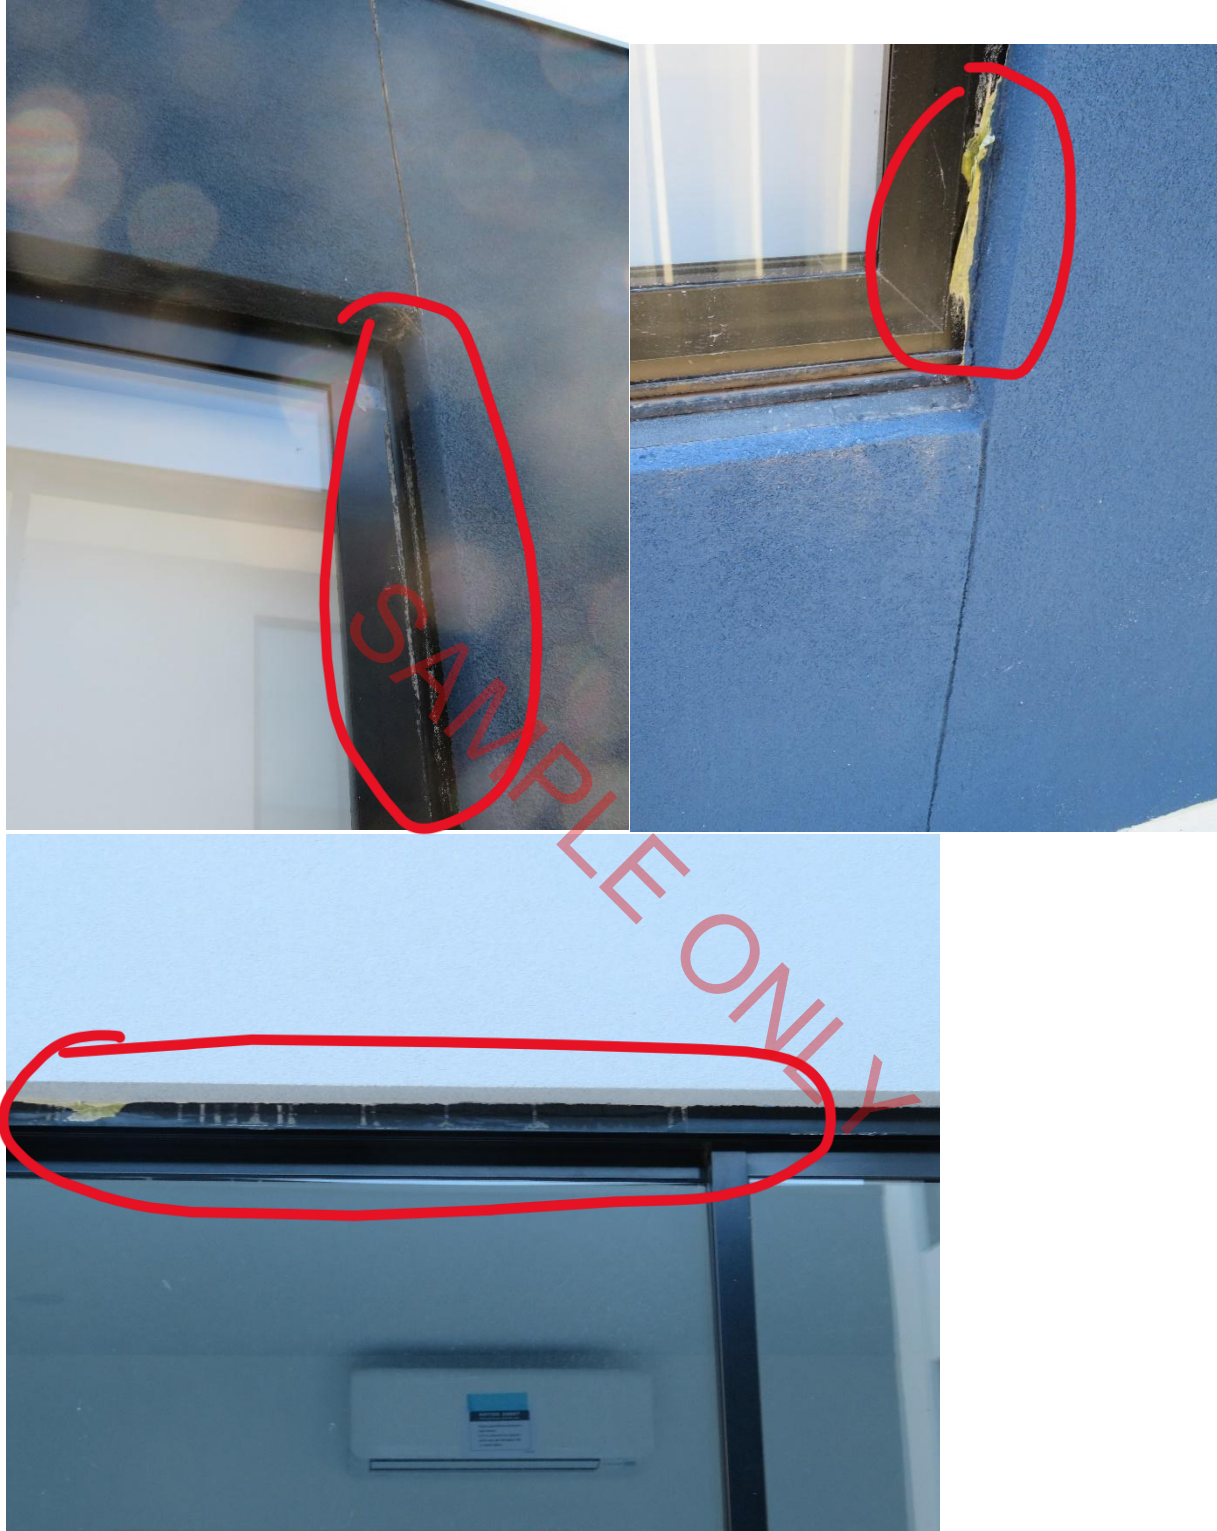
Findings: 6

Location:	Final Builder Clean (Widespread)
Finding: Information:	<ul style="list-style-type: none"> • Window and door frames are not clean • Window Glass panels are dirty • Building Material left on site (roof, gutters, railheads etc) <p>As per VBA GUIDE TO STANDARDS AND TOLERANCES 2015</p> <p>18.08 Cleaning Owners are entitled to expect that the building site and works are clean and tidy on completion. Where handover is delayed for any reason, the owner must expect that dust may have settled on interior exposed surfaces.</p> <p>Building sites are defective if they are not clear of building debris.</p> <p>Building works are defective where windows are not clean, floors are not swept, mopped or vacuumed as appropriate, tiles, sinks, basins, troughs, baths, etc. are not cleaned, and shelving, drawers and cupboards ready for use.</p>
Is this item defective?	YES
Is this item incomplete?	Yes
Recommendation	The builder to rectify this finding in accordance with section 8(a) of the Act.

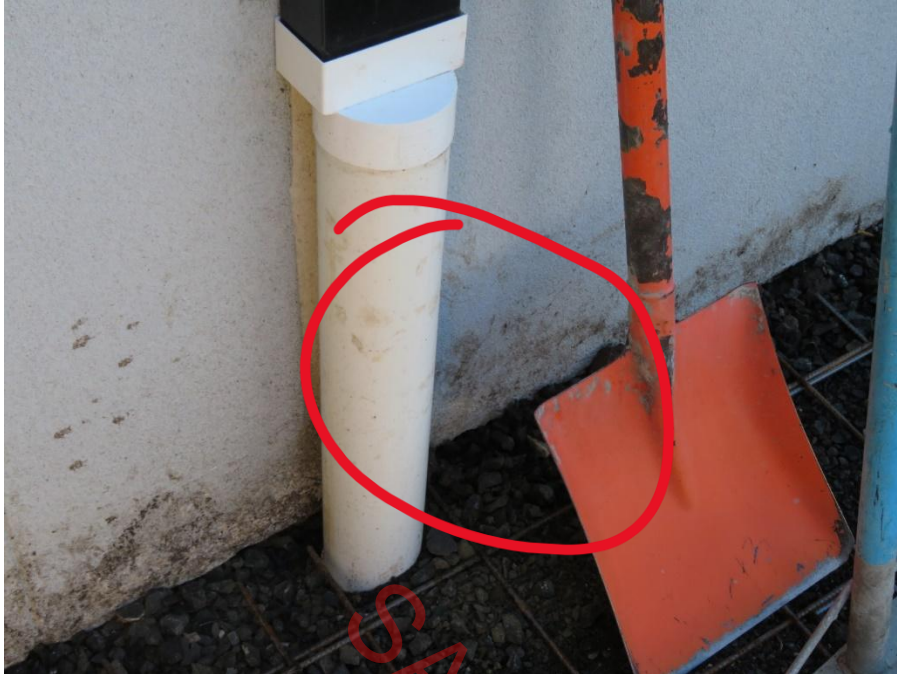
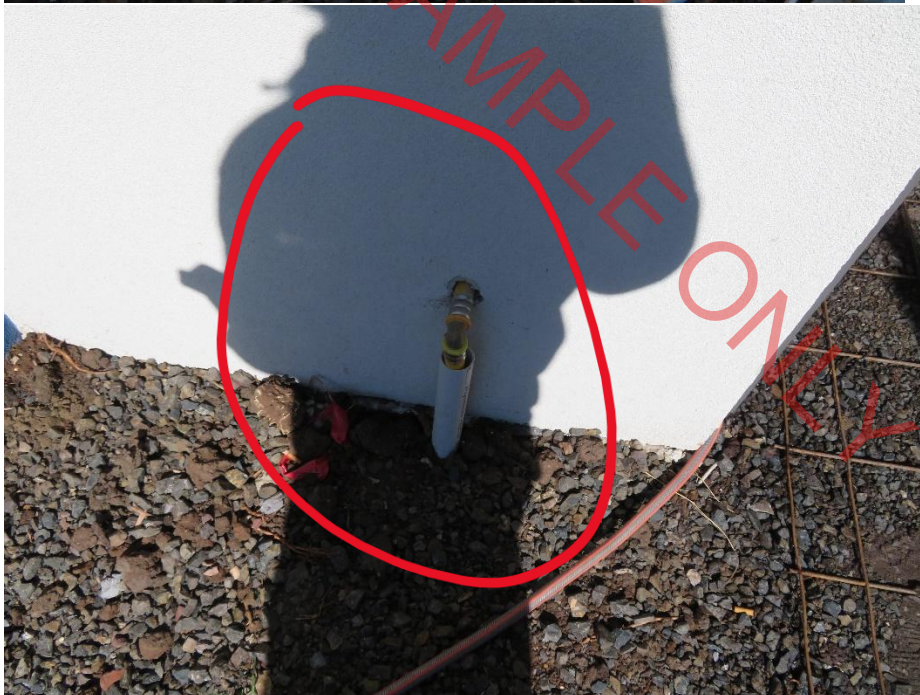
Findings: 7

Location:	Penetration are not sealed & PVC risers are painted
Finding: Information:	<ul style="list-style-type: none"> • Gas pipe penetrations is not sealed • PVC risers are not painted <p>As per VBA GUIDE TO STANDARDS AND TOLERANCES 2015</p> <p>7.08 Pipe penetrations through external walls and inside cupboards Plumbing holes are defective if they are not: a) properly grouted as appropriate b) fitted through neat minimal size penetrations (in the case of cabinetwork) c) fitted with tight fitting cover plates or collars with penetrations kept to the smallest size practicable.</p> <p>Above ground multilayer gas piping is not protected from ultraviolet exposure. At the time of inspection, the multilayered gas pipe at the gas meter was exposed. Multilayered gas pipe that is not UV stabilized is to be protected from the time of Installation AS/NZS 5601.1:2013 clause 5.3.17</p>
Is this item defective?	YES

Is this item incomplete?	Yes
Recommendation	The builder to rectify this finding in accordance with section 8(a) of the Act.

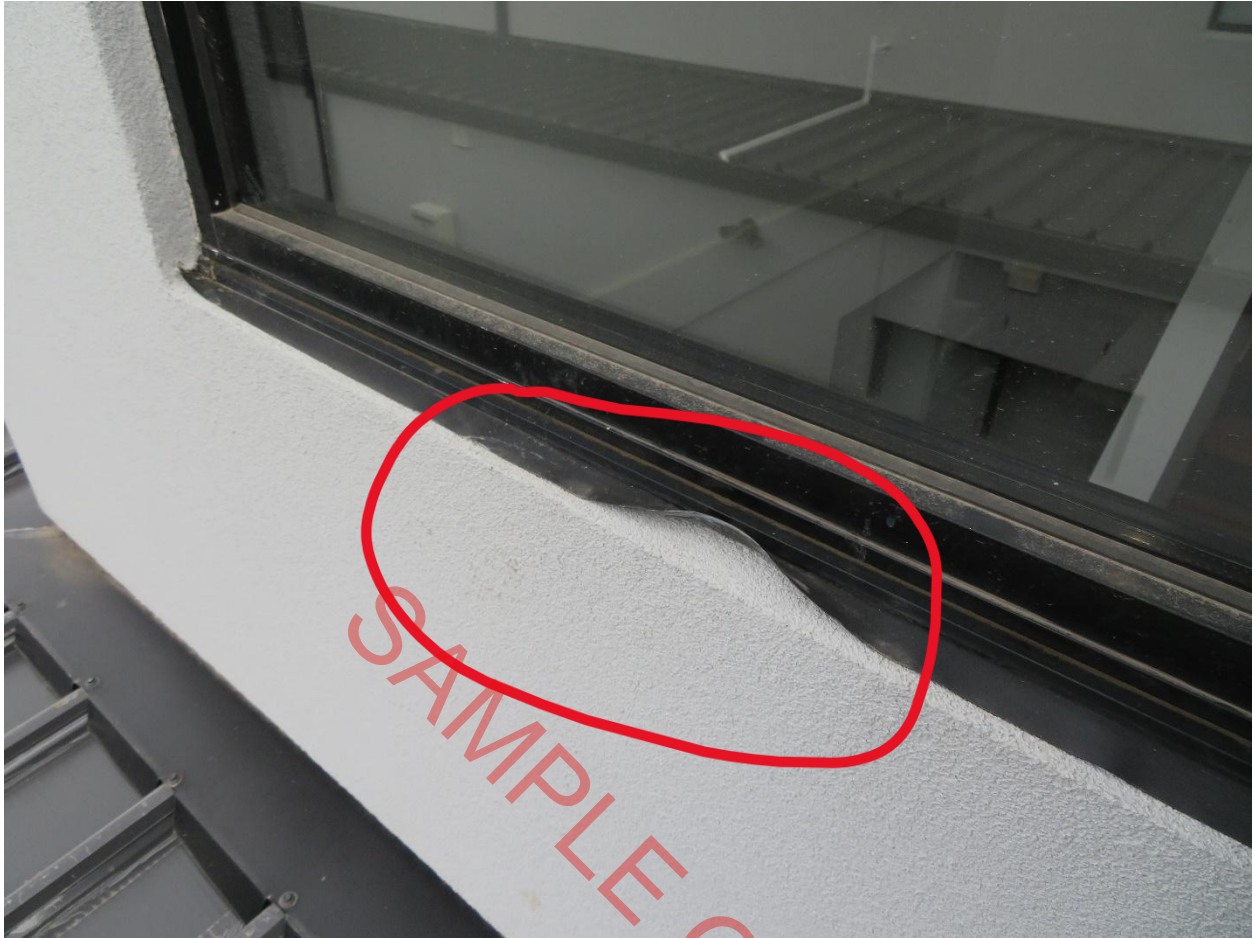
Findings: 8

Location:	Window rubber flap is twisted
Finding: Information:	<ul style="list-style-type: none">• Upper story rubber flap is not sitting firm on Hebel <p>As per VBA GUIDE TO STANDARDS AND TOLERANCES 2015</p> <p>8.02 Weather-tightness of windows, doors, and window and door frames Window frame and door frame installations are defective if, due to the builder's workmanship, they leak or cause unhealthy or dangerous conditions, loss of amenity for occupants, undue dampness or deterioration of building elements.</p> <p>Windows and doors are defective if, when closed, they allow the entry of water.</p> <p>Water entry through doors is not defective if they are not intended to prevent water entry.</p> <p>For example, vehicle access doors.</p> <p>Windows and doors are defective if they are not sealed in accordance with the requirements of the Building Code of Australia, where required.</p>
Is this item defective?	YES

Is this item incomplete?	No
Recommendation	The builder to rectify this finding in accordance with section 8(a) of the Act.

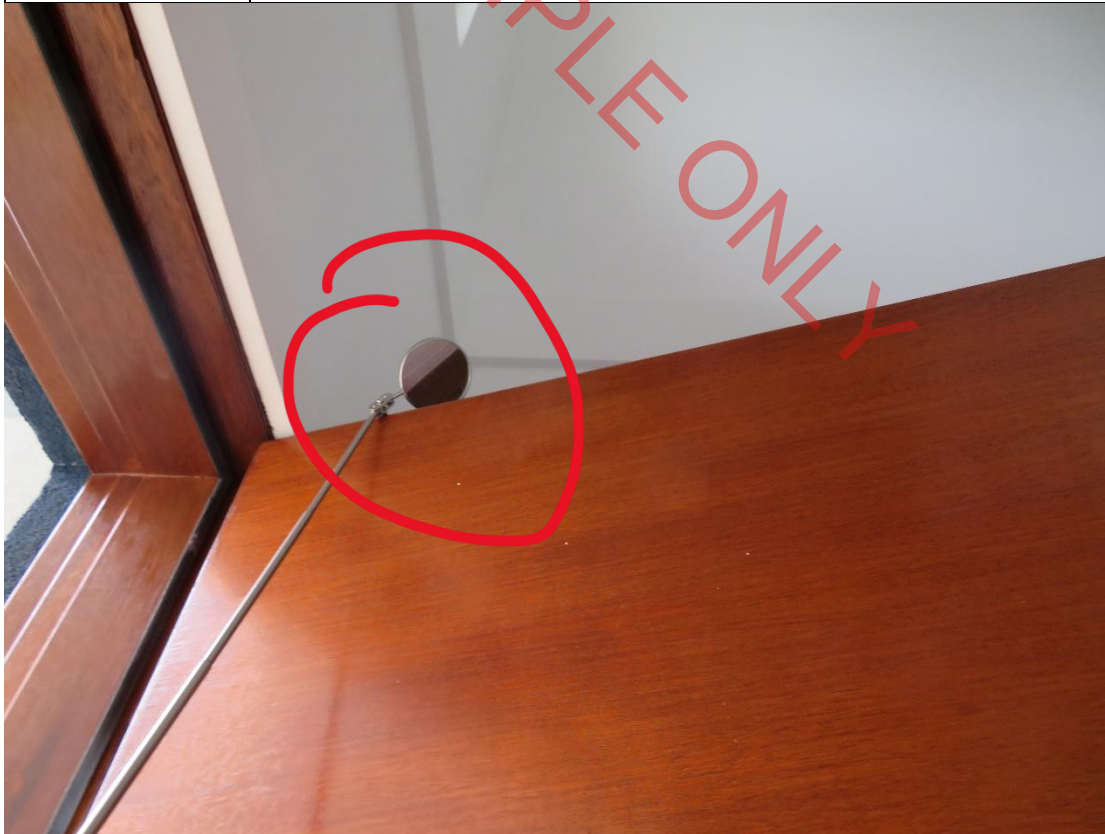
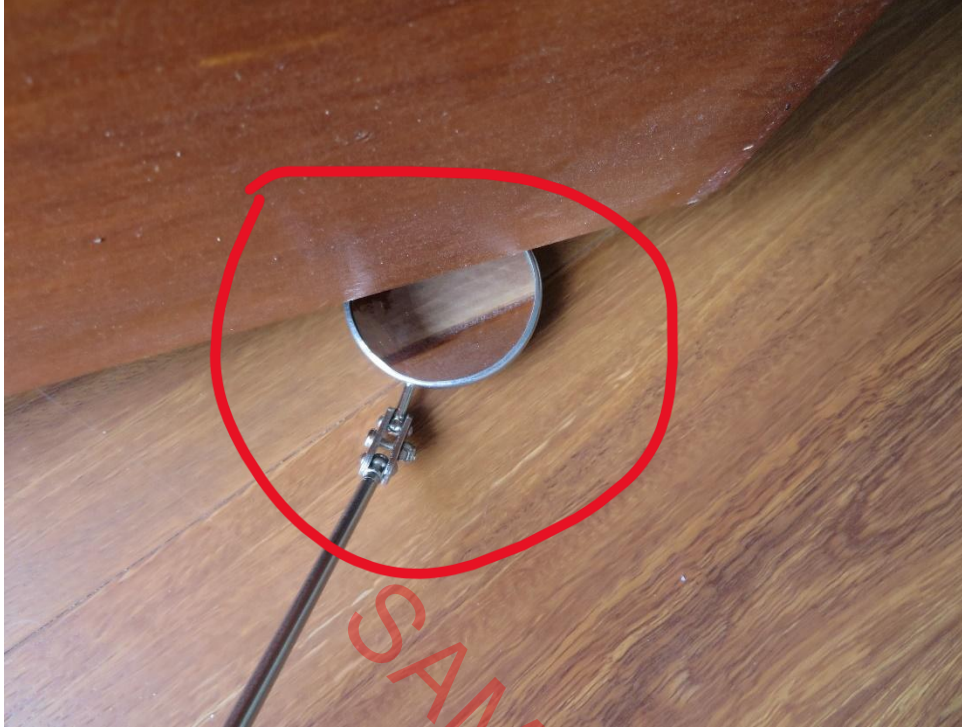
Findings: 9

Location:	Main door
Finding: Information:	<ul style="list-style-type: none">• Bottom of the main door is not sealed• Door frame is not sealed <p>As per VBA GUIDE TO STANDARDS AND TOLERANCES 2015</p> <p>8.06 Sealing of door edges</p> <p>Door leaves are defective if they do not have all sides, top and bottom edges sealed/painted in accordance with the manufacturer's specifications.</p>
Is this item defective?	YES
Is this item incomplete?	Yes
Recommendation	The builder to rectify this finding in accordance with section 8(a) of the Act.

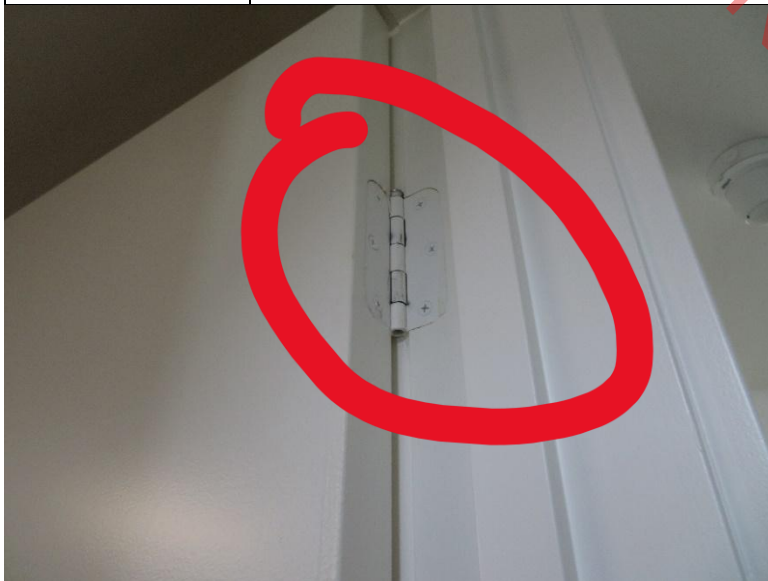
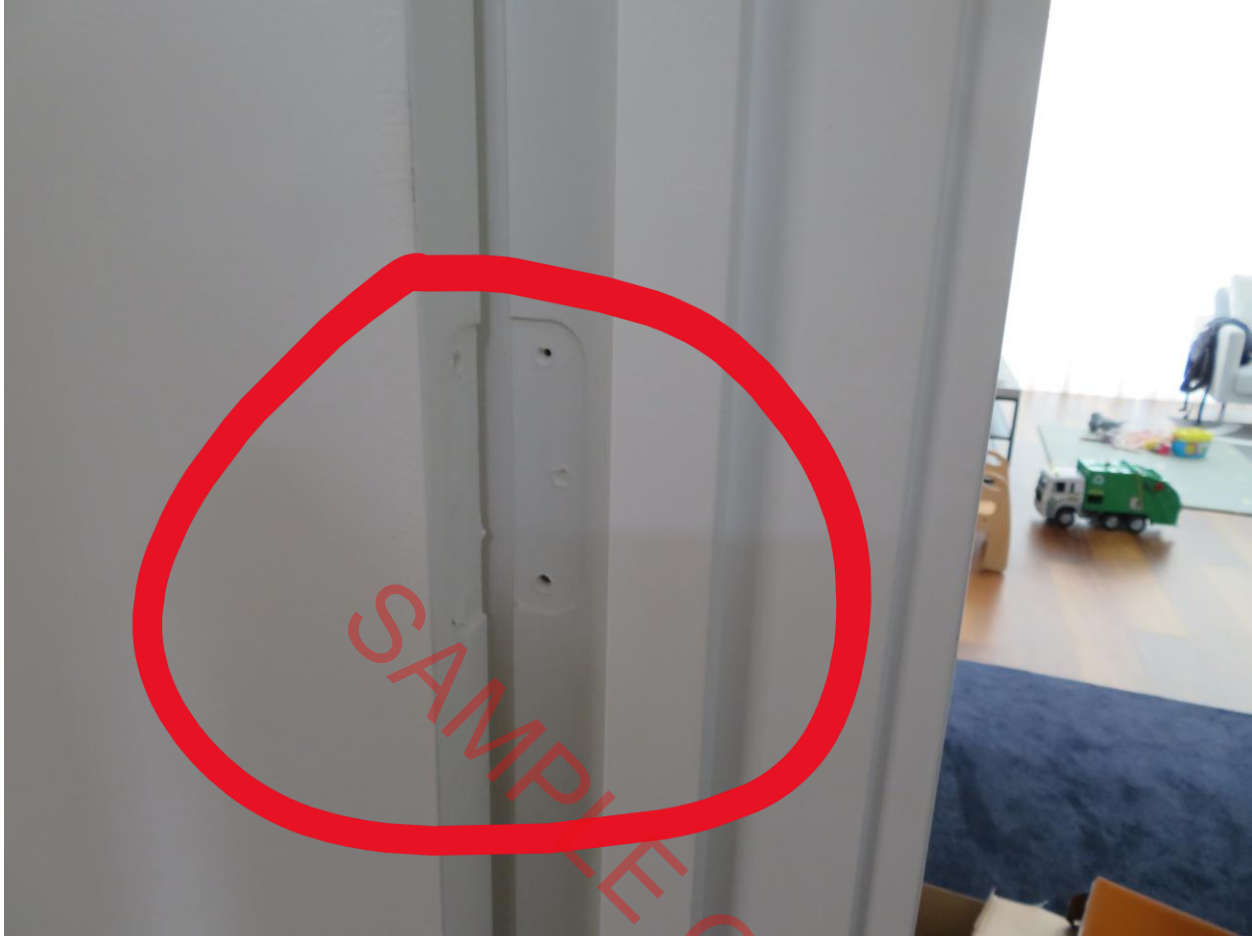
Findings: 9

Location:	Substandard Workmanship
Finding: Information:	<ul style="list-style-type: none">Internal door to garage bottom has paint runoff, missing hinge and poorly finished. <p>As per VBA GUIDE TO STANDARDS AND TOLERANCES 2015</p> <p>12.02 Surface finish of paintwork</p> <p>Paintwork is defective if the application has blemishes such as paint runs, paint sags, wrinkling, dust, bare or starved painted areas, colour variations, surface cracks, irregular and coarse brush marks, sanding marks, blistering, non-uniformity of gloss level and other irregularities in the surface that are visible from a normal viewing position.</p> <p>Paintwork is defective if the application results in excessive over-painting of fittings, trims, skirtings, architraves, glazing and other finished edges.</p>
Is this item defective?	YES
Is this item incomplete?	No
Recommendation	The builder to rectify this finding in accordance with section 8(a) of the Act.
