Post- HANDOVER INSPECTION REPORT

Property Address: Greenvale 3059

Stage of Works: Post Handover

Date of this Report: 11/11/2023

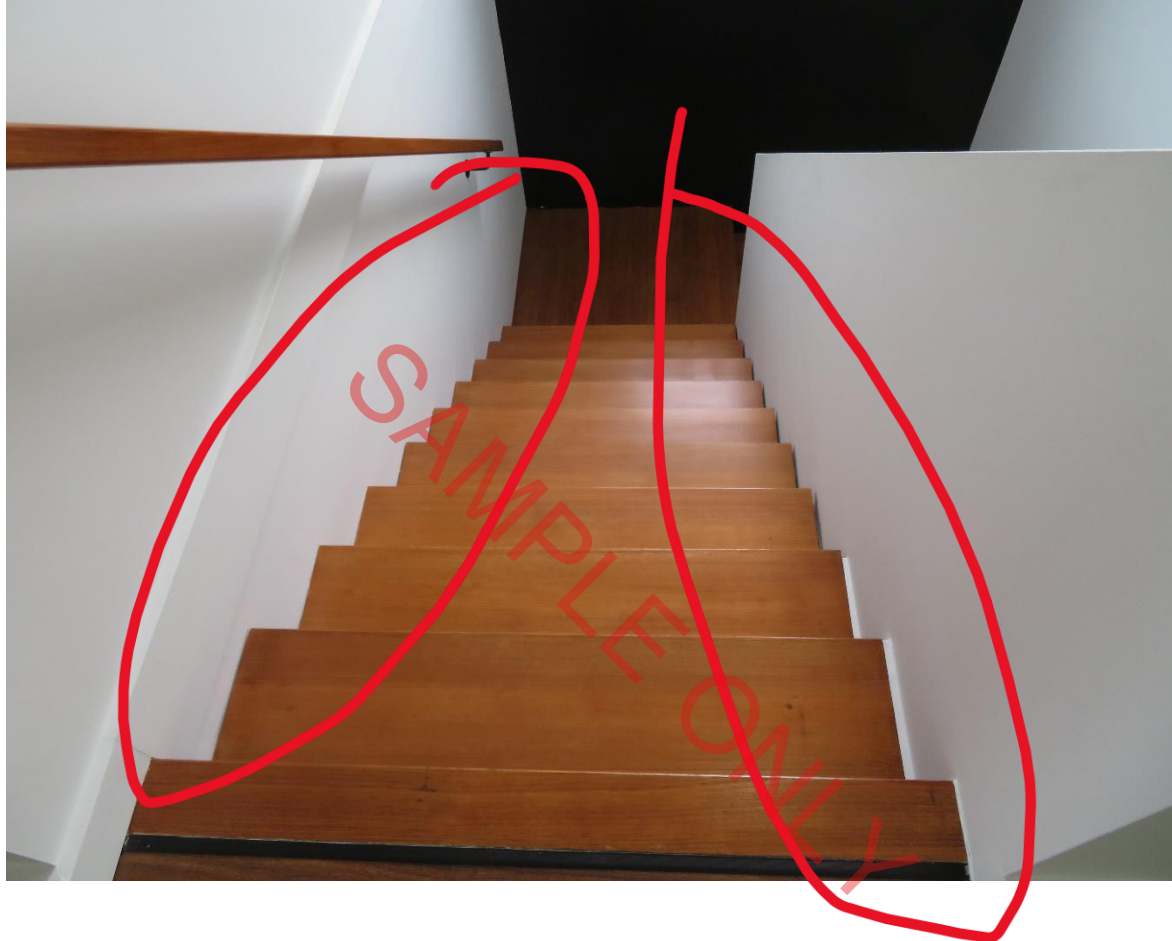
Findings: 10

Location:	Staircase
Finding: Information:	<ul style="list-style-type: none">Staircase is not finished as per the plan and installer specs. As per the manufacturer, it's a concealed stringer which need double plaster to conceal the gaps between treads and stringer. Builder has failed to follow their specs and poorly finished the stairs. <p>As per VBA GUIDE TO STANDARDS AND TOLERANCES 2015</p> <p>4.06 Treads and risers in timber stairs Timber stairs are defective if they do not comply with the requirements of the Building Code of Australia.</p>

The finished riser and going dimensions after installation of floor finishes nominated in the contract are defective if they do not result in consistent riser and going dimensions as required by the BCA.

Is this item defective?	YES
Is this item incomplete?	Yes
Recommendation	The builder to rectify this finding in accordance with section 8(a) of the Act.

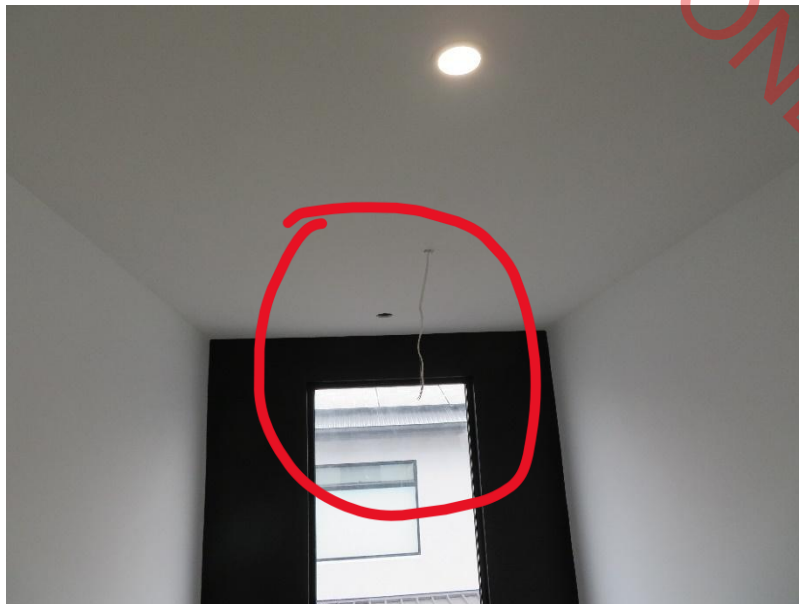
Findings: 11

Location:	Safety Hazard (Electrical)
Finding: Information:	<ul style="list-style-type: none">• Suspected live wire hanging in the void area above stair landing• Incomplete electrical Fitoff <p>As per VBA GUIDE TO STANDARDS AND TOLERANCES 2015</p> <p>15.01 Electrical</p> <p>Any electrical work is defective if it does not comply with the relevant regulations or the contract documents.</p> <p>The builder shall provide the owner with a Certificate of Electrical Safety when a certificate is required to be issued by the licensed electrician.</p>
Is this item defective?	YES
Is this item incomplete?	YES
Recommendation	The builder to rectify this finding in accordance with section 8(a) of the Act.

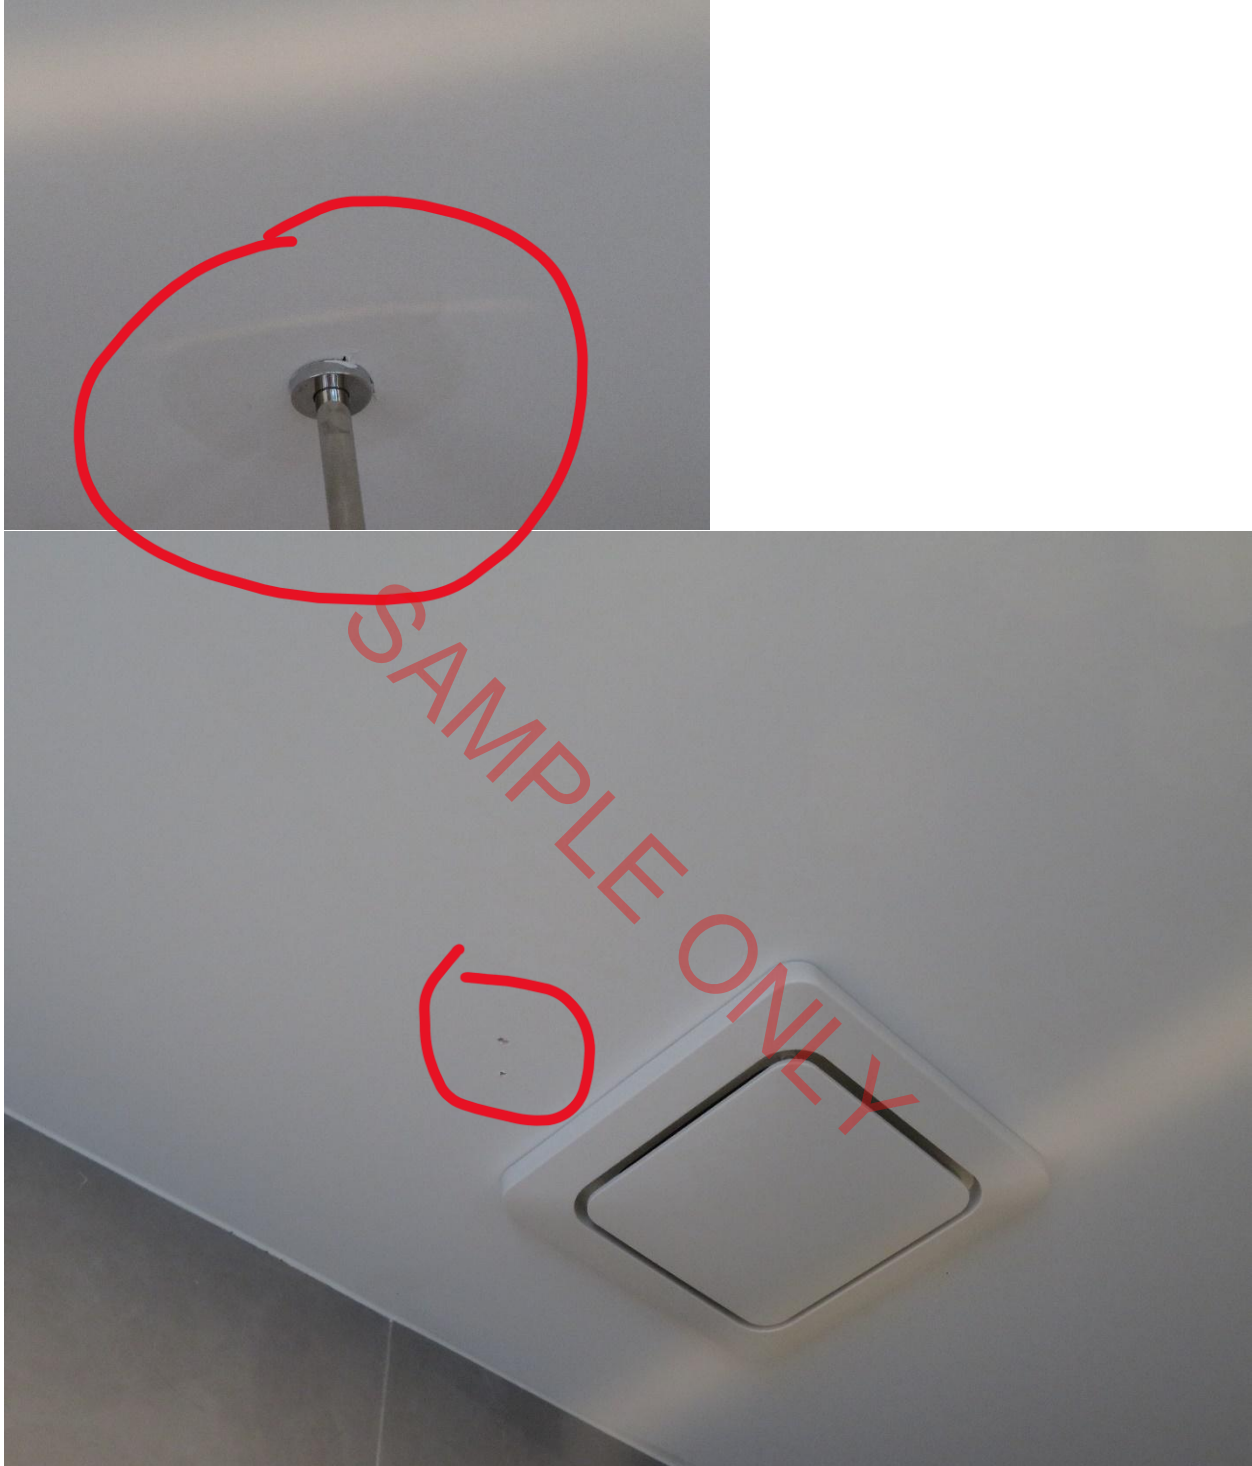
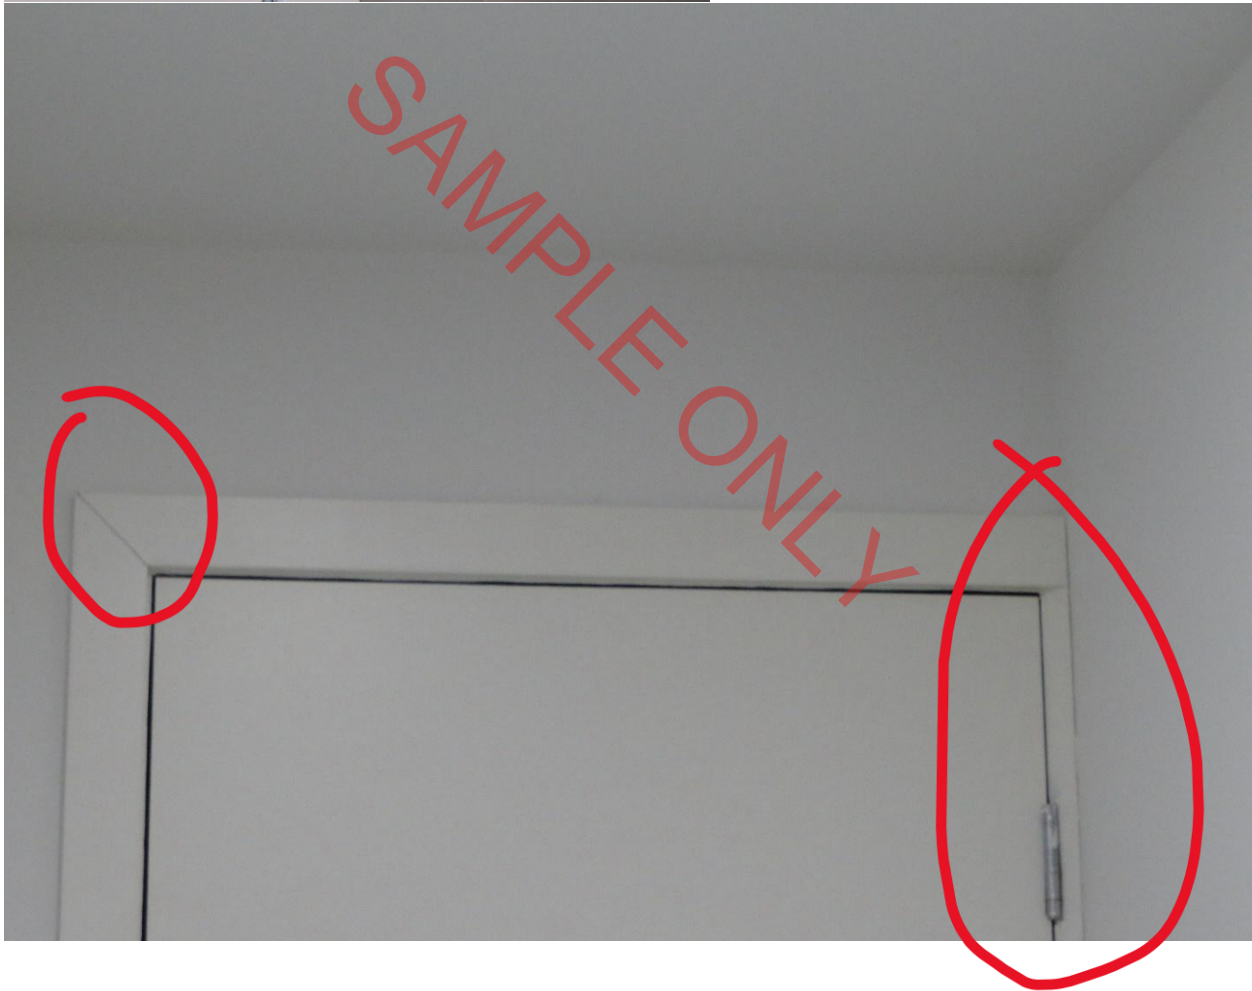
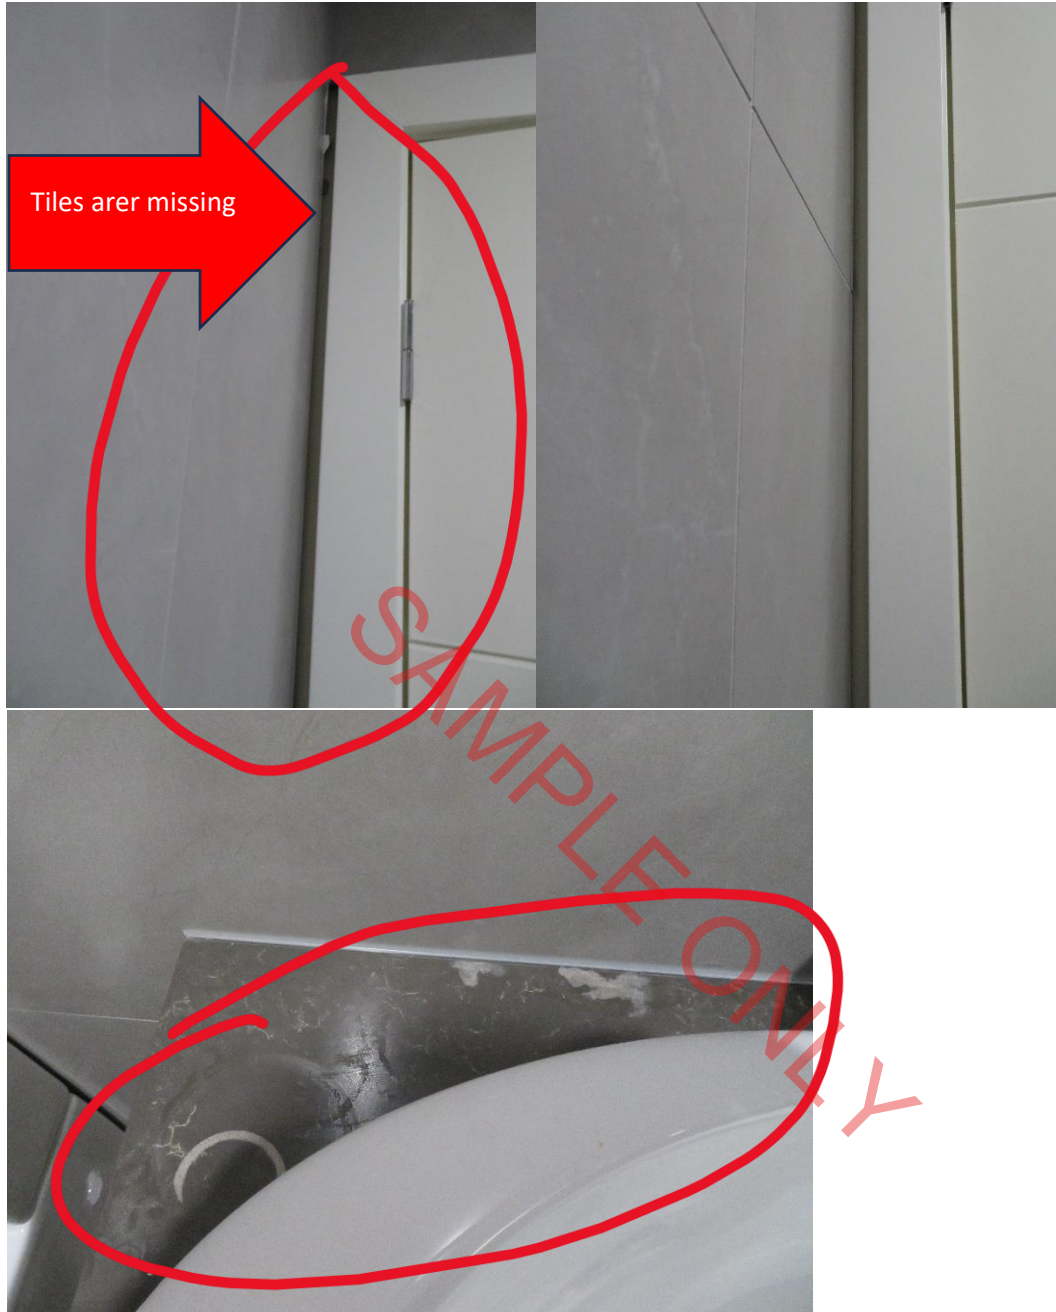
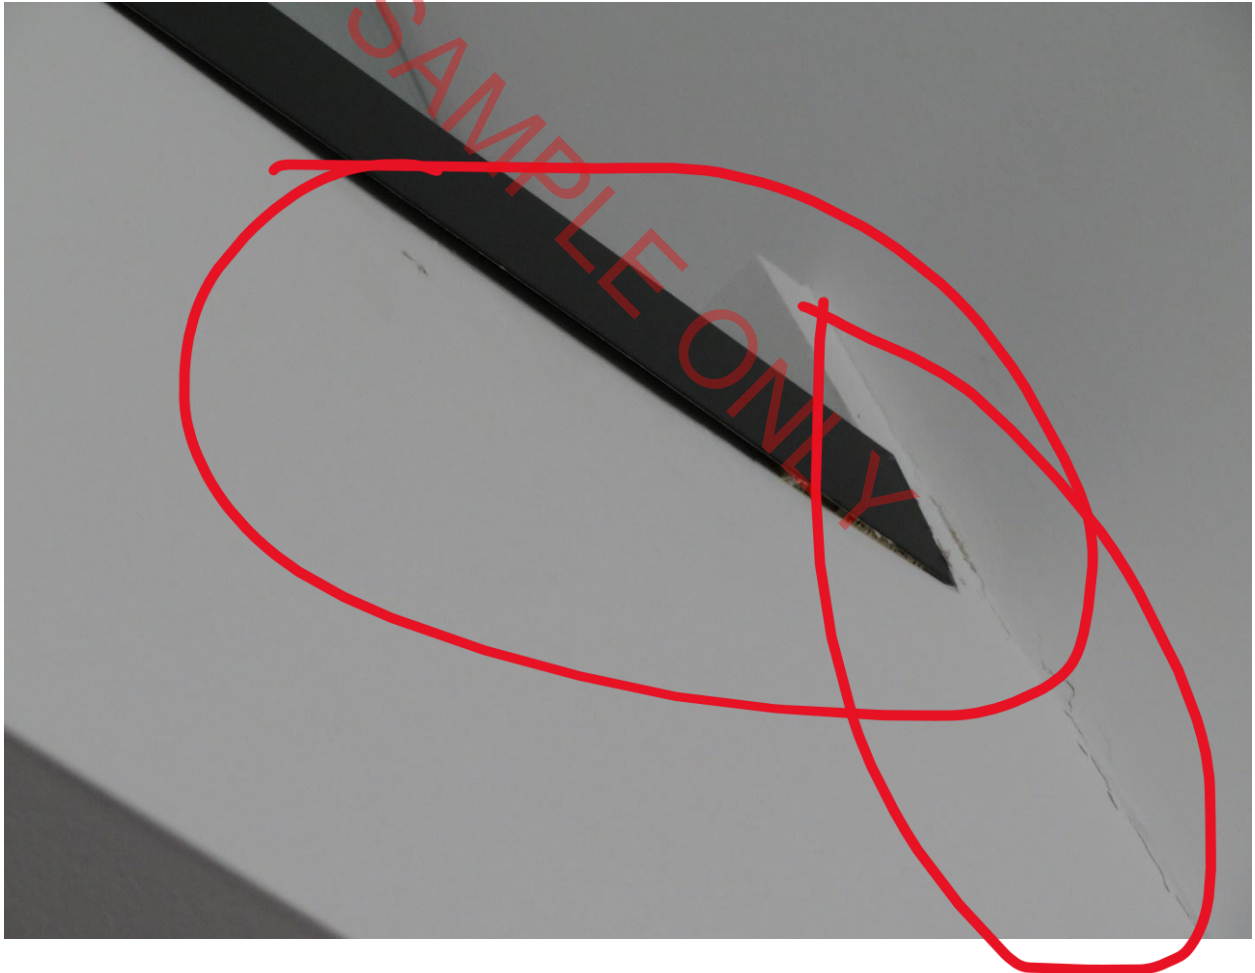
Findings: 12

Location:	Various
Finding: Information:	<p>First Floor</p> <ul style="list-style-type: none"> • Powder room: Distorted silicone on top of the door frame. • Balustrade channel is scratched • Plaster wall has visible dents and scuff marks (TV wall) • Balcony ceiling paint is poorly finished in the grooves • Balcony capping is done as per the regulation • Paint touch ups are required (widespread) • Ineffective caulking behind the free-standing bath. <p>Ground Floor:</p> <ul style="list-style-type: none"> • Under the stairs storage ceiling needs gap filling and touchups. • Pantry Bulkhead needs to be painted. • Plaster repair is required behind the range hood (Butler's pantry) • Bedroom 2 door hinge – Missing screw • Powder room stone benchtop is damaged with grinder marks. • Ensuite shower head needs to be sealed properly and dents and scratches need to be repaired.
Is this item defective?	YES

Is this item incomplete?	YES
Recommendation	The builder to rectify this finding in accordance with section 8(a) of the Act.
