Building and Timber Pest Inspection Report

Inspection Date: Wednesday, September 18, 2024
Property Address: Truganina 3029

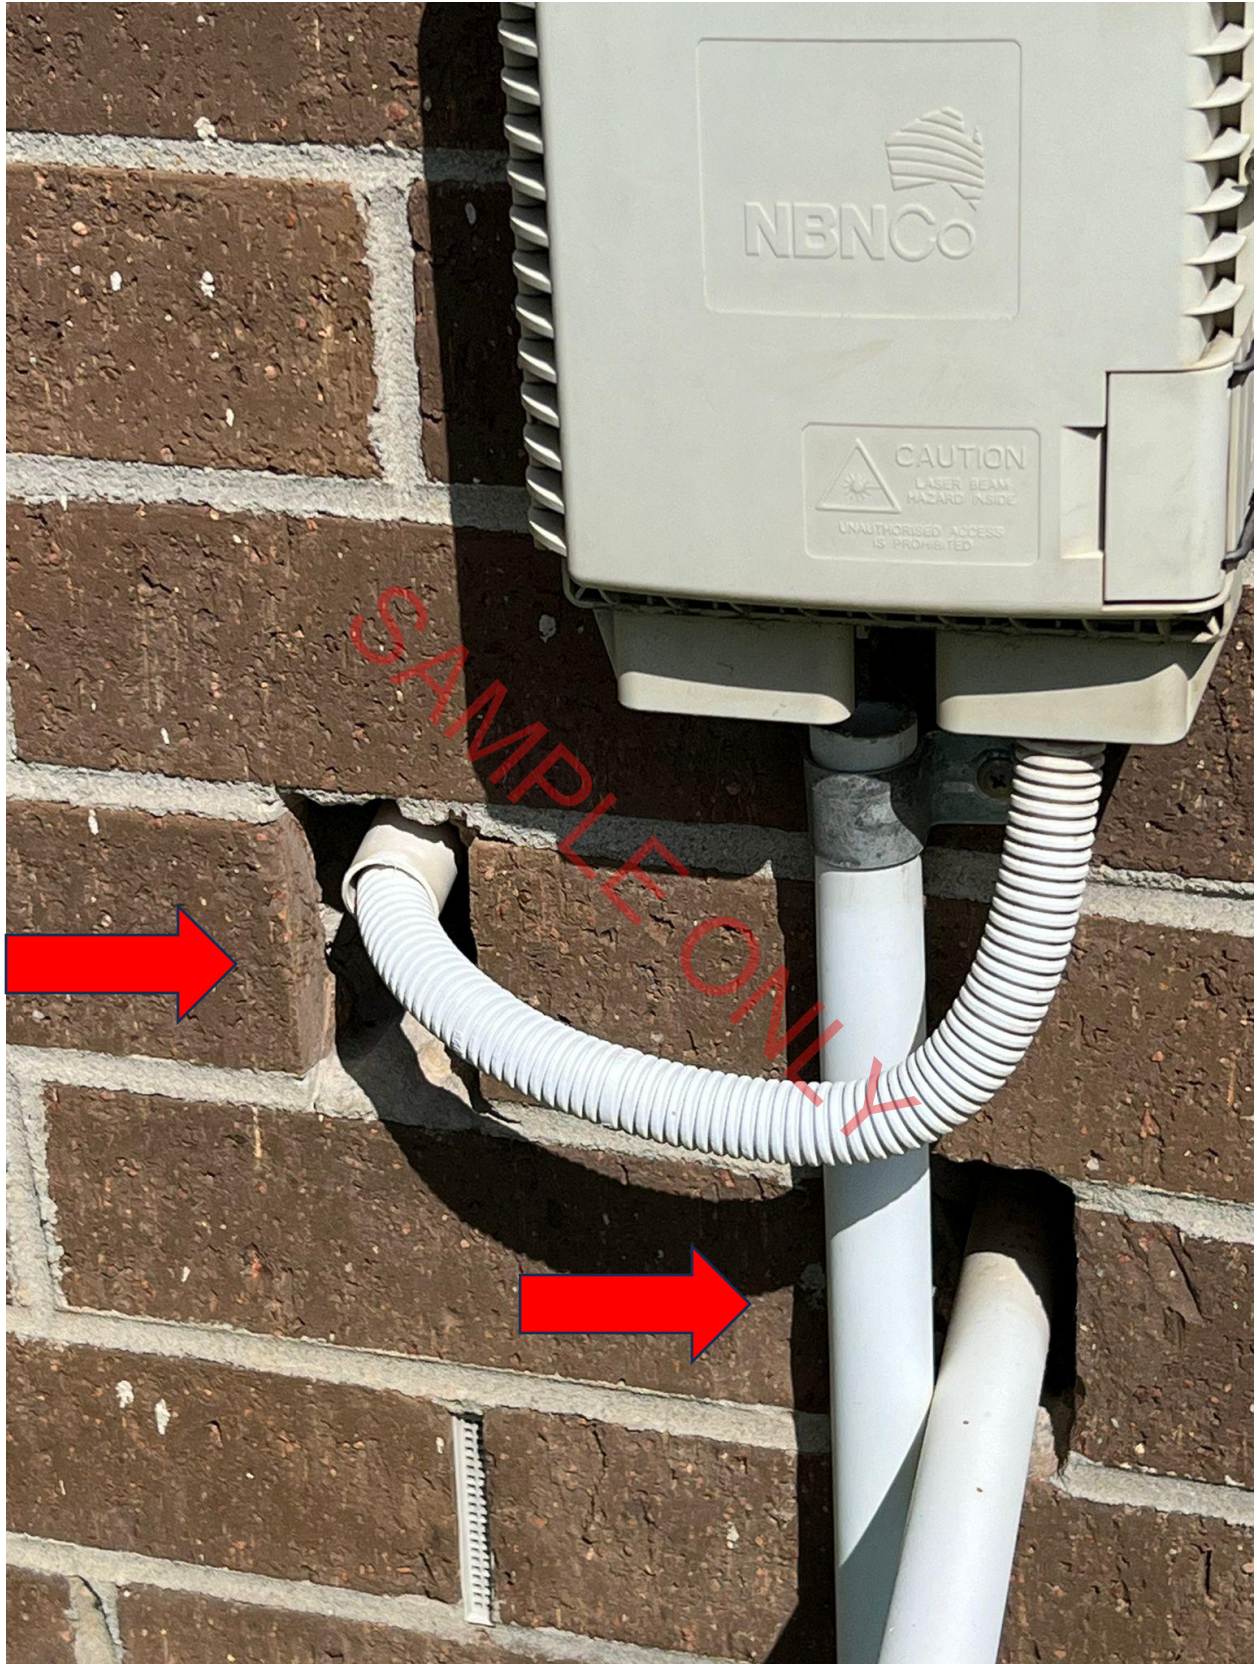
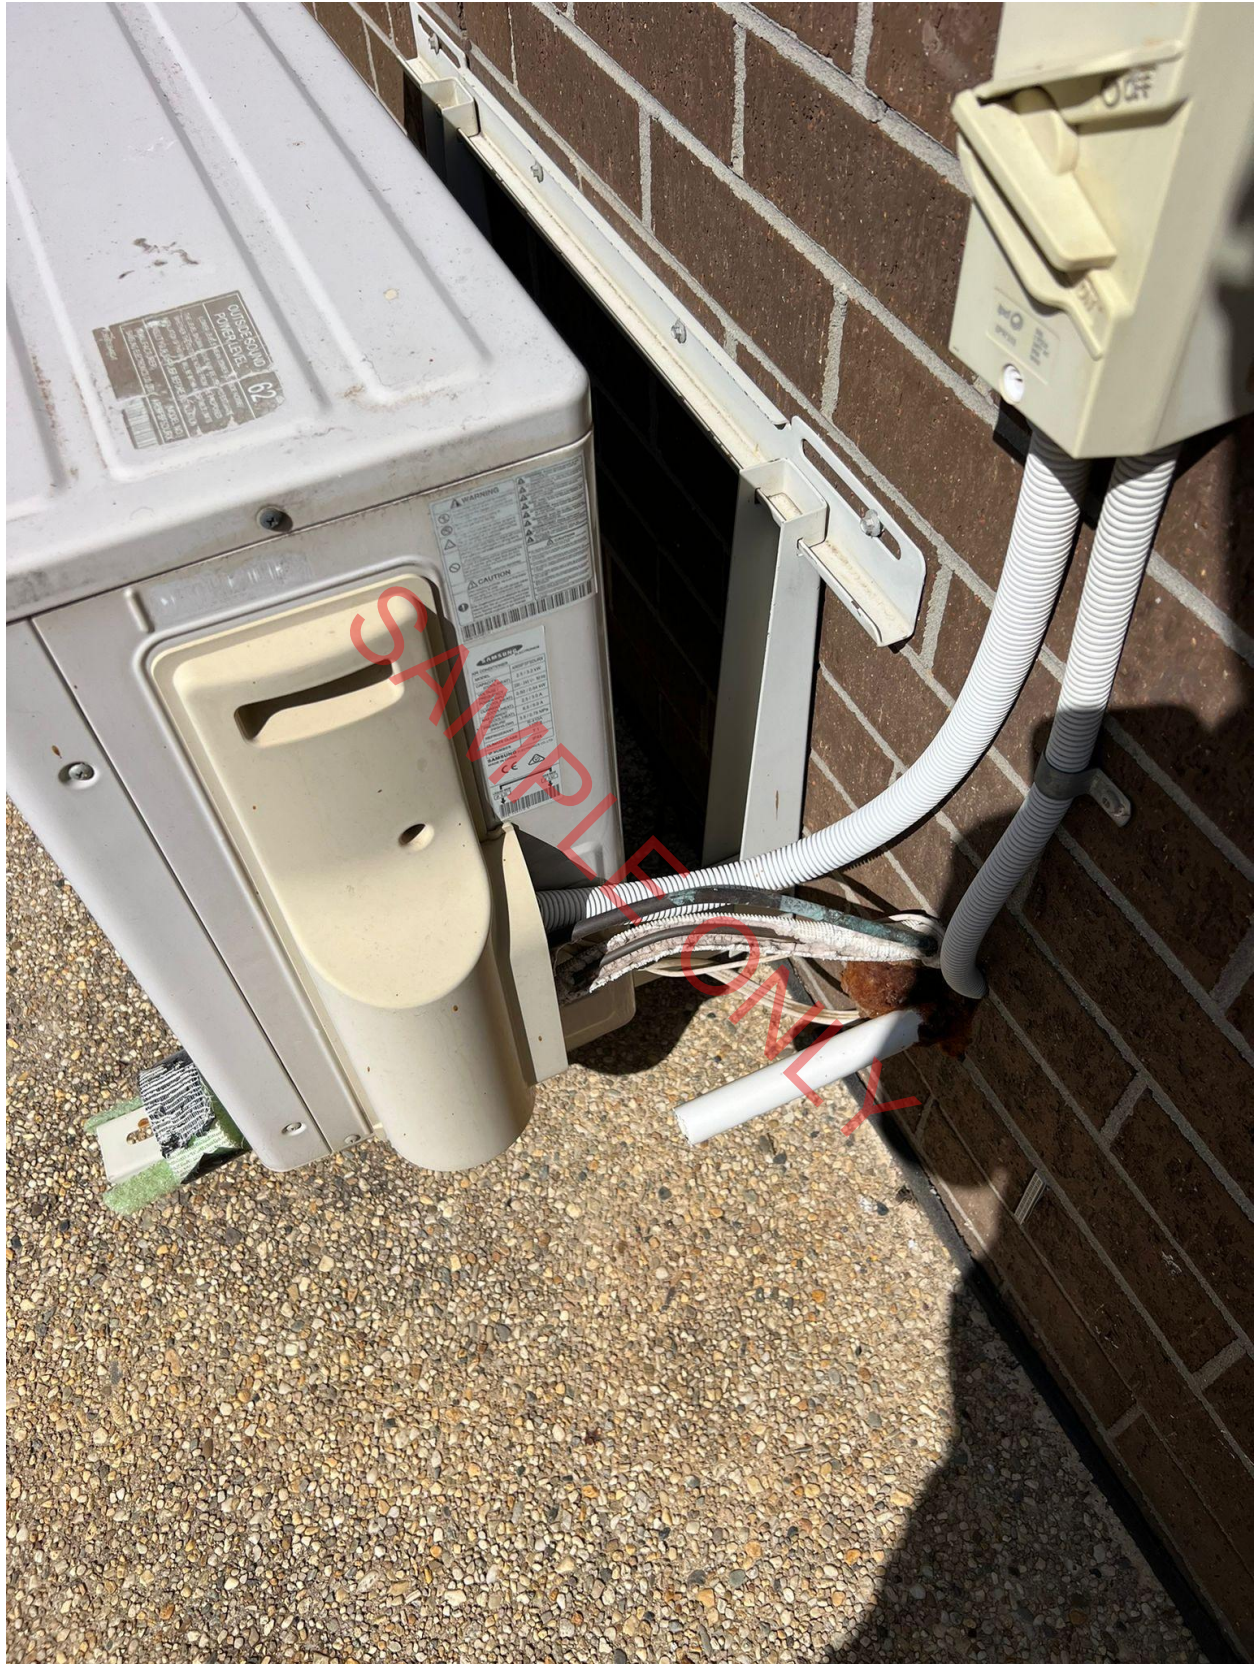
DEFECT: 1.0

Location: Finding:	Wall penetrations – Aircon drains
Information:	<p>If wall penetrations are not properly sealed, it's a potential BCA Non-Compliance. Wall penetrations, such as for pipes, cables, or ducts, need to be sealed to prevent water, air, or pest infiltration, as well as to maintain insulation and fire safety standards.</p> <p>Unsealed penetrations could lead to water damage, mold growth, or energy inefficiency.</p> <p>We recommend sealing these gaps to meet the necessary safety and compliance requirements in Victoria.</p> <p>Please refer to the Victorian Building Authority </p> <p>GUIDE TO STANDARDS AND TOLERANCES 2015: 7.08</p> <p>Pipe penetrations through external walls and inside cupboards Plumbing holes are defective if they are not:</p> <ul style="list-style-type: none">a) properly grouted as appropriateb) fitted through neat minimal size penetrations (in the case of cabinetwork)c) fitted with tight fitting cover plates or collars with penetrations kept to the smallest size practicable. <p>Seal penetrations with appropriate material. Please consult a builder to rectify the issue."</p> <p>End Sub</p>

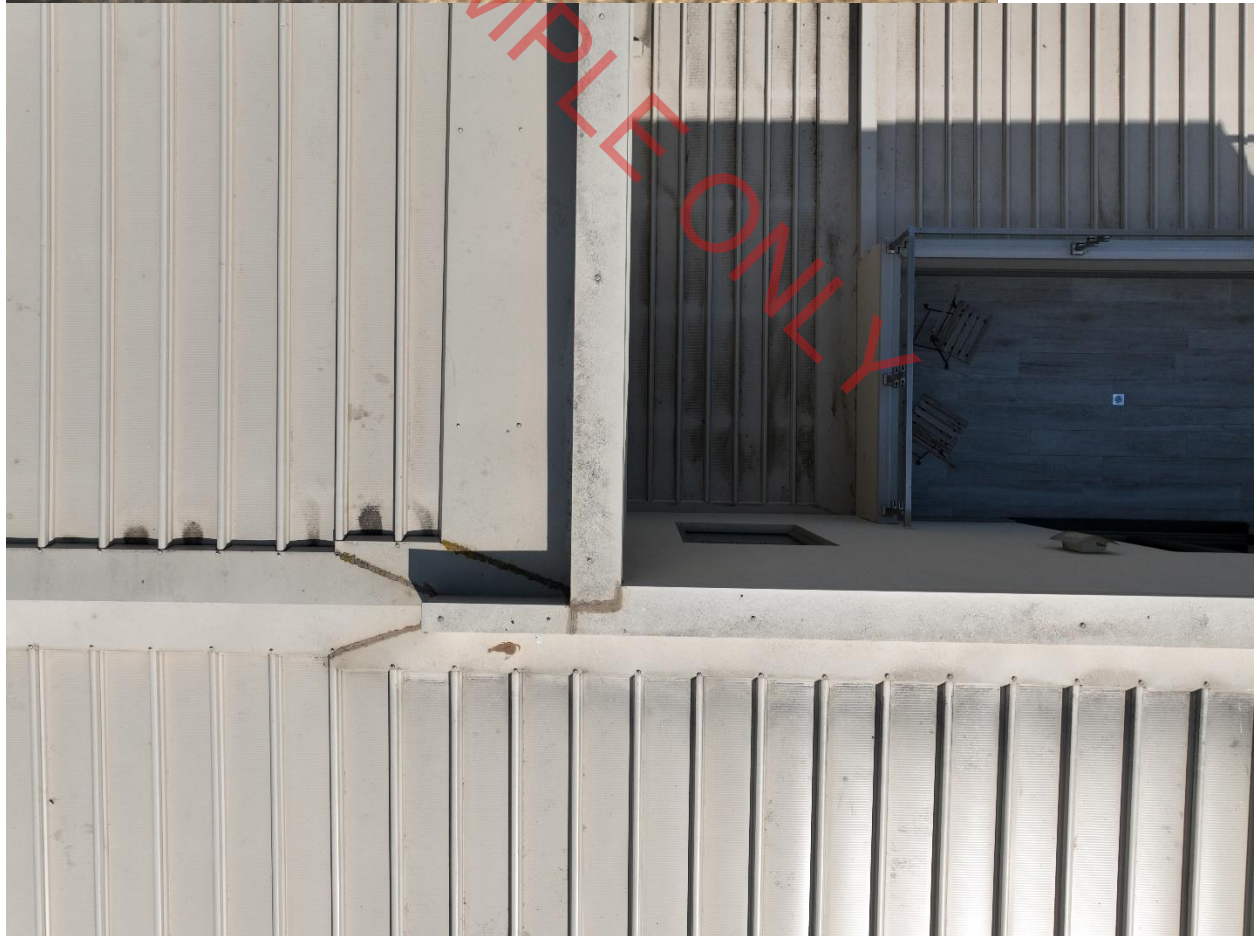
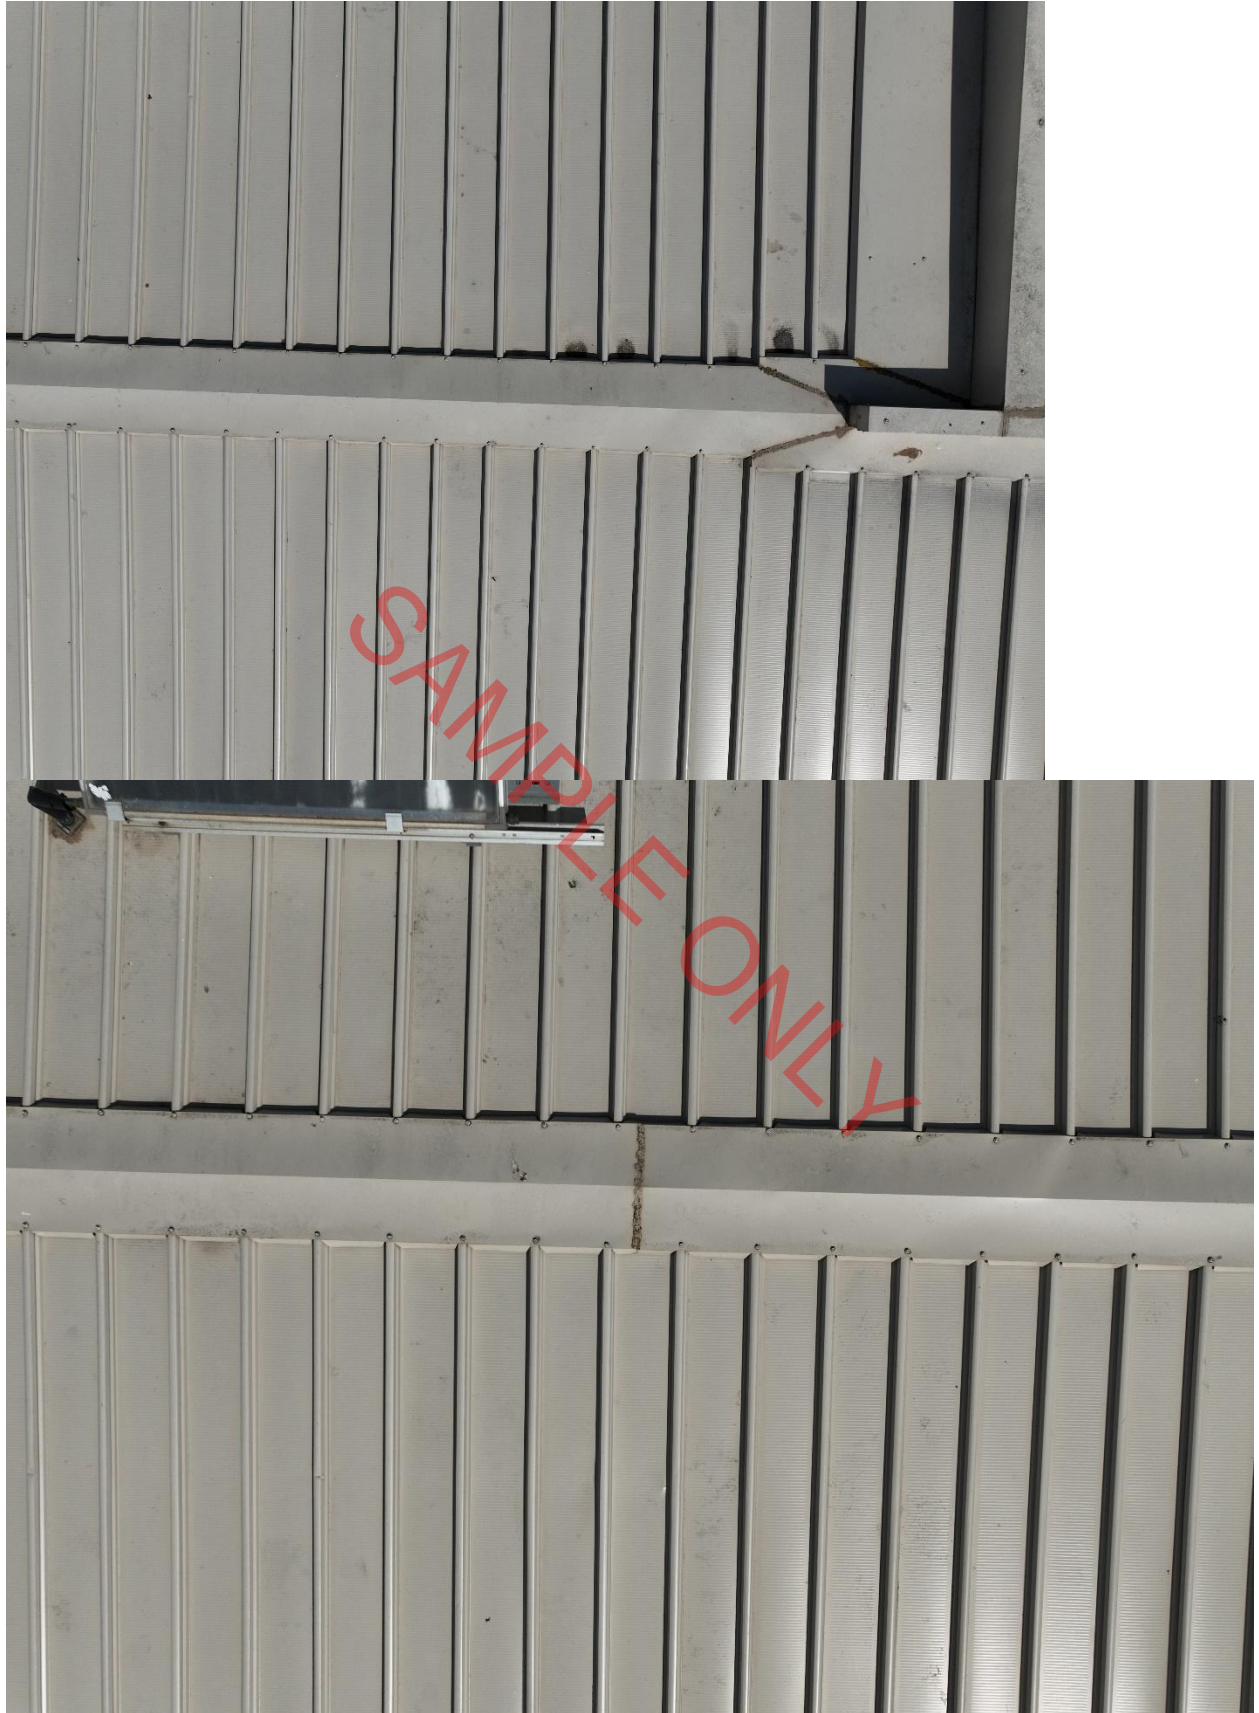
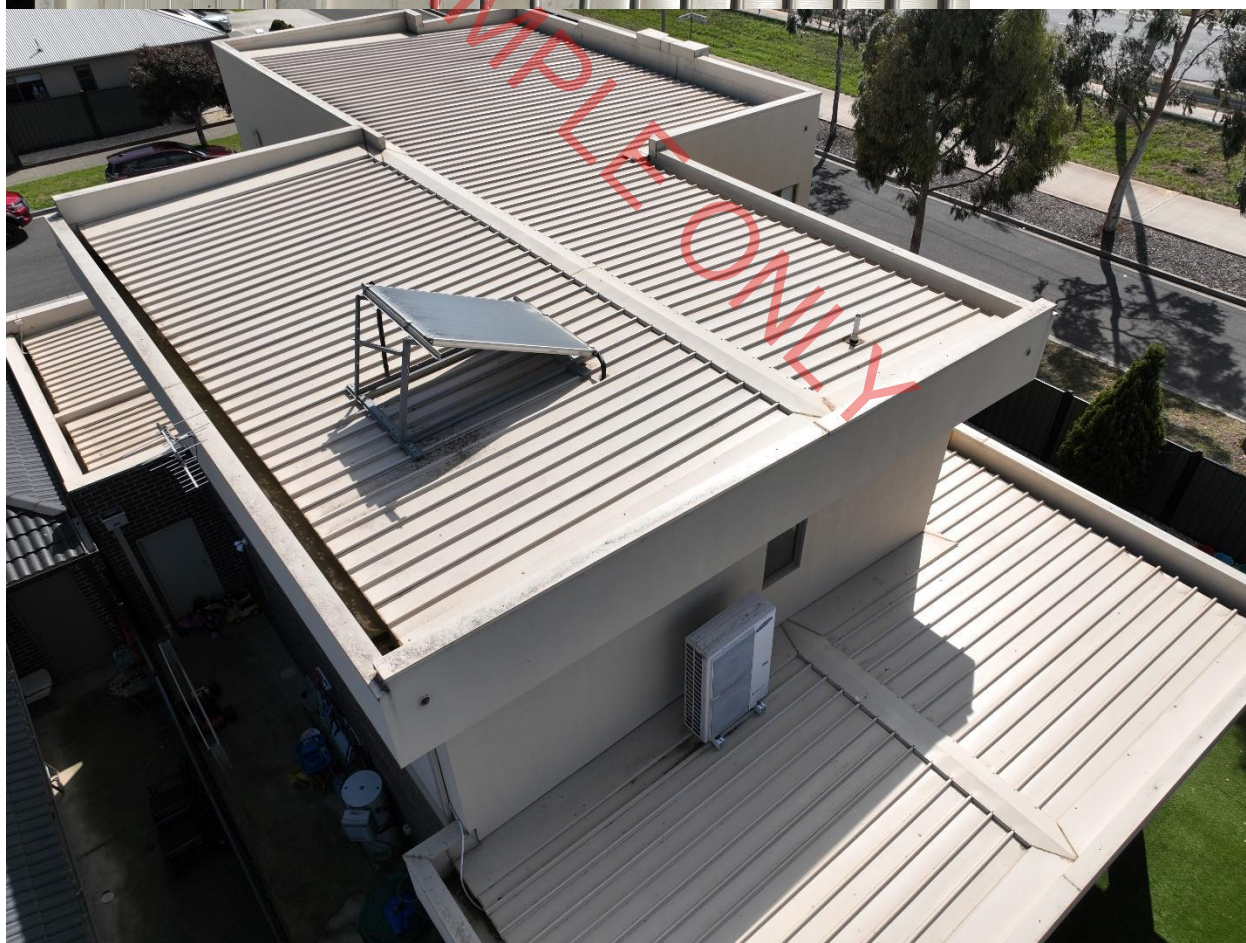
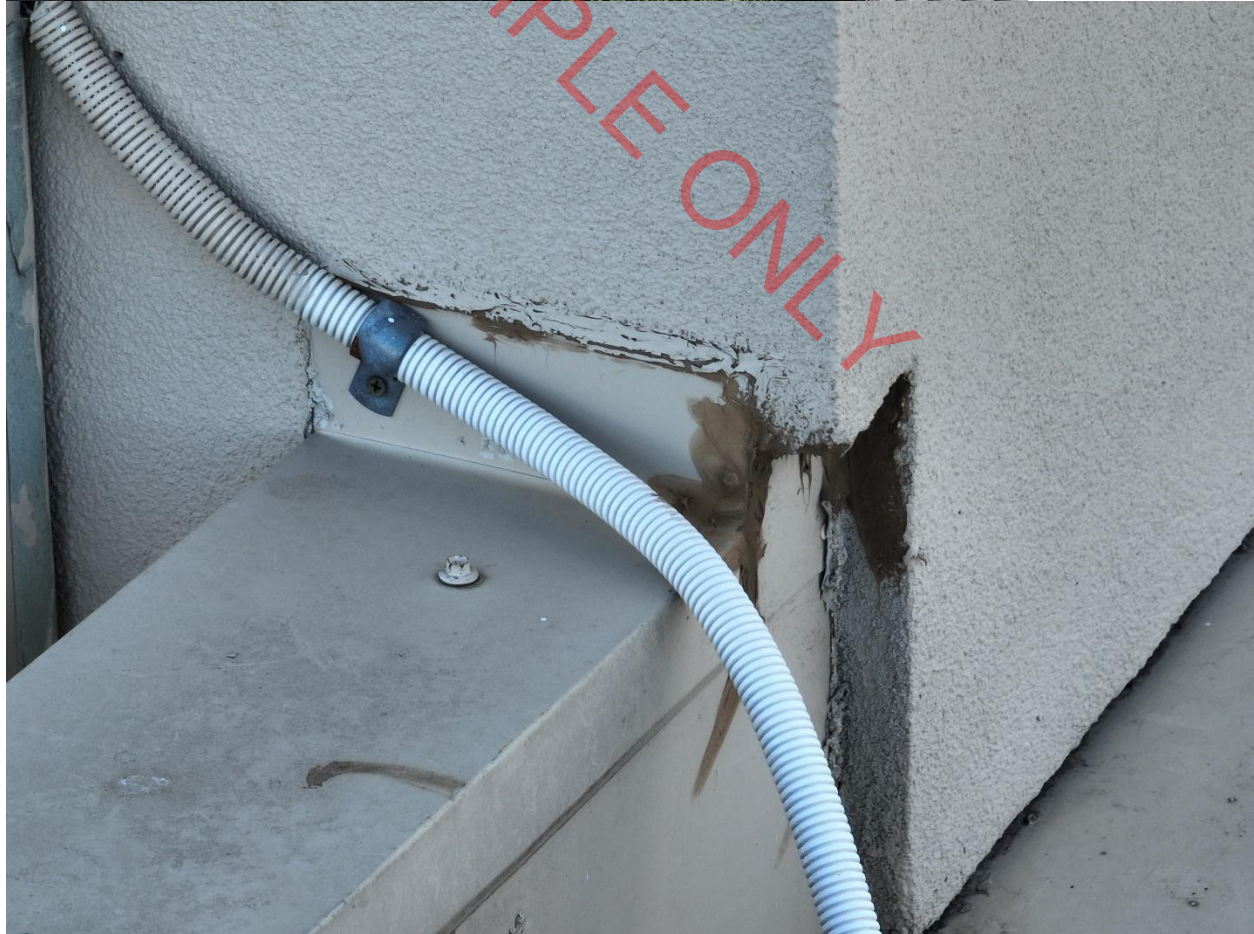
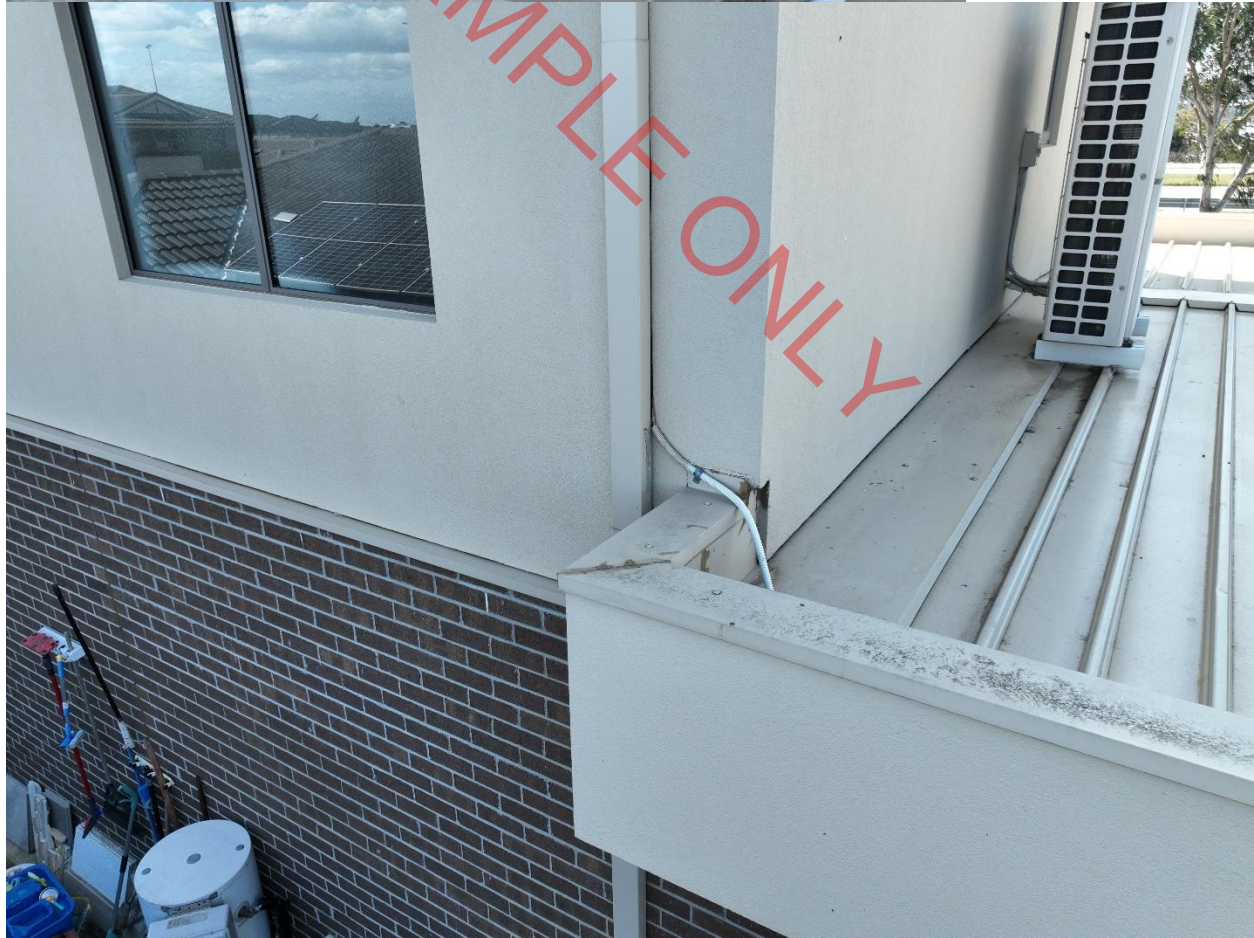
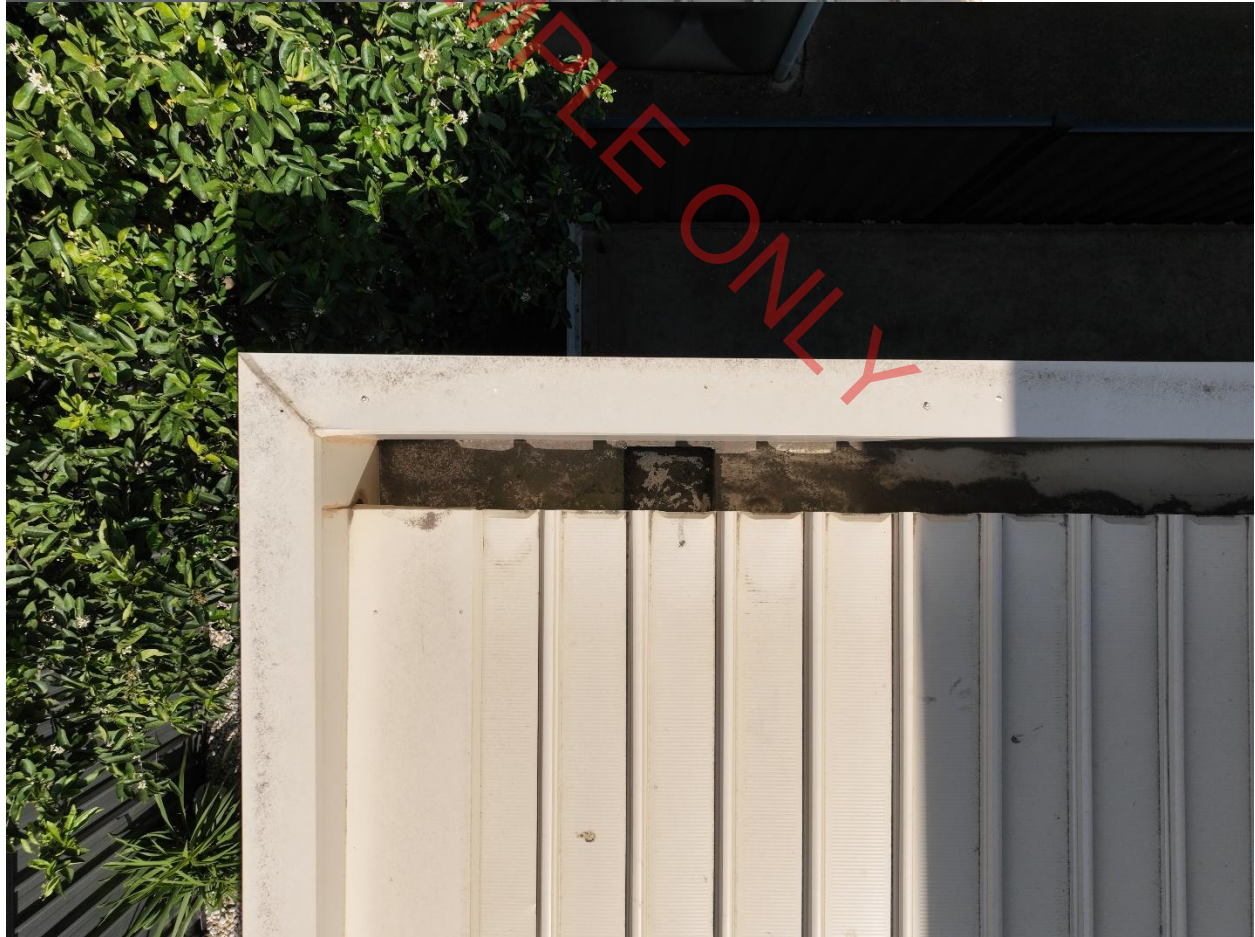
Findings: 1.0

Location: Finding:	Roof Inspection by Drone
Information:	<p>1. Roof Covering Condition: The roof covering appears to be in generally good condition. There are no visible signs of major damage such as cracks or missing tiles. Minor wear and tear consistent with the age of the roof was observed, but no immediate repairs are required.</p> <p>2. Box Gutters Observation: The box gutters were found to be holding some water, which may indicate poor drainage or slight sagging in some areas.</p> <p>Condition: The gutters are also filled with dirt and debris, which is likely contributing to the water retention issue.</p> <p>Recommendation: It is recommended to clean the gutters and check for any obstructions. If water pooling persists after cleaning, further inspection for slope and drainage problems should be conducted.</p> <p>3. Capping and Flashings:</p> <p>Observation: The capping and flashings are in good structural condition, with no signs of rust or damage.</p> <p>Condition: However, the silicone applied at joints and seams appears to be distorted in some areas.</p> <p>Recommendation: The distorted silicone should be checked and replaced where necessary to ensure a watertight seal and prevent potential water ingress.</p> <p>Overall Condition: Overall, the roof is in functional condition, but some minor maintenance tasks such as cleaning the gutters and addressing the silicone in the capping and flashings are recommended to maintain its integrity.</p> <p>Conclusion: While no significant issues were identified during this inspection, routine maintenance should be carried out to prevent small issues from developing into larger problems. Addressing the</p>

silicone and cleaning the box gutters will ensure the longevity of the roof.
--	--

Please consult a registered roof plumber to address the concerns.
--	---

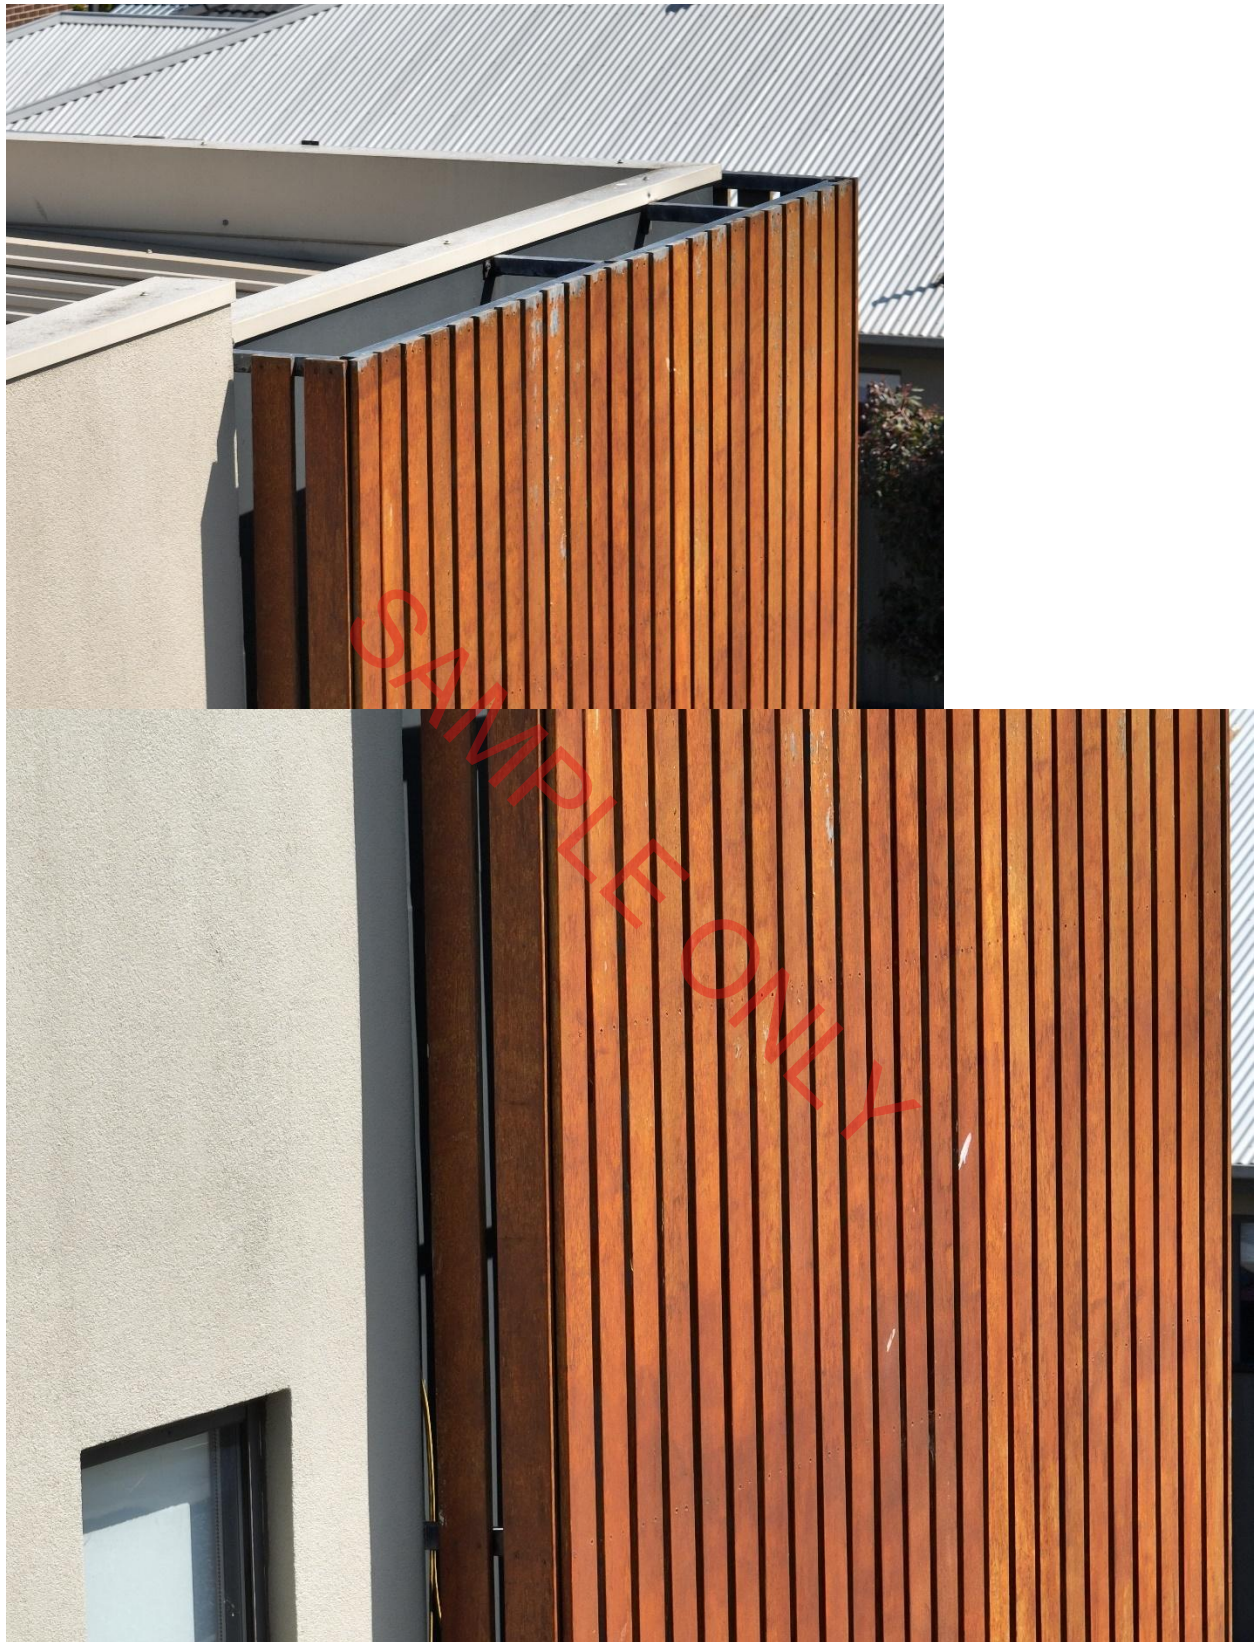
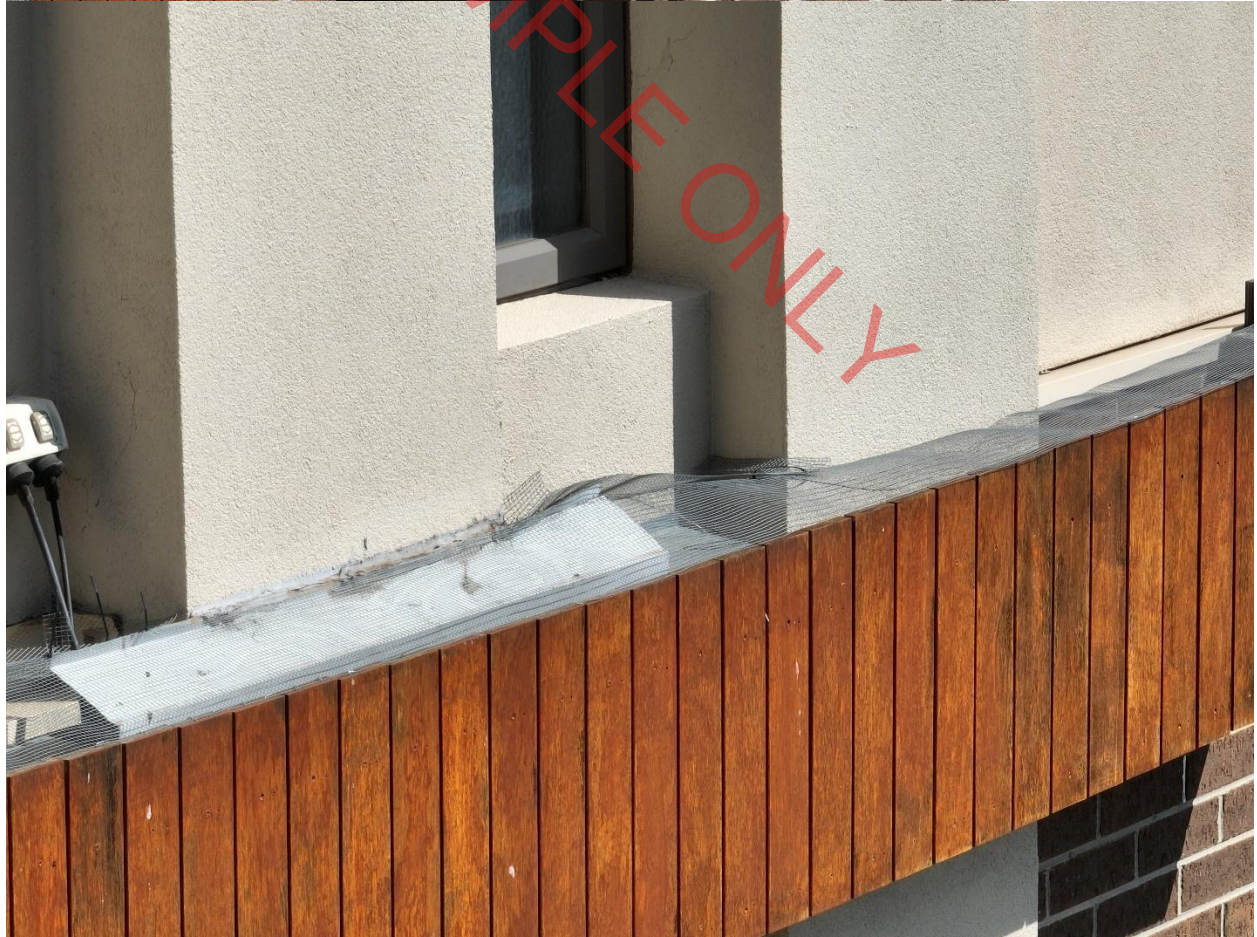
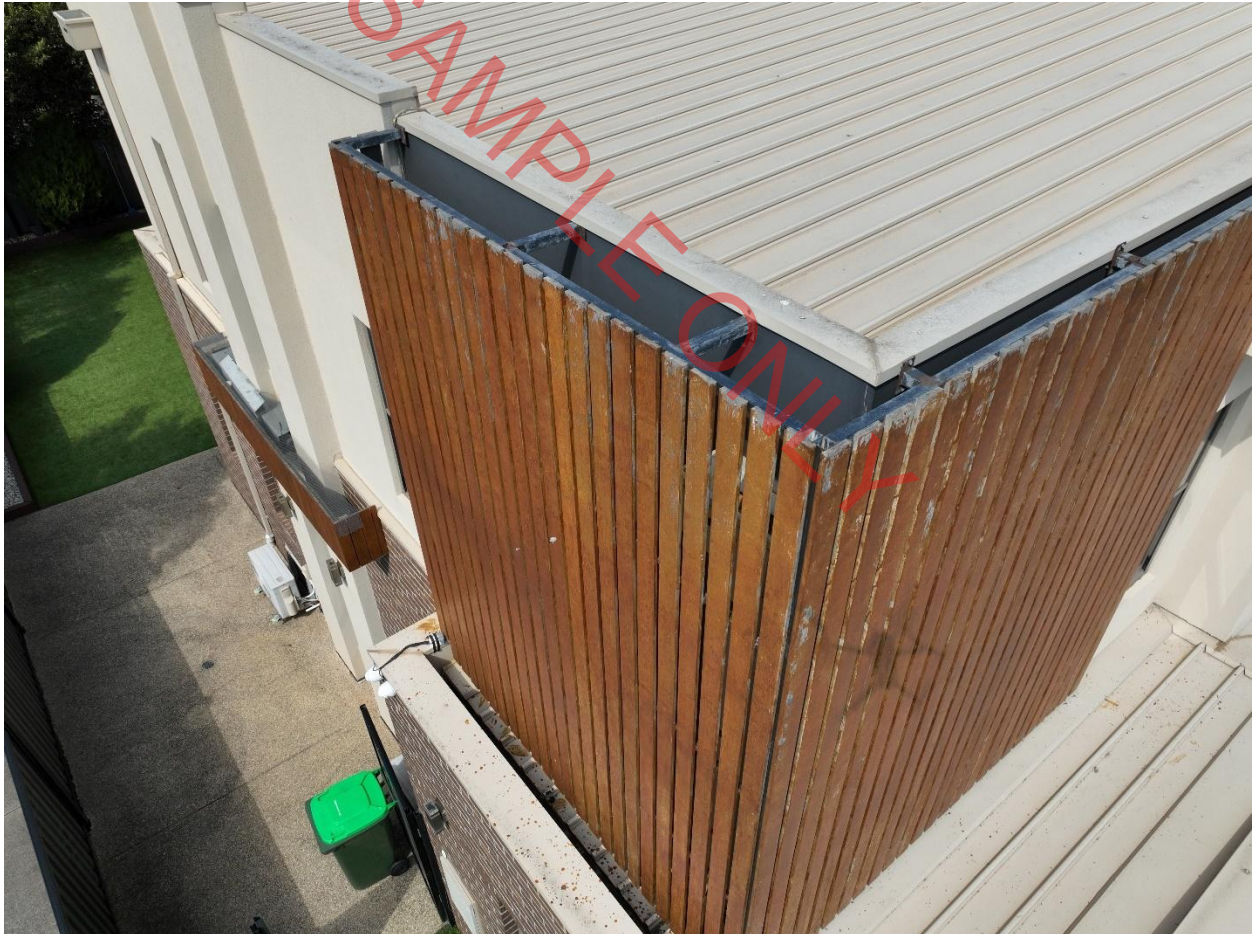
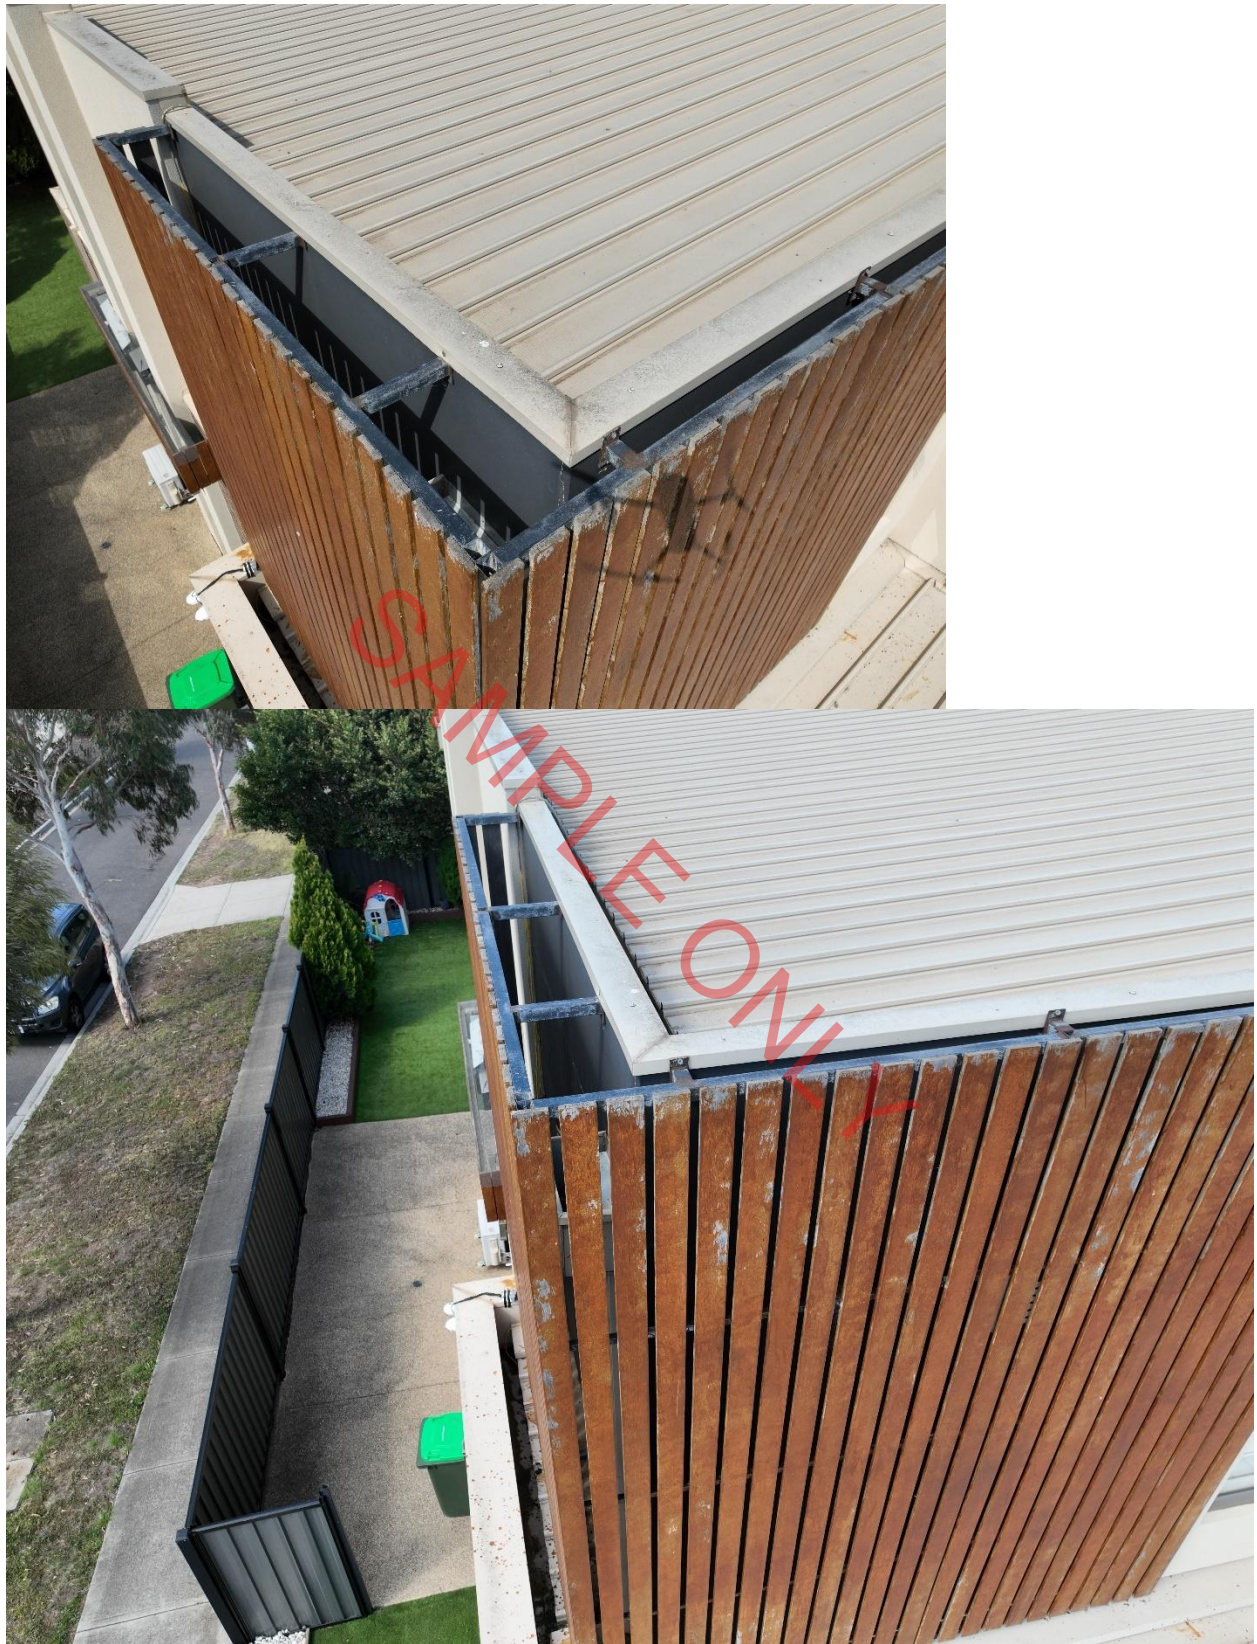
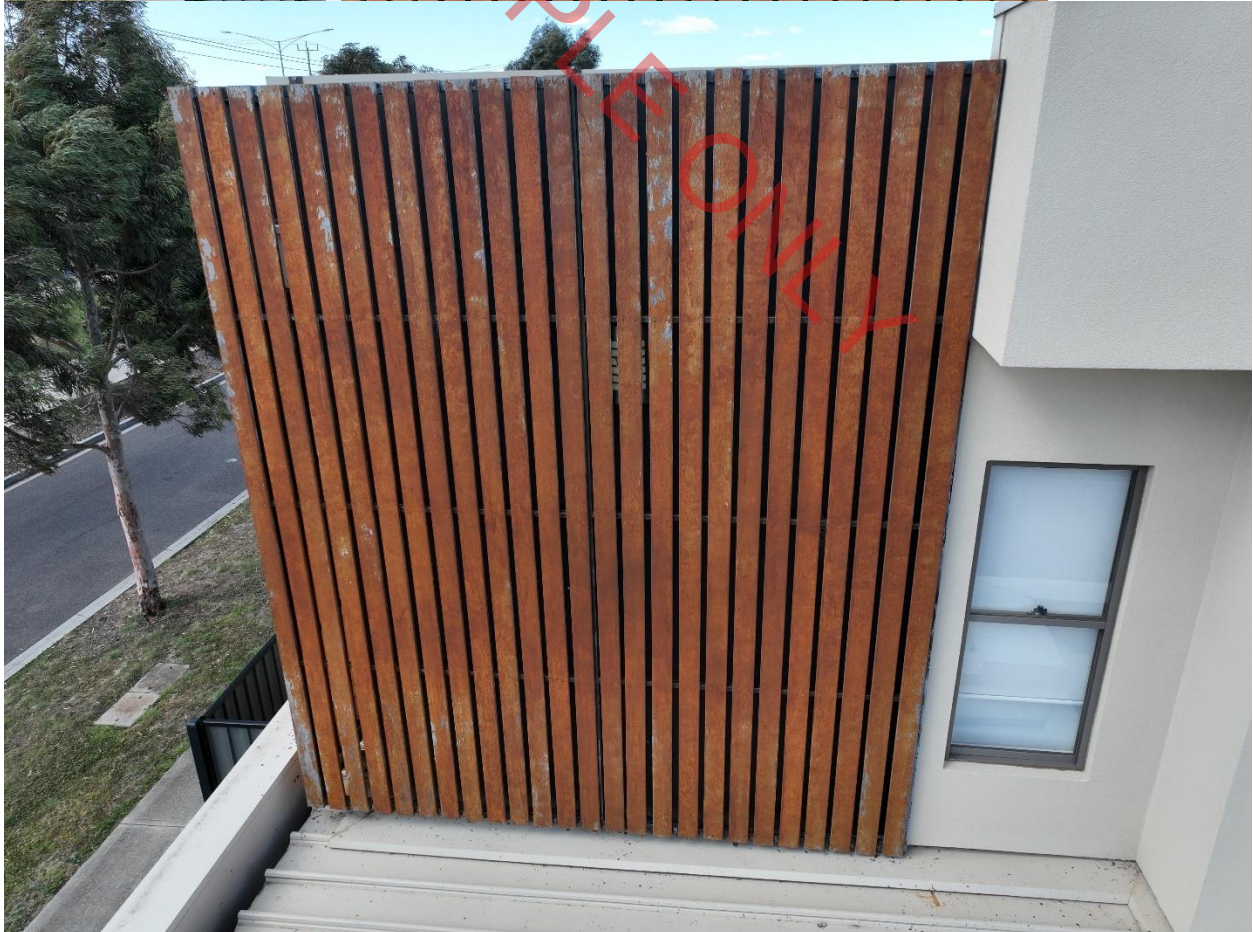
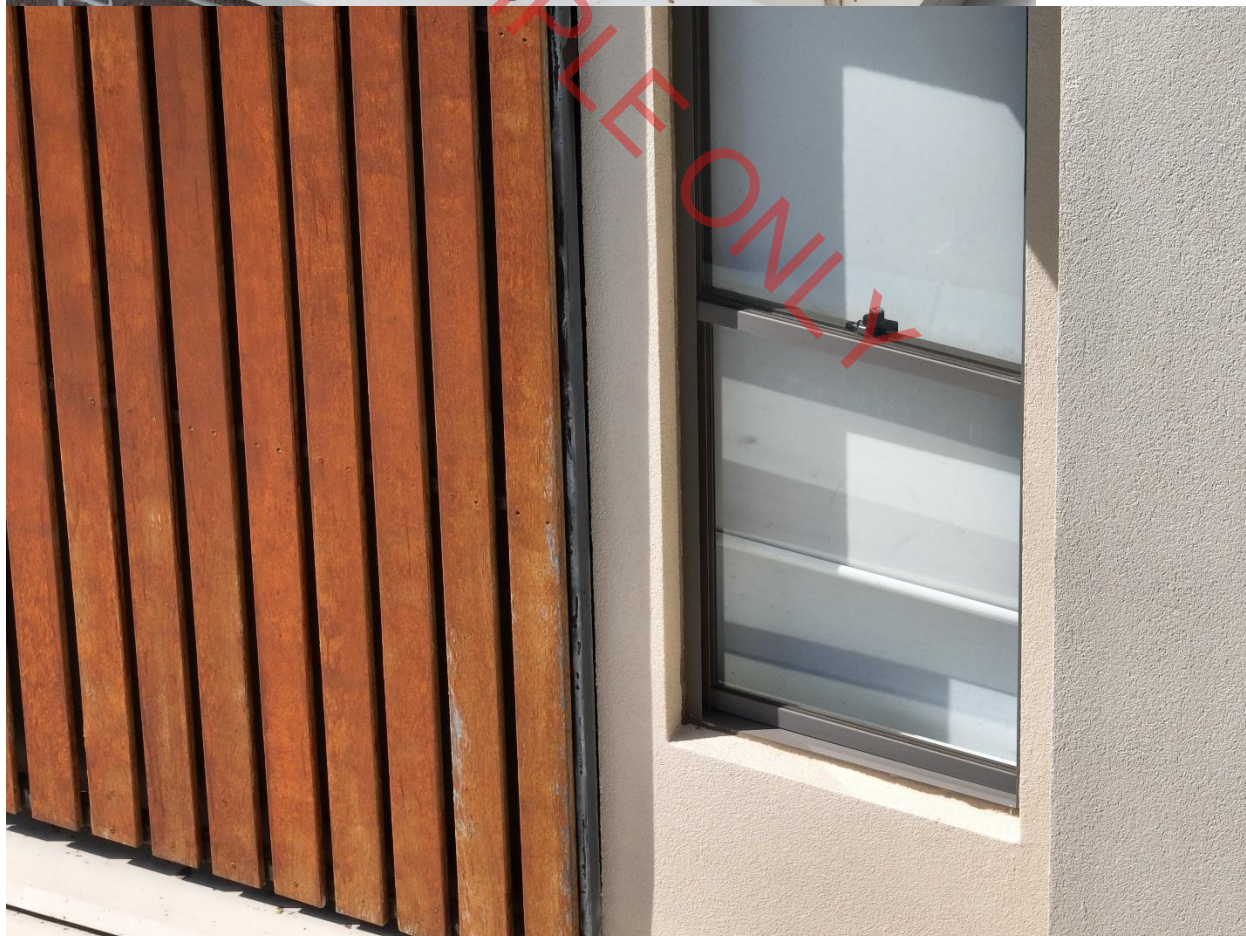
Findings: 2.0

Location: Finding:	Timber slats (Decking timber) on metal frame (Façade) – Drone inspection
Information:	<p>The drone inspection was conducted on a set of timber slats affixed to a metal frame. The purpose was to evaluate the integrity and overall condition of the structure due to observed issues of distortion and rotting at the end caps.</p> <p>2. Observations</p> <p>2.1 Timber Slats</p> <p>Distortion: Multiple timber slats have shown visible signs of distortion, particularly near the central sections and ends, likely caused by environmental exposure, moisture absorption, or lack of adequate protection.</p> <p>Extent: Approximately [50] % of the slats are affected.</p> <p>Possible Cause: This distortion may be a result of: Prolonged exposure to moisture without proper treatment. Changes in temperature causing expansion and contraction of the wood. Poor-quality wood or improper installation techniques.</p> <p>Condition of Wood: The wood's finish has faded or peeled, indicating a lack of maintenance or ineffective protective coatings.</p> <p>2.2 End Capping</p> <p>Rotting: The end caps of the timber slats are suffering from significant rot. This is likely due to constant exposure to moisture, which has penetrated the wood at its most vulnerable points—the exposed ends. These areas seem to lack proper sealing or protective capping.</p> <p>Extent of Rotting: The rot is present on [25] % of the end caps, affecting their structural integrity and potentially leading to further degradation.</p> <p>Possible Cause: Insufficient weatherproofing of the timber ends.</p> <p>2.3 Metal Frame</p> <p>Condition of Metal Frame: Despite the issues with the timber, the metal frame appears to be in fair condition, with no significant signs of rust or structural damage. However, there is minor surface rust at some junctions, which should be monitored and treated to prevent further corrosion.</p> <p>Fixings and Connections: The connections between the timber and the metal frame are secure in some areas, potentially few fixings have loosened due to the distortion of the slats.</p>

The timber slats on the metal frame show significant signs of wear, particularly in the form of distortion and end cap rotting. These issues are compromising the structural integrity and aesthetic appeal of the structure. Immediate action is recommended to replace affected components and apply protective measures to prevent further deterioration.

It is recommended that the distorted and cracked slats be replaced with treated, weather-resistant timber.

To prevent future distortion and moisture damage, all timber should be coated with a high-quality wood preservative and sealant.

All rotting end caps should be replaced with durable, weather-resistant material. Consider using plastic or metal caps instead of timber to ensure longer-lasting protection.

Ensure that all end caps are properly sealed to prevent water ingress. A high-grade waterproofing sealant should be applied to these areas.

Light rust on the metal frame should be treated using a rust remover, followed by the application of a rust-inhibiting primer and paint.

All timber-to-metal connections should be inspected and refastened as needed to ensure structural integrity.
