Building and Timber Pest Inspection Report

Inspection Date: Wednesday, September 18, 2024
Property Address: Truganina 3029

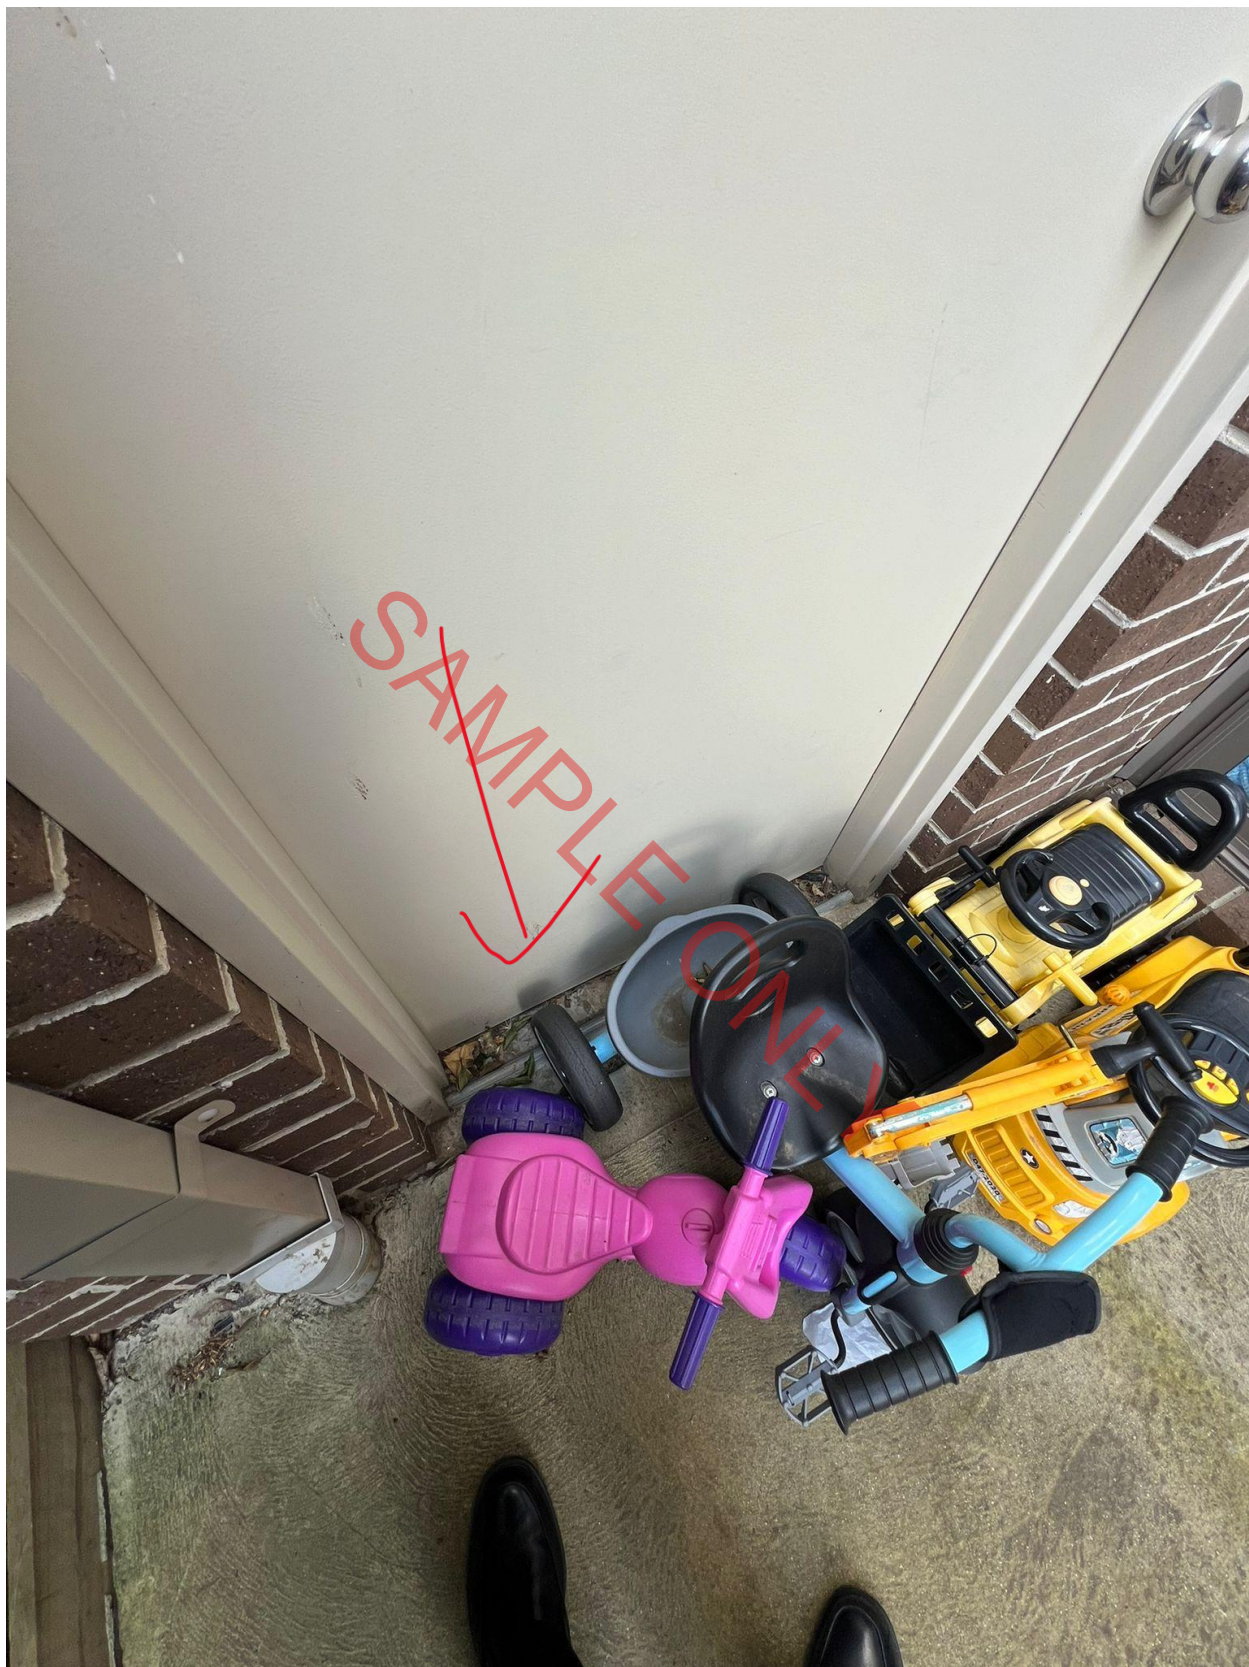
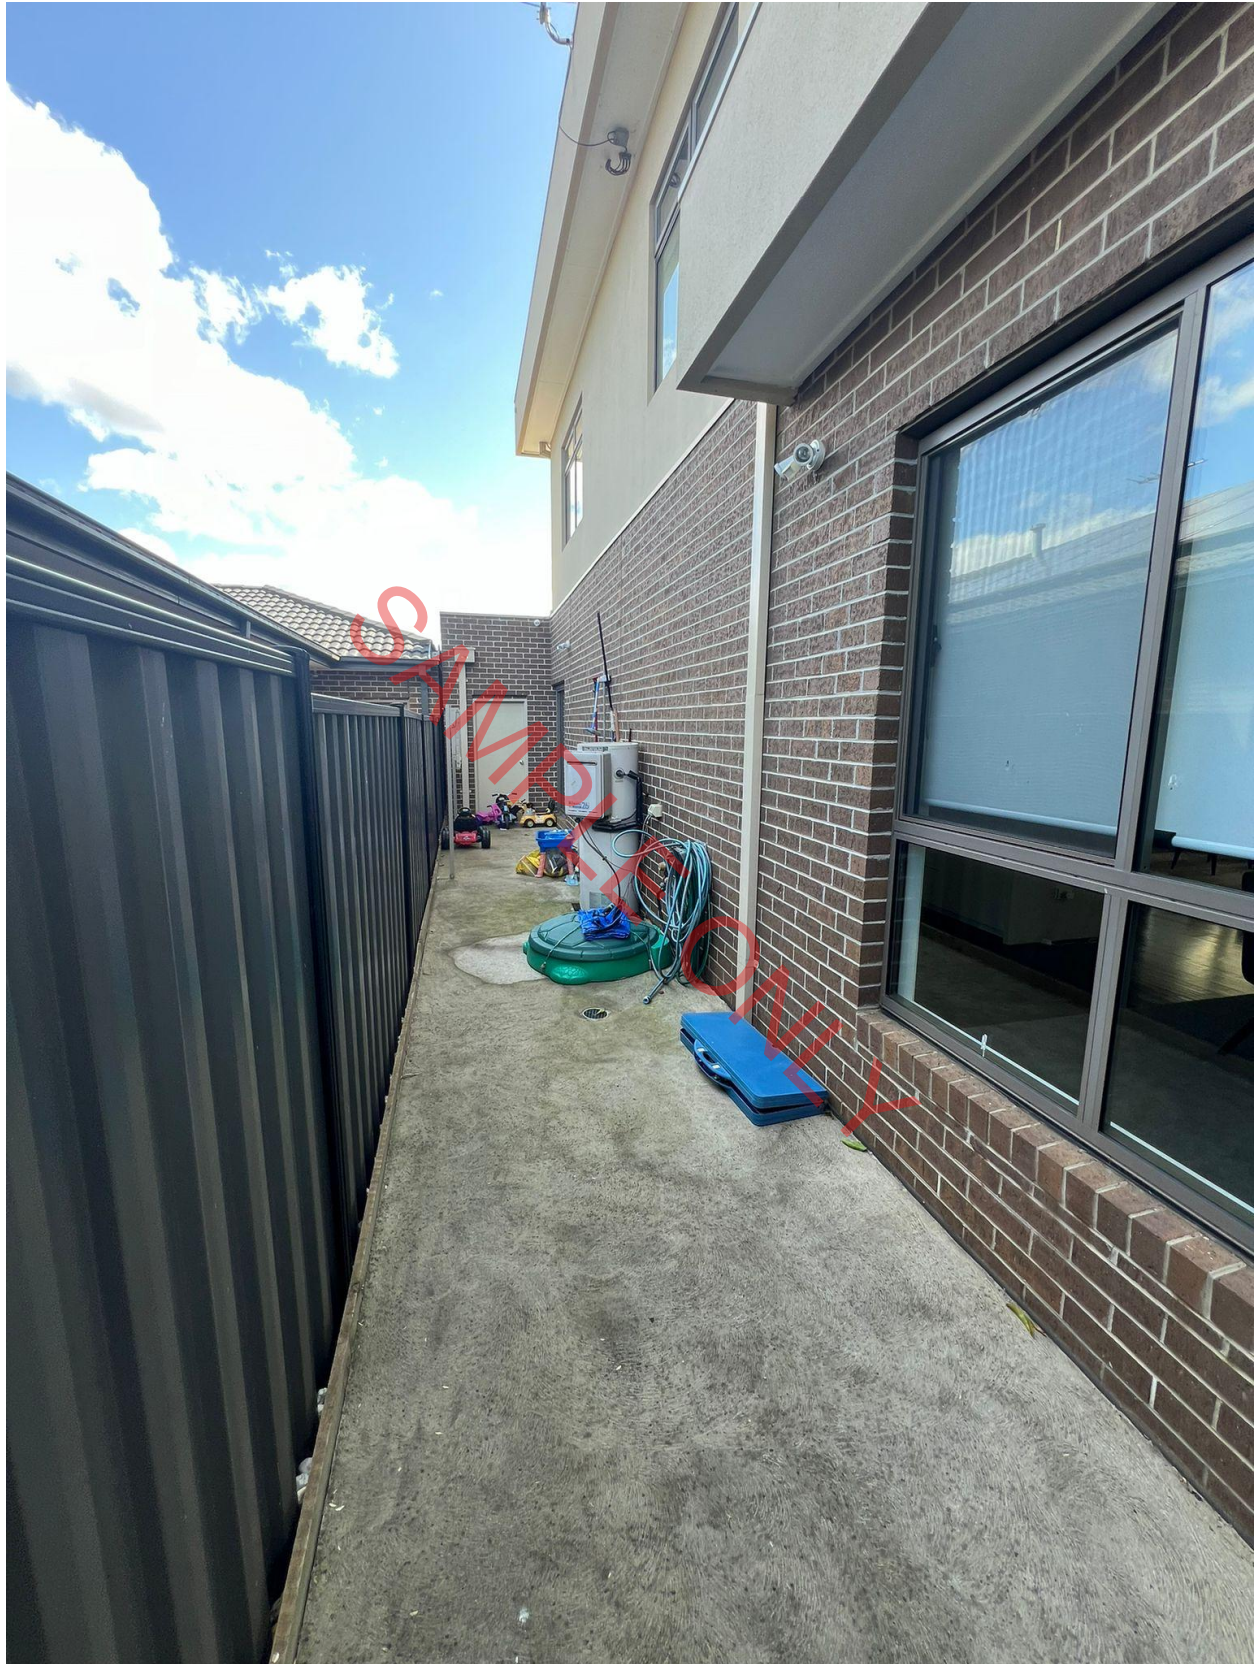
Findings: 3.0

Location: Finding:	Pedestrian garage door – Weather Seal required
Information:	<p>During a inspection, it was observed that the external weather seal is missing from the pedestrian garage door located at rear of the garage. The weather seal, which is crucial for protecting the building from external elements, is not present on this door.</p> <p>Impact:</p> <p>The absence of the weather seal can lead to several issues, including:</p> <p>Water Infiltration: Without the seal, rainwater may enter the garage area, potentially causing water damage to the interior and increasing the risk of mould growth.</p> <p>Drafts: Cold air or drafts may enter the garage, making the space less comfortable and potentially affecting any sensitive equipment or stored items.</p> <p>Security Concerns: An incomplete seal could potentially compromise the security of the premises by allowing easy access for pests or unauthorized entry.</p> <p>Recommendations:</p> <p>Immediate Installation: It is recommended that an automatic weather seal be installed on the pedestrian garage door before the handover.</p> <p>Inspection and Maintenance: Regular inspections should be scheduled to ensure that all weather seals are intact and functioning properly.</p> <p>Verify Installation: Ensure that the new seal is properly installed and aligned to provide an effective barrier against weather elements.</p> <p>Conclusion:</p> <p>The absence of the external weather seal on the pedestrian garage door needs to be rectified promptly to prevent potential.</p>

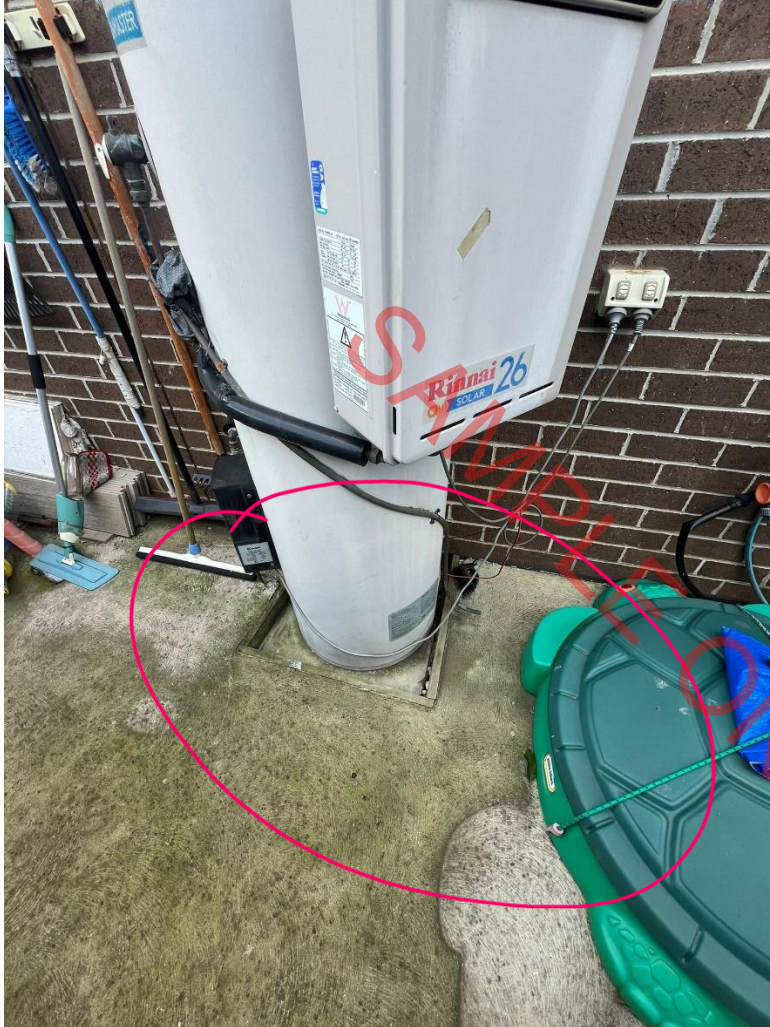
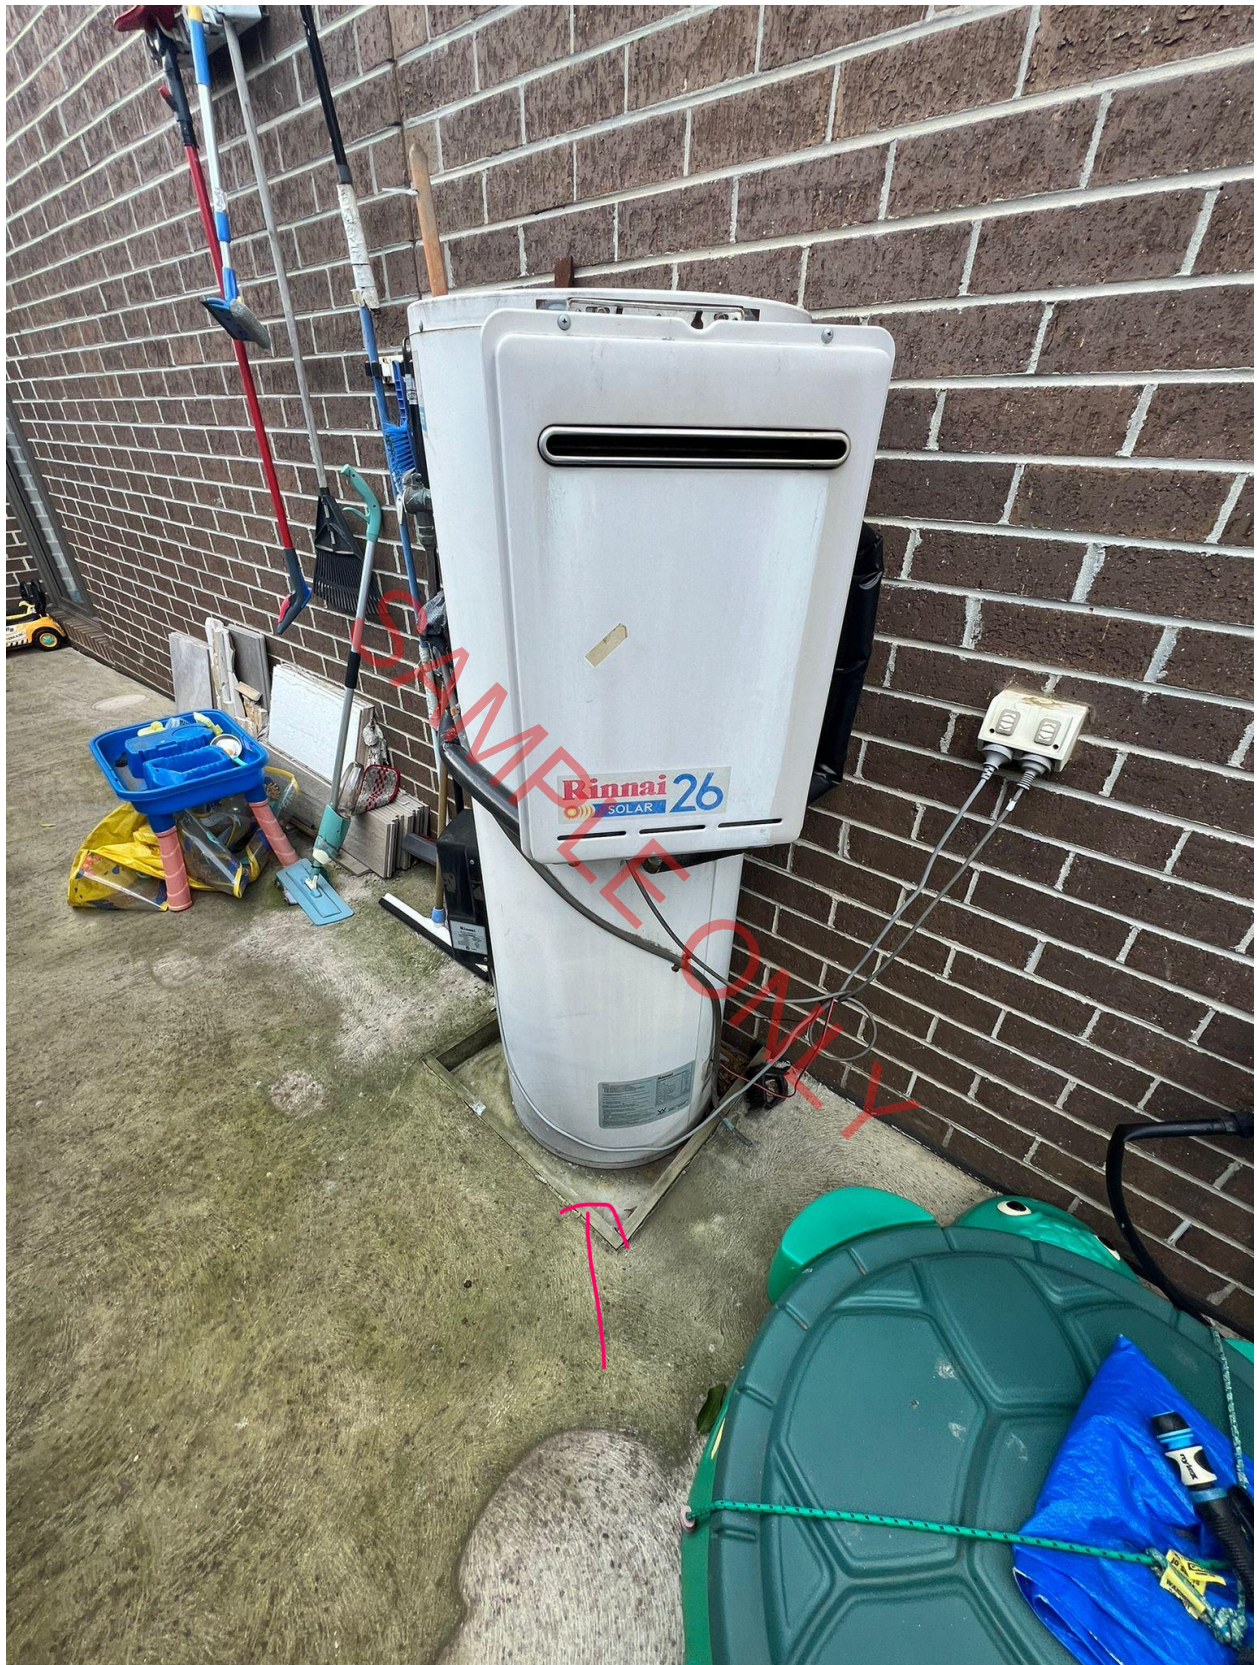
Findings: 5.0

Location: Finding:	Hot Water Unit is recessed
Information:	<p>During the inspection of the hot water unit, it was observed that the unit is recessed below the level of the surrounding pavement. Additionally, no drainage system is in place to manage overflow or leakage from the unit. Green patches were also found on the concrete pavement near the hot water unit, indicating possible algae or mould growth, likely due to water accumulation.</p> <p>Impact:</p> <p>The current setup presents several concerns:</p> <p>Water Accumulation: The lack of proper drainage means that any overflow or leakage from the hot water unit could collect in the recessed area, leading to standing water.</p> <p>Surface Damage: Prolonged water exposure can cause significant wear to the surrounding pavement, potentially leading to cracks or other structural damage.</p> <p>Algae and Mold Growth: The green patches found on the concrete are a likely sign of algae or mold, which thrive in damp environments. This not only presents a hygiene issue but could also be a safety hazard.</p> <p>Corrosion Risk to the Unit: Standing water around the hot water unit can lead to corrosion or other damage to the unit itself, shortening its operational lifespan.</p> <p>Recommendations:</p> <p>Install Proper Drainage System: A proper drainage system should be installed to allow for the safe disposal of any overflow or leaks from the hot water unit. This will prevent water from pooling in the recessed area.</p> <p>Level the Hot Water Unit: If possible, consider raising the hot water unit to be level with the surrounding pavement, which would help prevent water accumulation and reduce long-term damage risks.</p> <p>Clean and Treat Affected Areas: The green patches on the pavement should be cleaned and treated with an anti-fungal or anti-algae solution to prevent further growth. Monitor for regrowth and re-treat as necessary.</p> <p>Regular Maintenance and Monitoring: Implement a regular inspection and maintenance schedule to monitor for any new signs of water accumulation, algae growth, or pavement damage.</p> <p>Consider Waterproofing: If leveling the unit is not feasible, applying a waterproof membrane to the recessed area may help reduce water retention.</p>

The current condition of the hot water unit, being recessed below pavement level and lacking a drainage system, is leading to water accumulation and associated algae or mold growth. Immediate action is required to install proper drainage and address the green patches to prevent further structural damage, reduce safety hazards, and protect the longevity of the hot water unit.

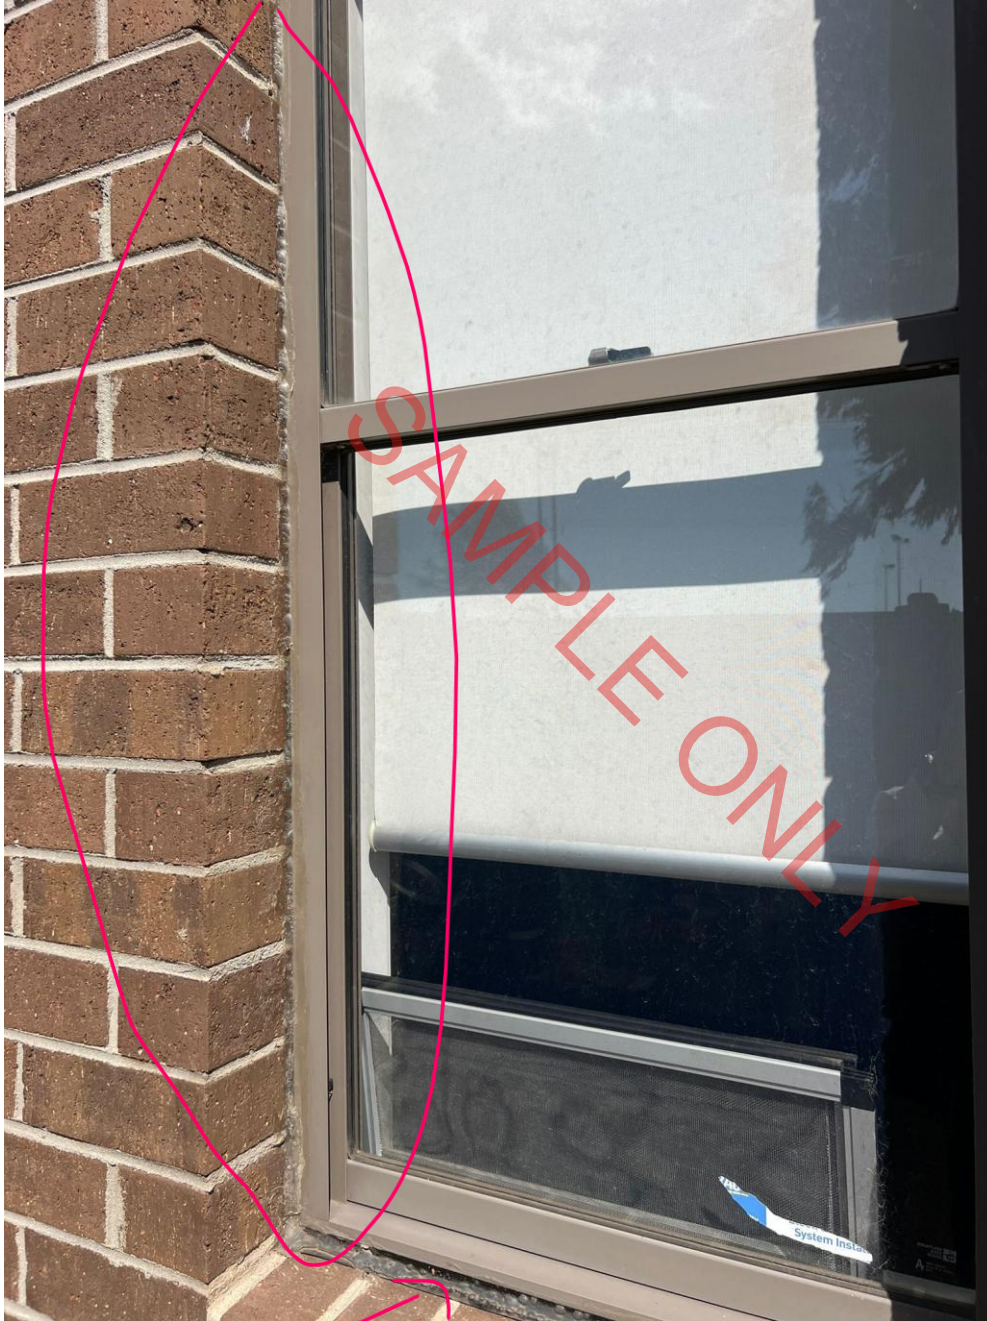
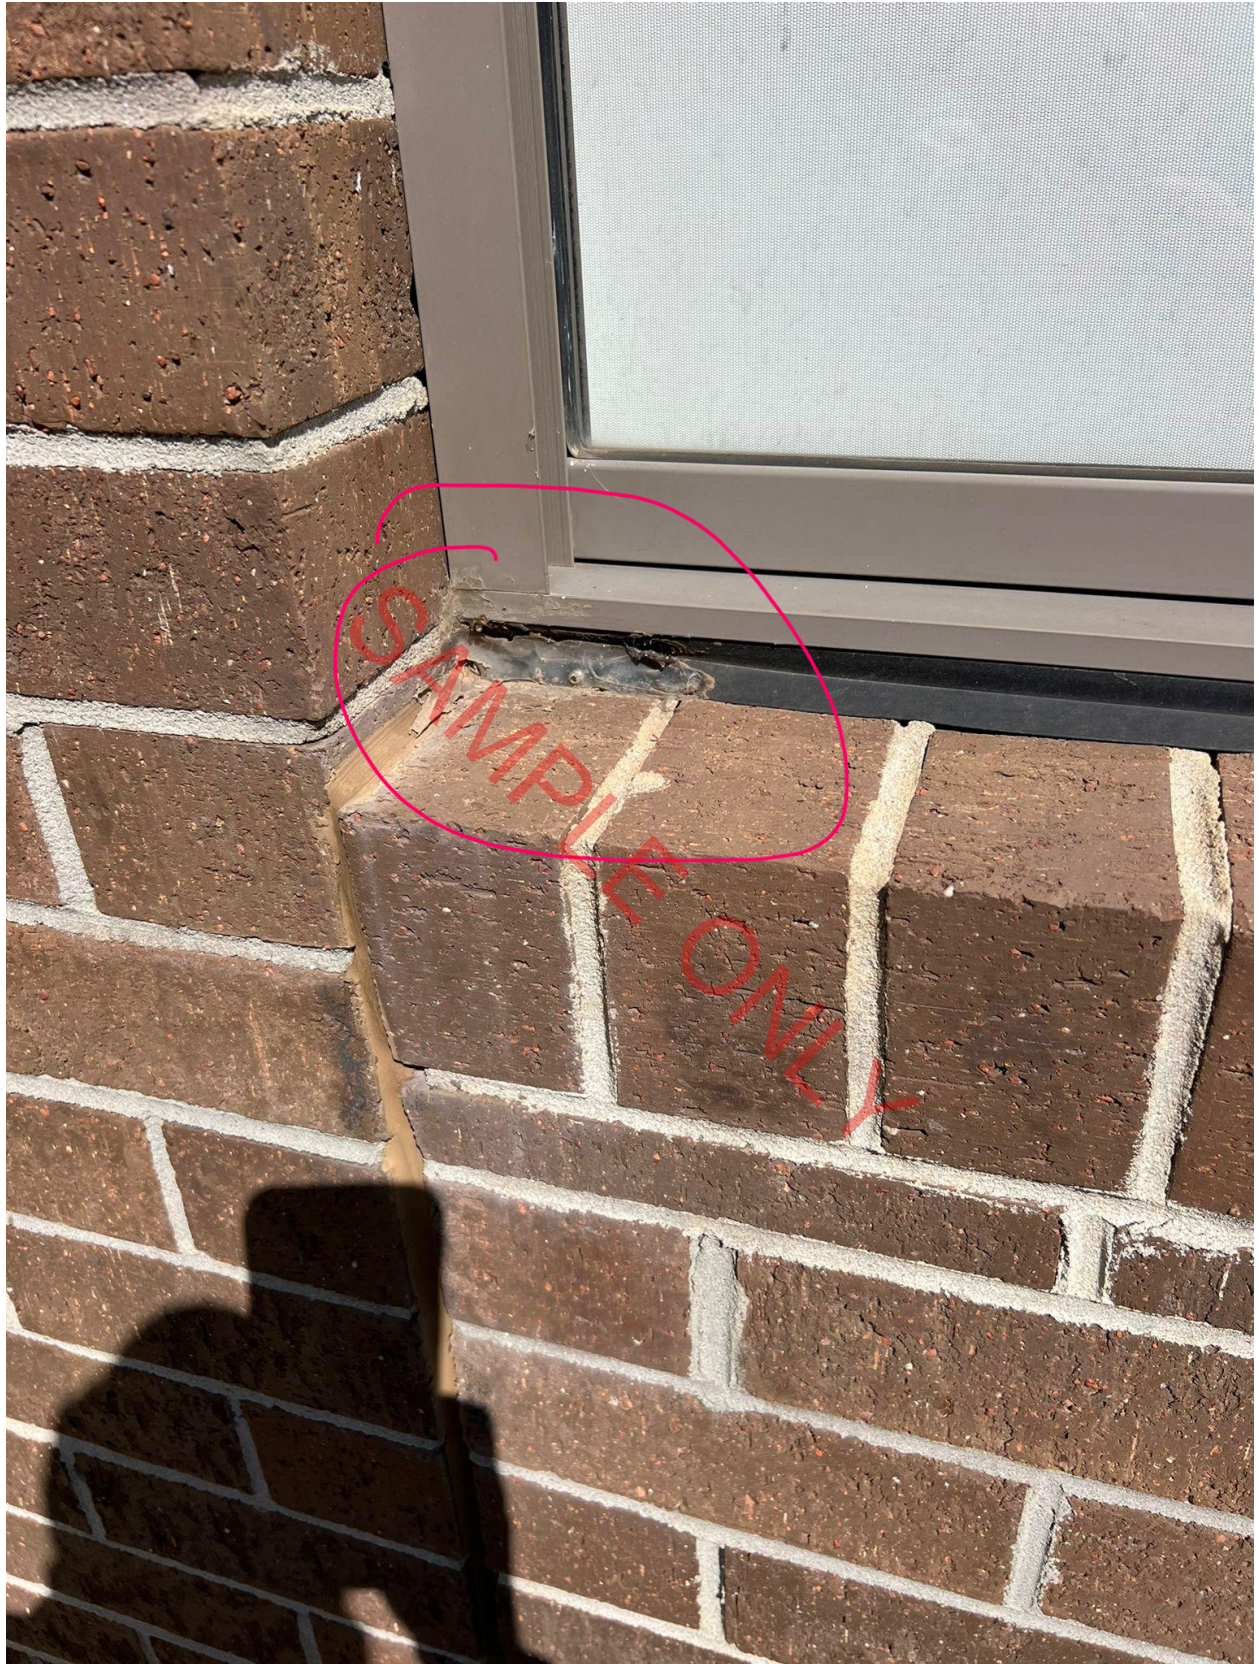
Findings: 6.0

Location: Finding:	Poorly Finished Window Frames Sealed with Clear Silicone
Information:	<p>During the inspection of the windows at North, it was observed that several window frames have been sealed with clear silicone. The sealant appears to have been applied unevenly, resulting in a poorly finished look. There are visible inconsistencies in the application, such as excess silicone around the edges, smudges on the window glass, and irregular bead lines.</p> <p>Impact:</p> <p>The improper application of silicone sealant can have several negative consequences, including:</p> <p>Aesthetic Impact: The uneven and sloppy silicone application detracts from the overall appearance of the windows and the building, giving it an unprofessional and unfinished look.</p> <p>Potential Water Infiltration: If the silicone has not been applied correctly, gaps may exist between the window frames and the building envelope. This can allow water infiltration, leading to potential water damage, mold growth, or compromised insulation.</p> <p>Decreased Durability: Poorly applied silicone may not provide an effective long-term seal, resulting in the need for more frequent maintenance or replacement.</p> <p>Dirt and Debris Accumulation: The excess silicone and irregular bead lines may trap dirt and debris over time, further degrading the appearance and potentially affecting the seal's integrity.</p> <p>Recommendations:</p> <p>Reapply Silicone Sealant: It is recommended that the current silicone be carefully removed, and the windows be resealed by a professional using the correct technique. This will ensure both a clean finish and an effective seal.</p> <p>Quality Control: During the resealing process, ensure that the bead lines are smooth, uniform, and free of excess sealant. Any smudges on the window glass should be promptly cleaned off.</p> <p>Inspect for Gaps: After resealing, perform a thorough inspection to ensure that no gaps remain between the window frame and the building, which could allow water infiltration.</p> <p>Regular Maintenance: Implement a schedule for regular inspections of window seals to ensure their continued effectiveness and appearance, especially in high-exposure areas.</p>

The clear silicone applied to some window frames is poorly finished, leading to both aesthetic concerns and potential functional issues. Resealing the windows with proper technique and care is necessary to improve both the appearance and performance of the seals.

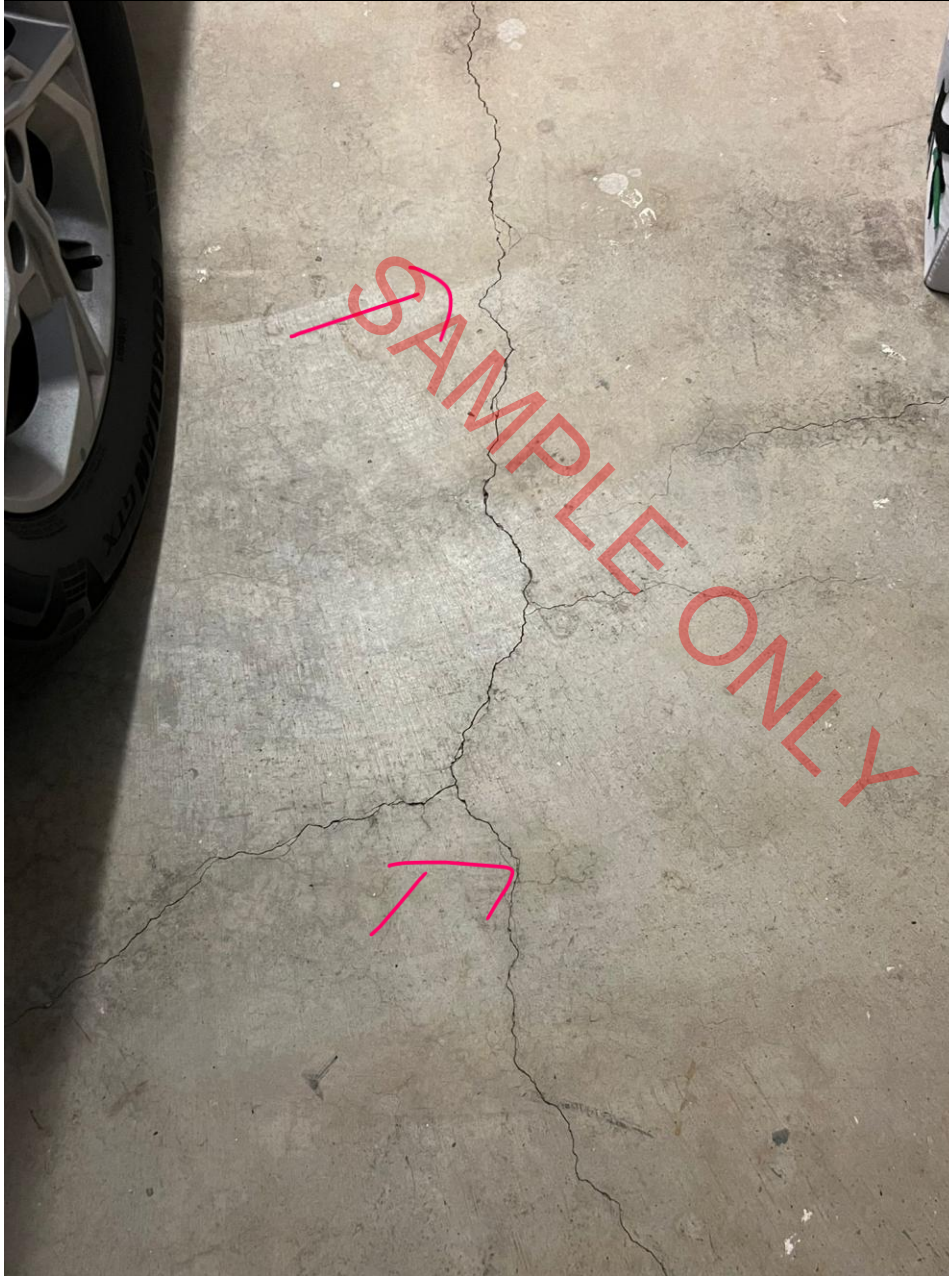
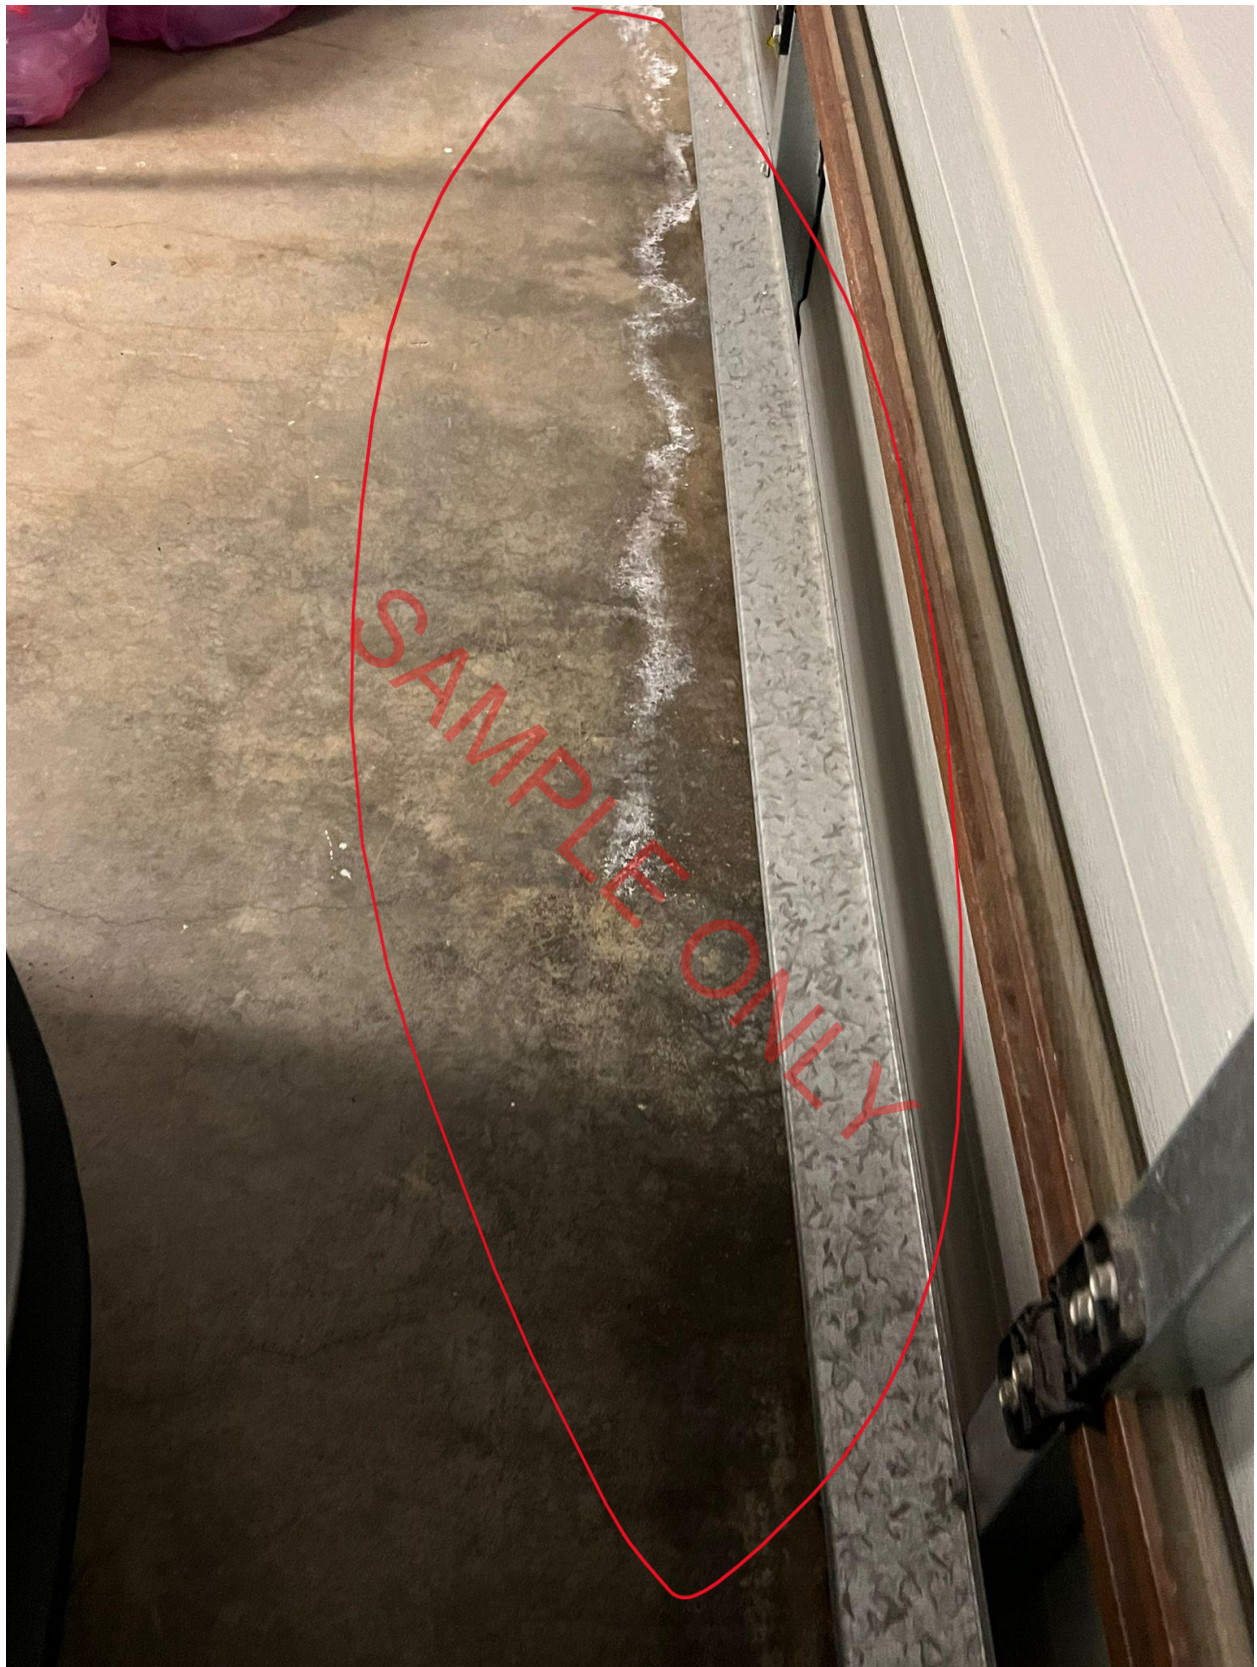
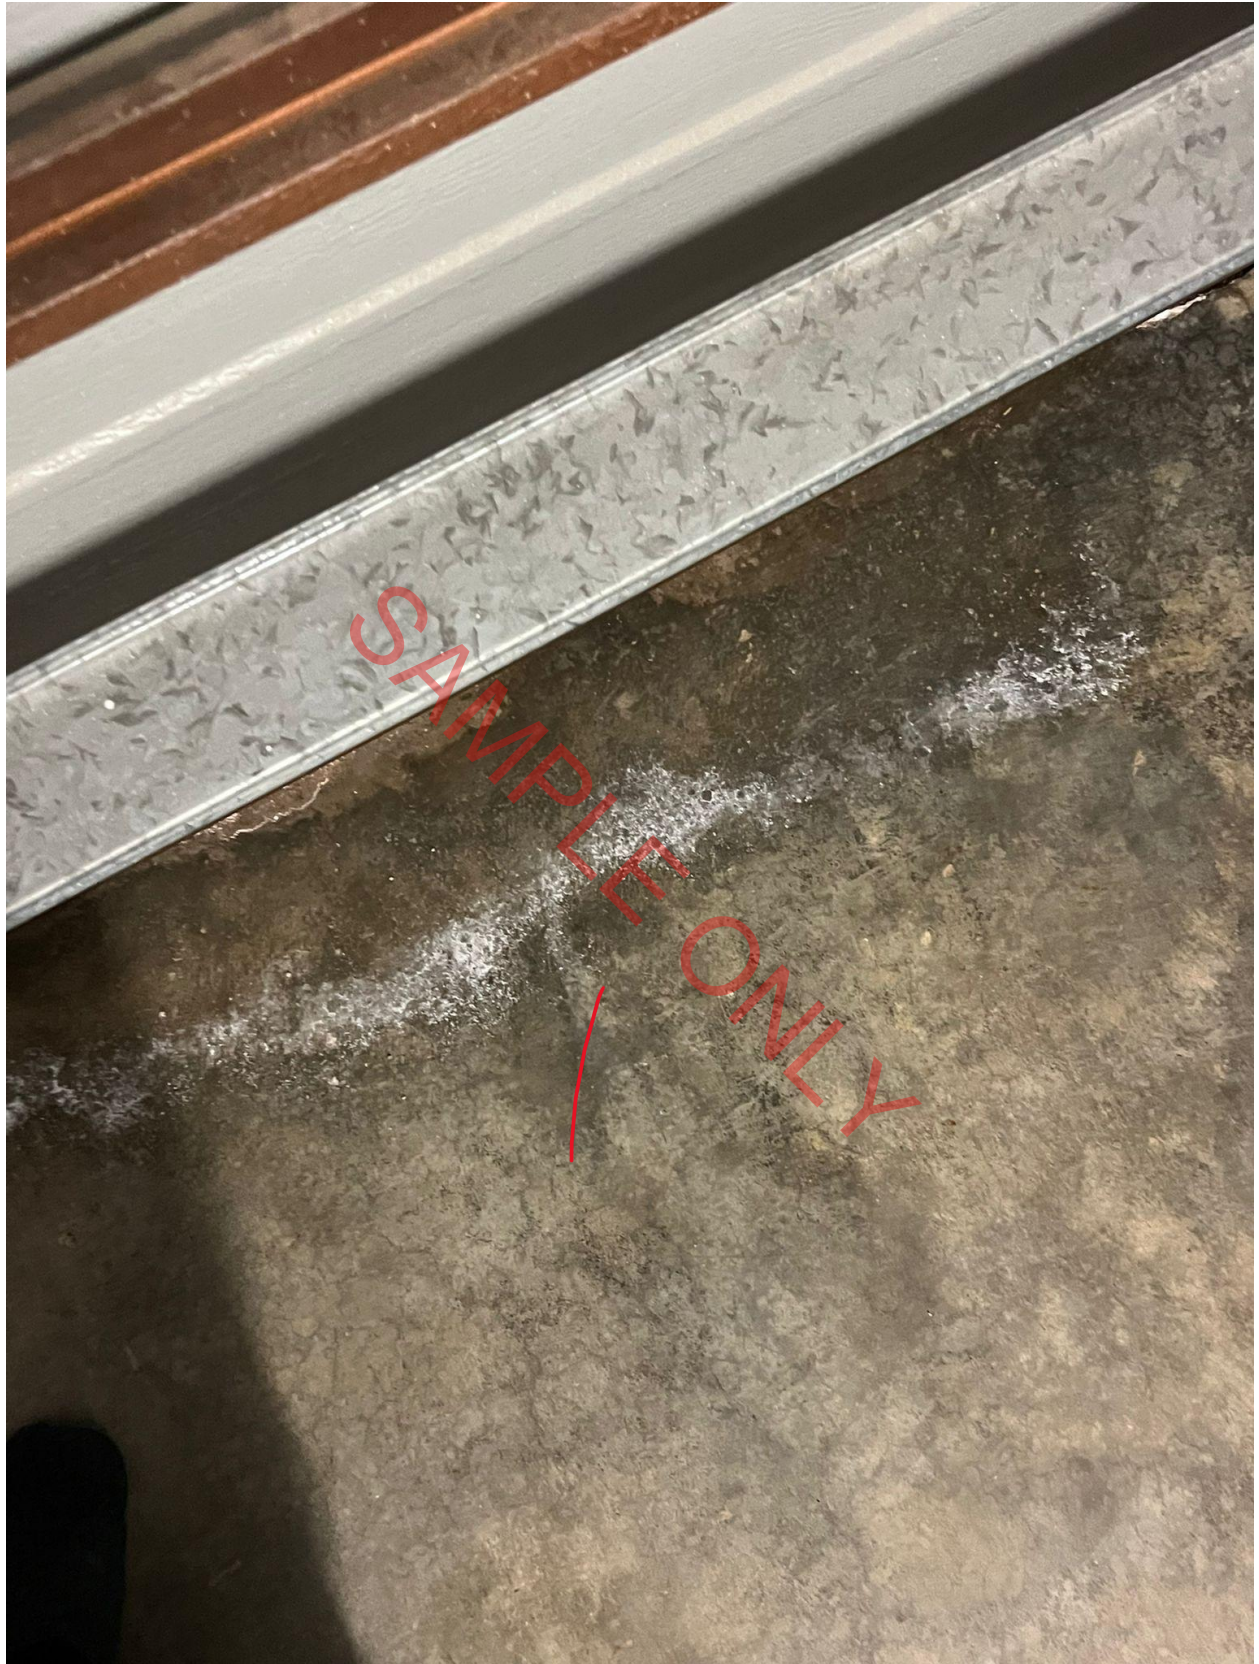
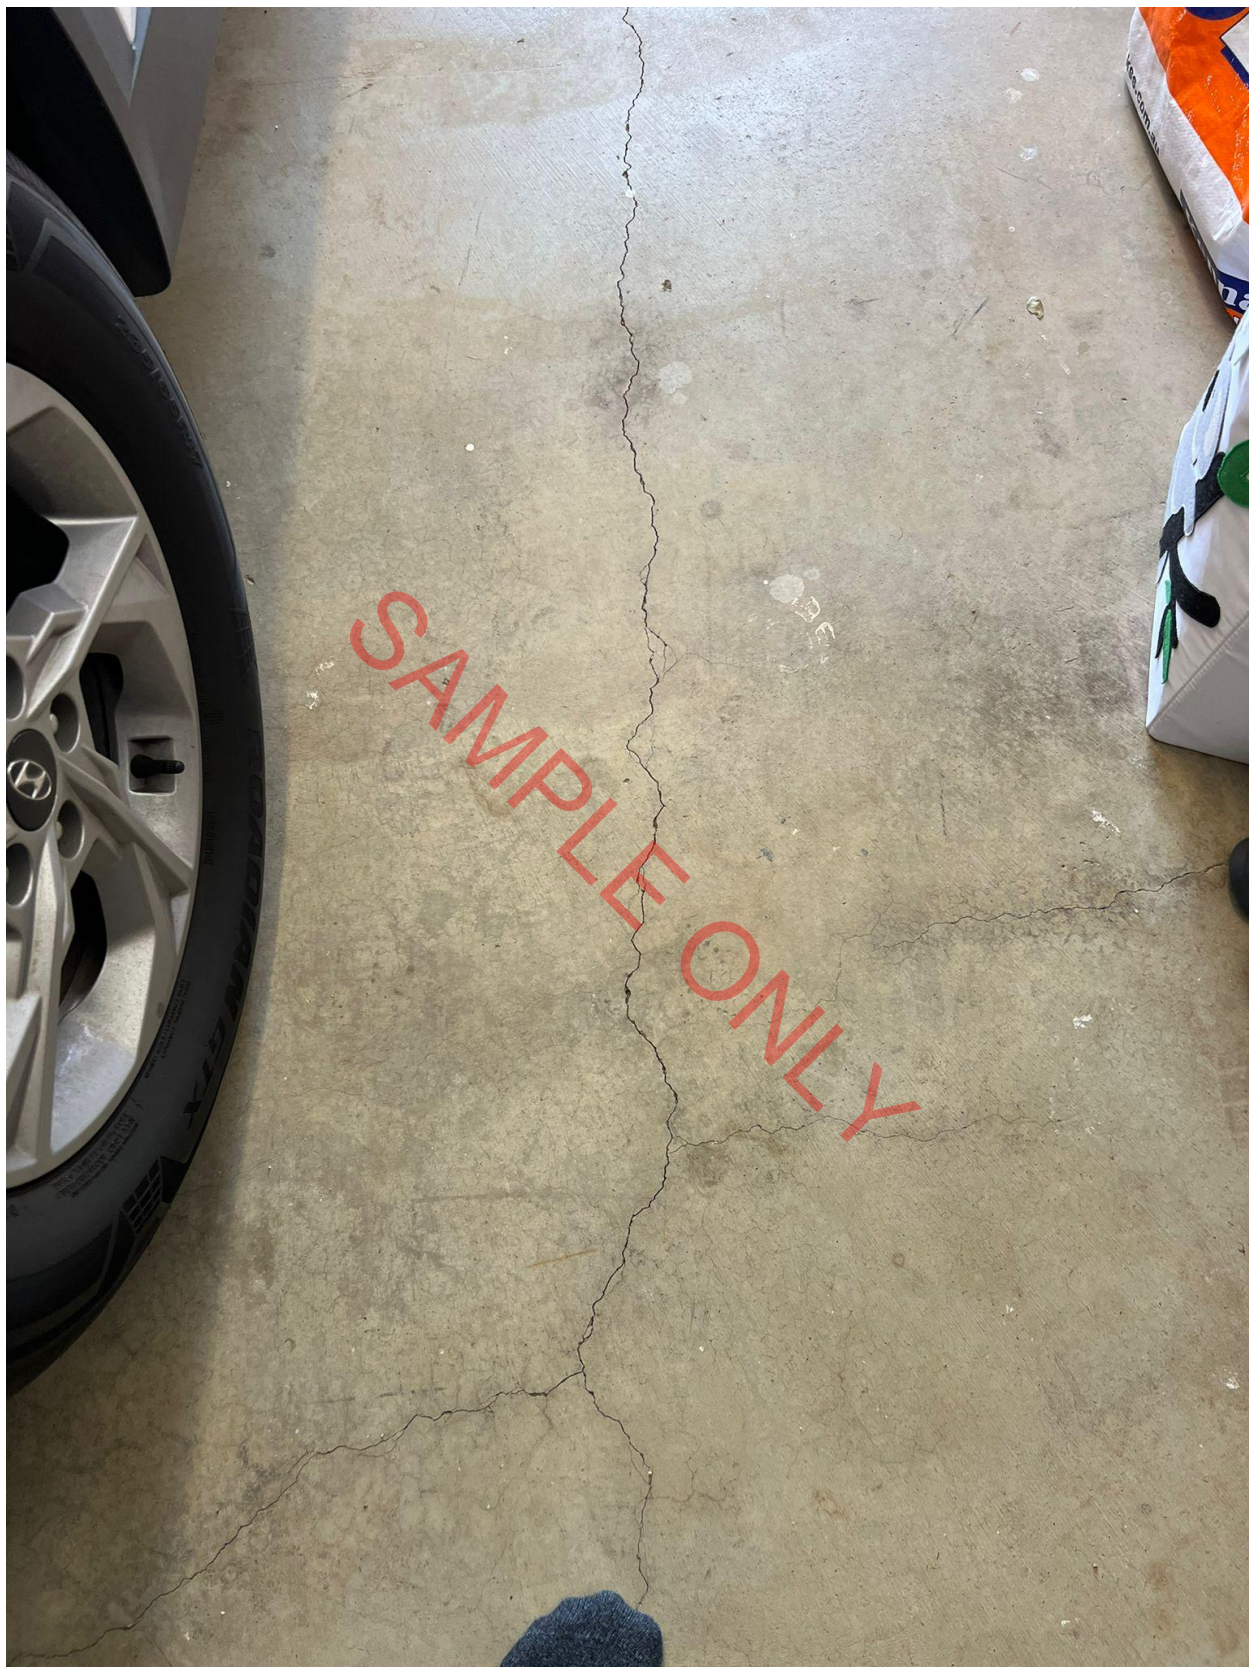
Findings: 7.0

Location: Finding:	Surface Cracks and Salt Marks on Garage Floor
Information:	<p>During the inspection of the garage floor at [specific location], it was observed that there are multiple surface cracks along the concrete floor. Additionally, white salt marks (efflorescence) are visible in several areas of the floor. These signs indicate potential issues with moisture penetration and the integrity of the concrete surface.</p> <p>Impact:</p> <p>The presence of surface cracks and salt marks can lead to several concerns:</p> <p>Structural Integrity: While surface cracks are often a result of normal wear, they could also indicate underlying structural issues. If left unattended, these cracks may widen and lead to more significant damage over time.</p> <p>Water Infiltration: The visible salt marks are a sign of efflorescence, which occurs when water penetrates the concrete and evaporates, leaving behind salt deposits. This moisture infiltration could contribute to further damage, such as the weakening of the concrete, spalling, or even the growth of mold or mildew.</p> <p>Aesthetic Impact: The cracks and salt marks detract from the appearance of the garage floor, making it look weathered and poorly maintained.</p> <p>Safety Concerns: If the cracks become larger, they could create uneven surfaces, increasing the risk of tripping or other safety hazards in the garage.</p> <p>Recommendations:</p> <p>Repair Surface Cracks: The cracks should be cleaned and filled with a suitable concrete filler or sealant to prevent them from expanding and to protect the surface from further deterioration.</p> <p>Address Moisture Source: Investigate the source of moisture causing the salt marks. This may involve checking for any leaks, improper drainage, or inadequate waterproofing. Resolving the moisture issue will prevent future efflorescence and protect the concrete.</p> <p>Clean and Treat Efflorescence: The white salt marks should be cleaned using an appropriate cleaning solution to remove the deposits. Once cleaned, consider applying a concrete sealer to the affected areas to protect against further moisture penetration.</p> <p>Monitor for Further Damage: Regularly inspect the garage floor for any new cracks, signs of moisture infiltration, or recurring efflorescence. This will allow for timely maintenance and prevent larger issues from developing.</p>

The surface cracks and salt marks on the garage floor indicate potential issues with moisture infiltration and surface wear. Immediate repairs and addressing the moisture source are necessary to prevent further damage and ensure the longevity of the garage floor.

Optional Floor Resurfacing: If the damage is extensive or if aesthetics are a concern, resurfacing the garage floor with a new concrete overlay may be considered to restore both the look and durability of the surface.
