Building and Timber Pest Inspection Report

Inspection Date: Wednesday, September 18, 2024
Property Address: Truganina 3029

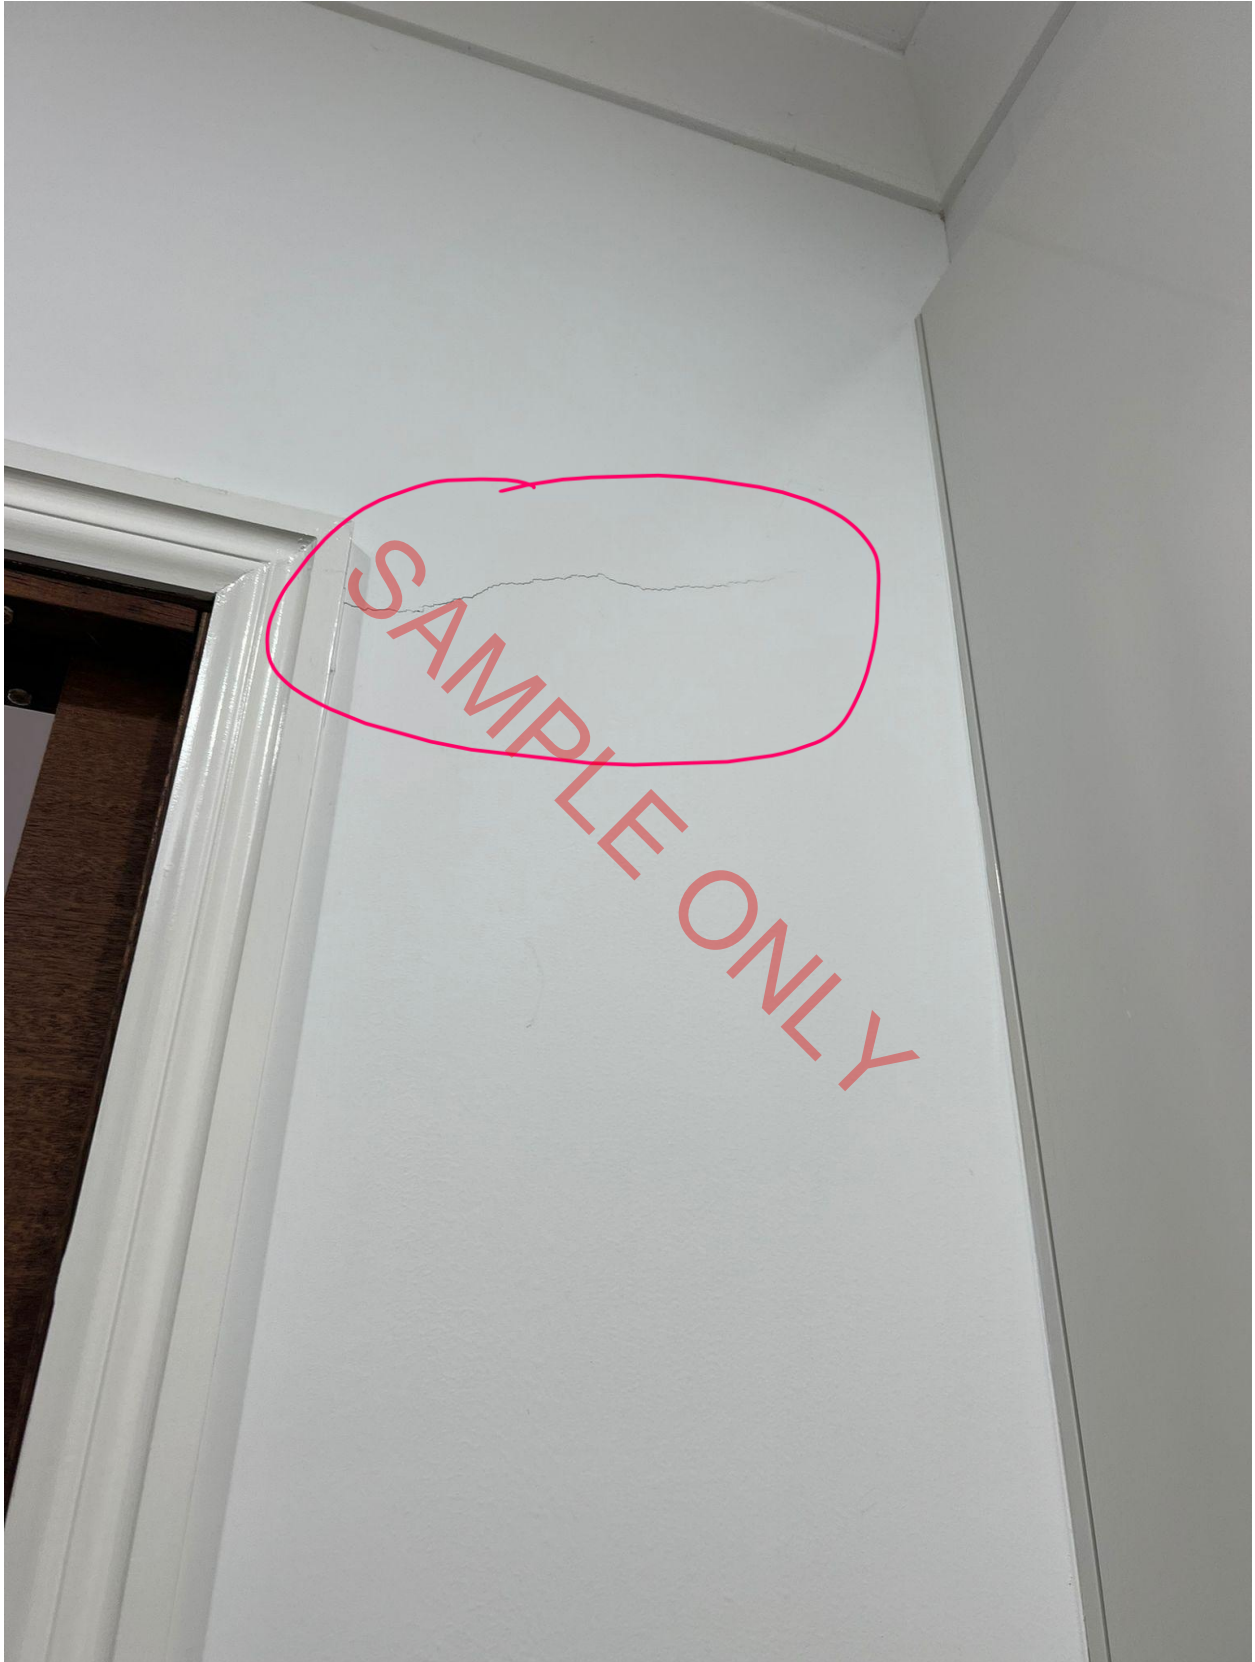
Findings: 8.0

Location: Finding:	Minor crack on plaster board – Butler's pantry
Information:	<p>During the inspection of the butler's pantry at, minor visible cracks were observed on the plasterboard near the door jamb. These cracks appear to be surface-level and do not show any signs of significant structural damage. The cracks may have developed due to natural settling of the building, minor movement around the door frame, or slight shifts in the structure.</p> <p>Impact:</p> <p>The cracks, though minor, can have several effects, including:</p> <p>Aesthetic Impact: The cracks detract from the overall appearance of the pantry, giving the area a worn or unmaintained look.</p> <p>Potential for Expansion: While the cracks are currently small, if not addressed, they may expand over time due to further movement or environmental factors, leading to more noticeable damage.</p> <p>Decreased Durability of Plasterboard: Repeated stress around the door jamb area could cause additional cracking, which may weaken the plasterboard and affect the durability of the surrounding area.</p> <p>Recommendations:</p> <p>Repair Cracks: The cracks should be filled with a suitable plaster filler and sanded smooth. Once the repair is complete, the area should be repainted to blend with the surrounding surface for a clean finish.</p> <p>Monitor for Future Movement: Regularly inspect the area near the door jamb to check for any additional cracks or signs of movement. If new cracks appear or existing ones worsen, further investigation into potential structural movement may be required.</p> <p>Ensure Proper Door Alignment: Inspect the door to ensure it is properly aligned and not causing undue stress on the surrounding plasterboard. If the door is misaligned, minor adjustments may be needed to prevent further cracking.</p> <p>Conclusion:</p> <p>The minor cracks near the door jamb in the butler's pantry are primarily cosmetic but should be repaired to maintain the aesthetic and integrity of the plasterboard. Regular monitoring is recommended to ensure that the cracks do not worsen over time.</p>

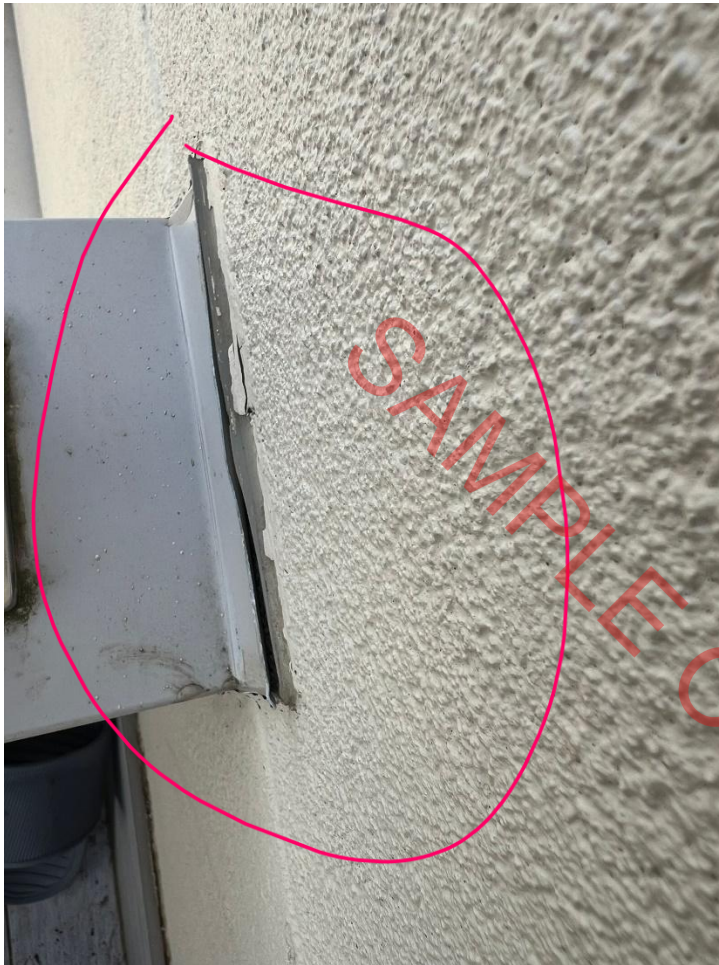
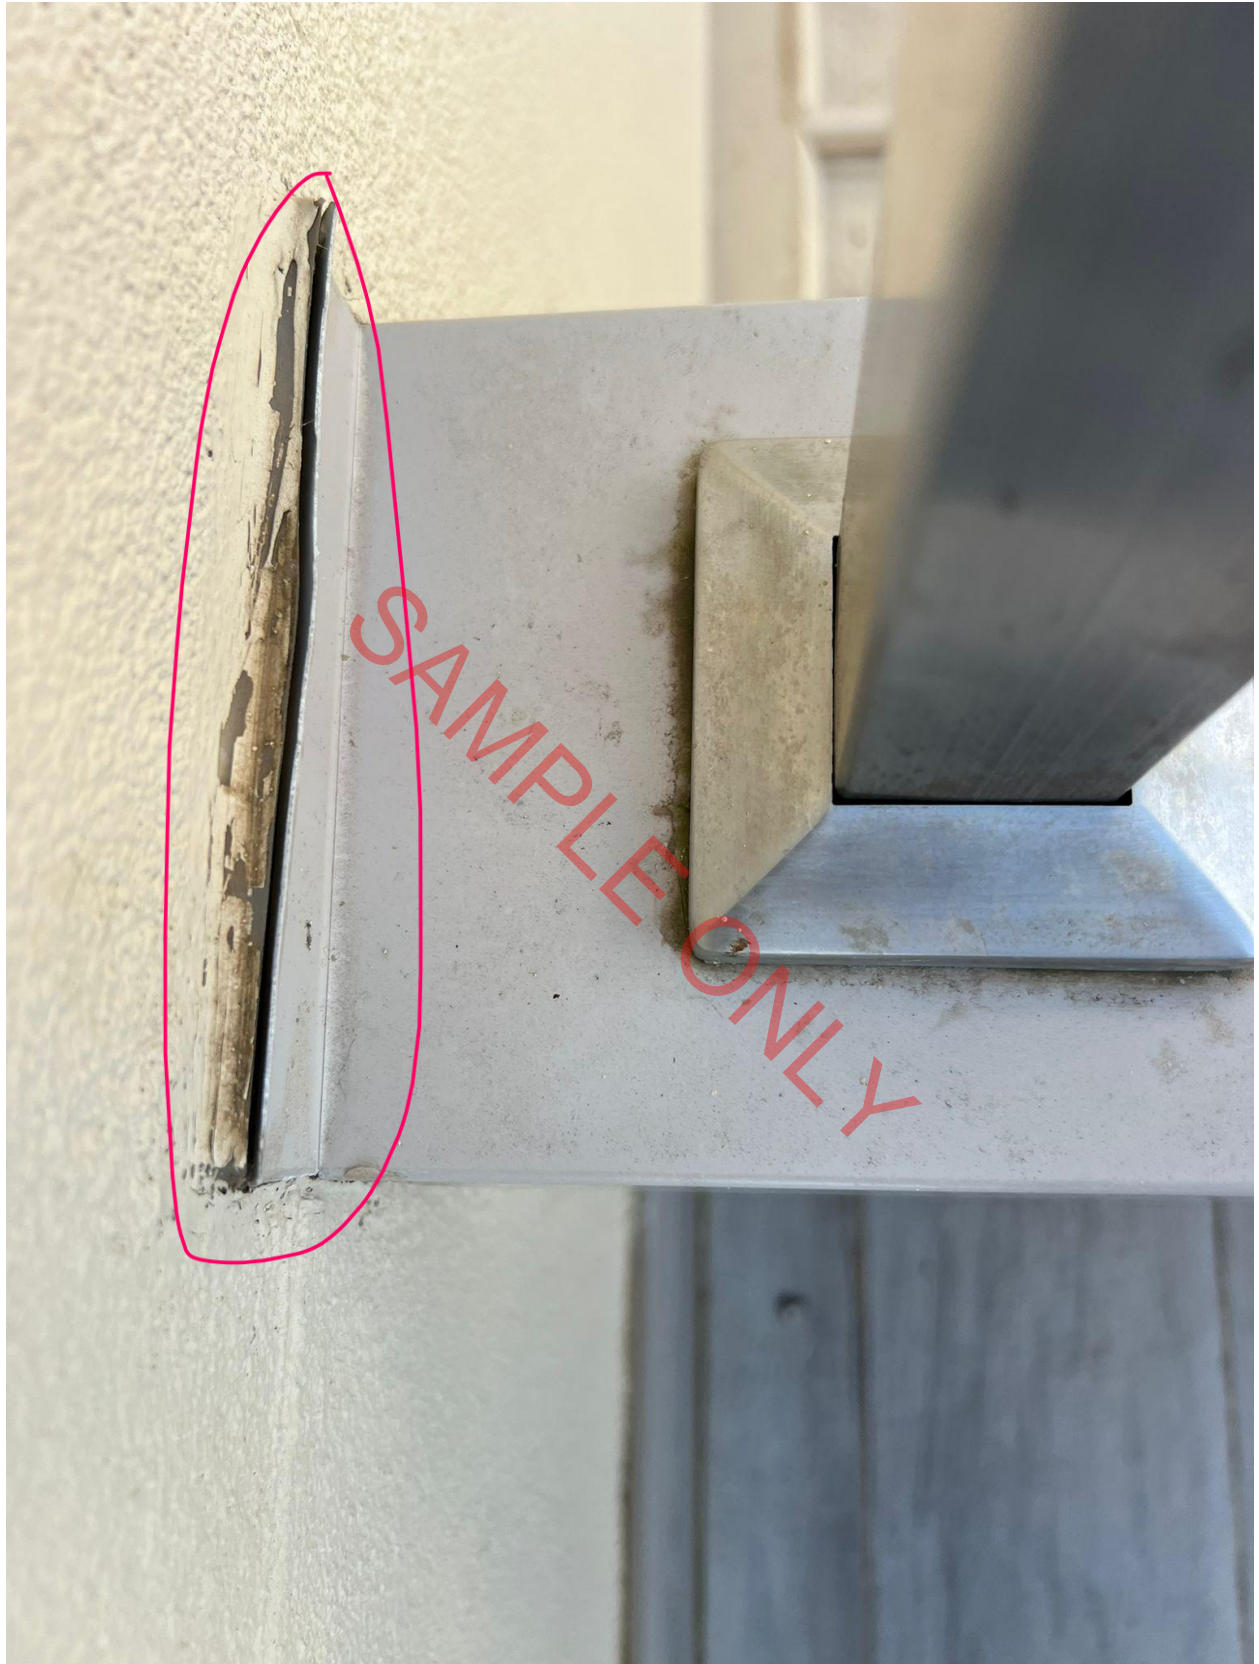
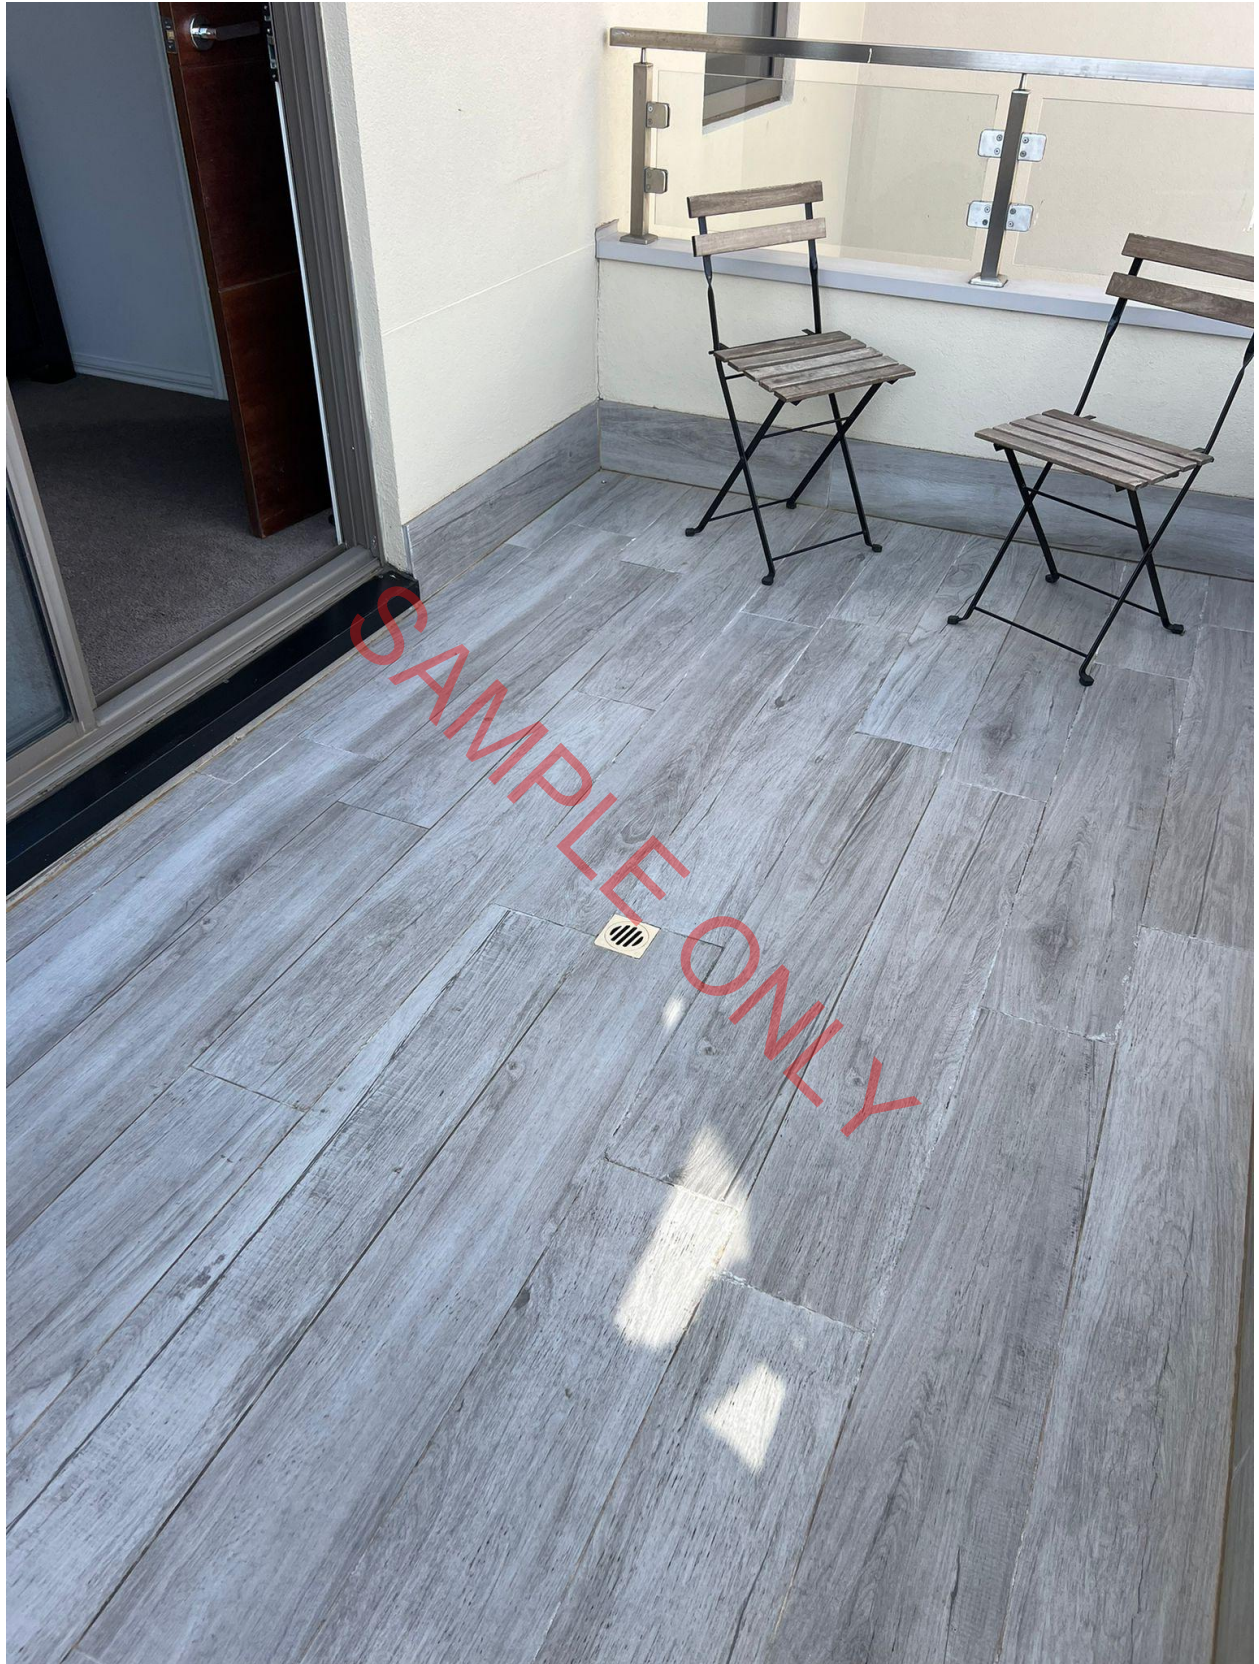
Findings: 9.0

Location: Finding:	Balcony – Distorted silicone on end flashing
Information:	<p>During the inspection of the balcony at, it was noted that the silicone sealant around the end capping is distorted and shows signs of degradation. Additionally, the silicone across the rest of the balcony appears worn and could benefit from replacement as part of regular maintenance.</p> <p>Impact:</p> <p>The distorted and aging silicone poses several concerns:</p> <p>Water Infiltration: Distorted or deteriorating silicone can lead to gaps, allowing water to penetrate the areas around the end capping and other parts of the balcony. This could result in water damage to the underlying structure and potentially cause leaks into the interior or lower levels of the building.</p> <p>Structural Integrity Risk: Prolonged water exposure due to failed sealant could weaken the materials used in the balcony's construction, leading to more significant repair needs in the future.</p> <p>Aesthetic Concerns: The distorted silicone detracts from the visual appearance of the balcony, making it look worn and poorly maintained.</p> <p>Increased Maintenance Costs: If the silicone is not replaced promptly, further deterioration could result in larger repair costs down the line due to potential water ingress or structural damage.</p> <p>Recommendations:</p> <p>Replace Distorted Silicone Around End Capping: The silicone around the end capping should be removed and replaced with new, high-quality sealant. Care should be taken to ensure a proper, smooth application to prevent future issues.</p> <p>Full Balcony Silicone Replacement: As part of routine maintenance, it is advisable to replace the silicone across the entire balcony. This will provide a uniform seal and ensure that no other areas are susceptible to water infiltration.</p> <p>Inspect for Damage: While replacing the silicone, inspect the balcony's structure, including joints, tiles, and railings, for any signs of damage caused by previous water infiltration. Repair any affected areas as necessary.</p> <p>Regular Maintenance Schedule: Establish a regular maintenance schedule for checking the condition of the silicone and other weatherproofing elements of the balcony. This will help prevent future issues and extend the longevity of the balcony.</p>

<p>The distorted silicone around the end capping and the aging sealant throughout the balcony require immediate attention. Replacing the silicone as part of a broader maintenance effort will help preserve the integrity of the balcony, prevent water damage, and improve its overall appearance.</p>
--	--

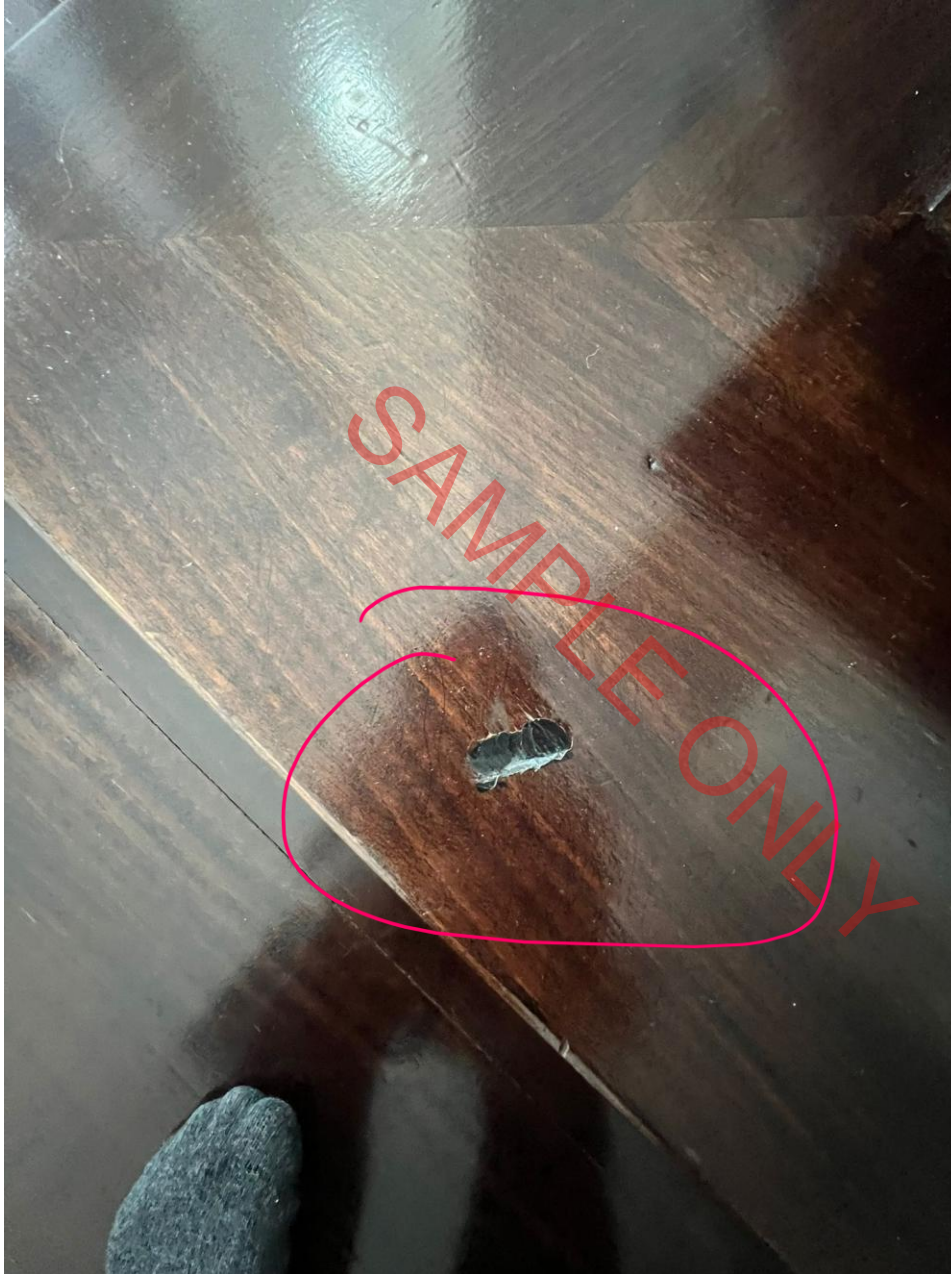
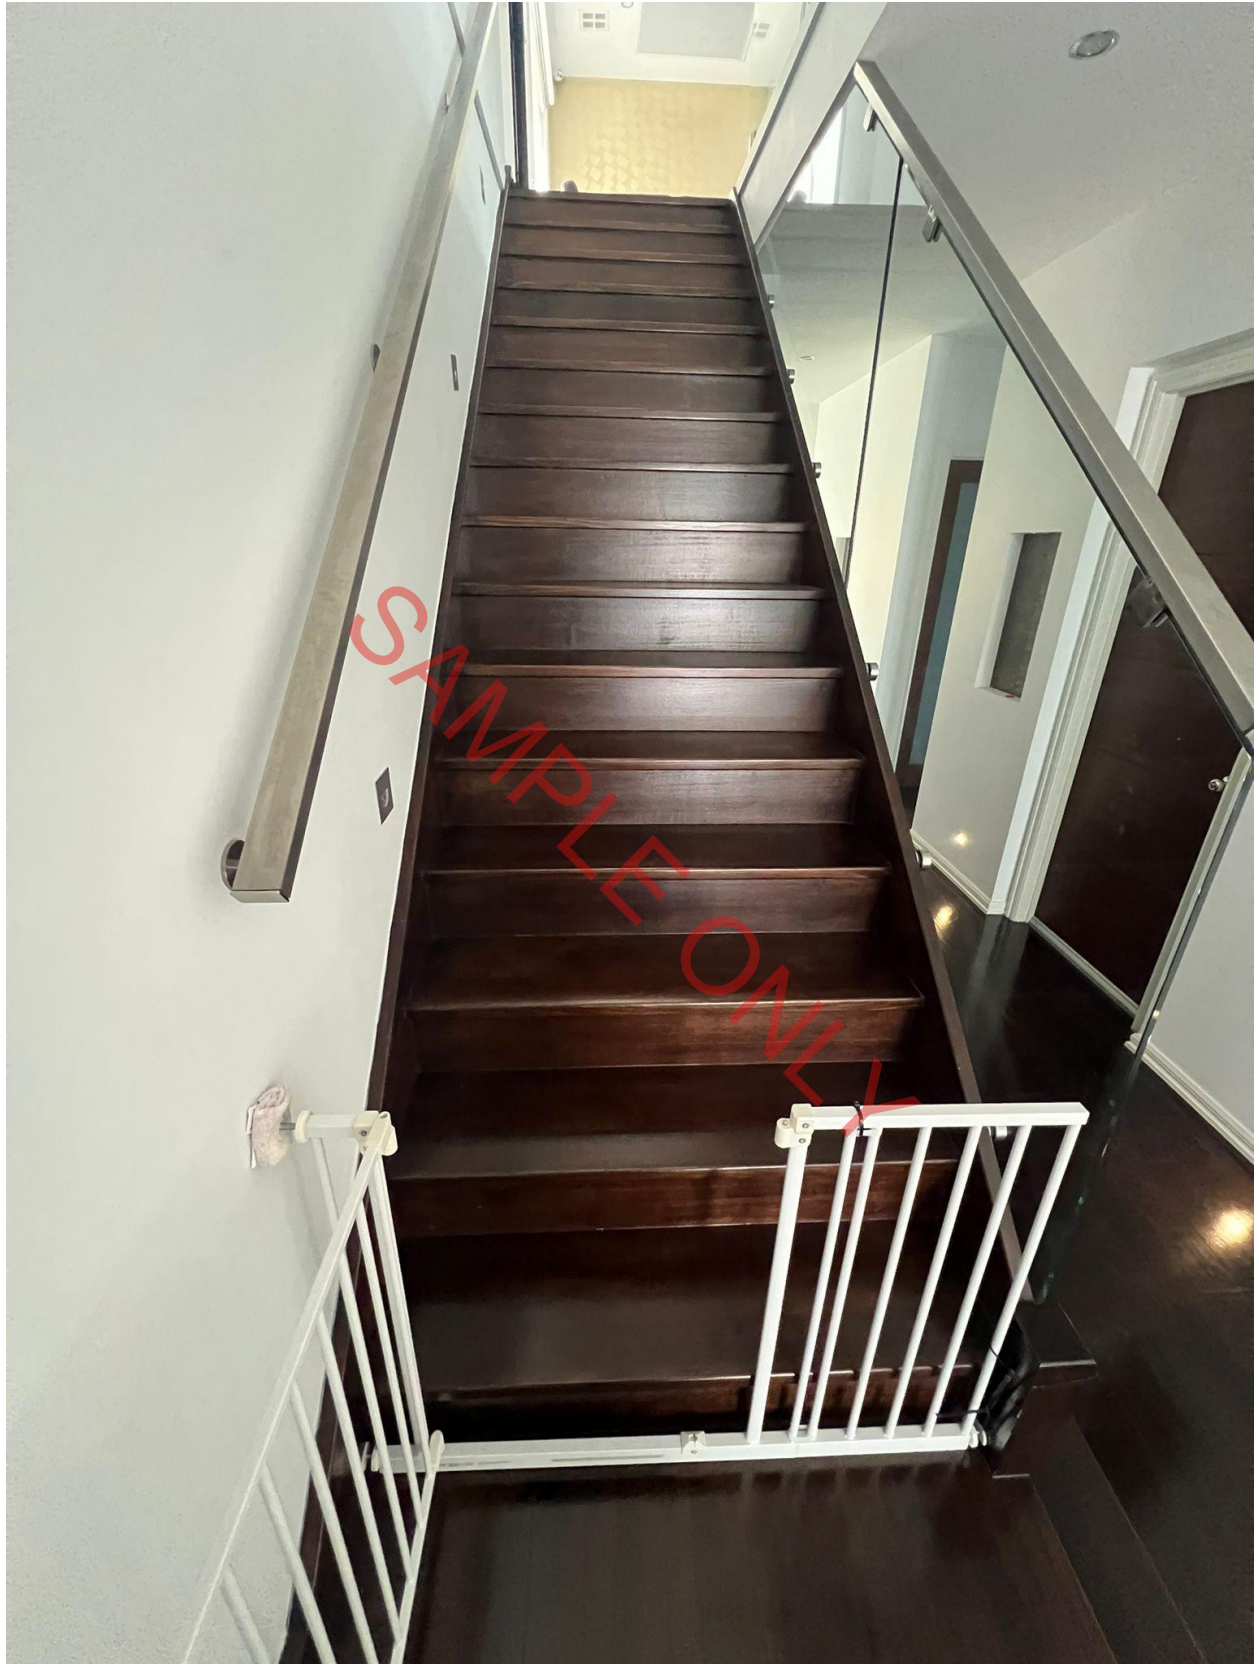
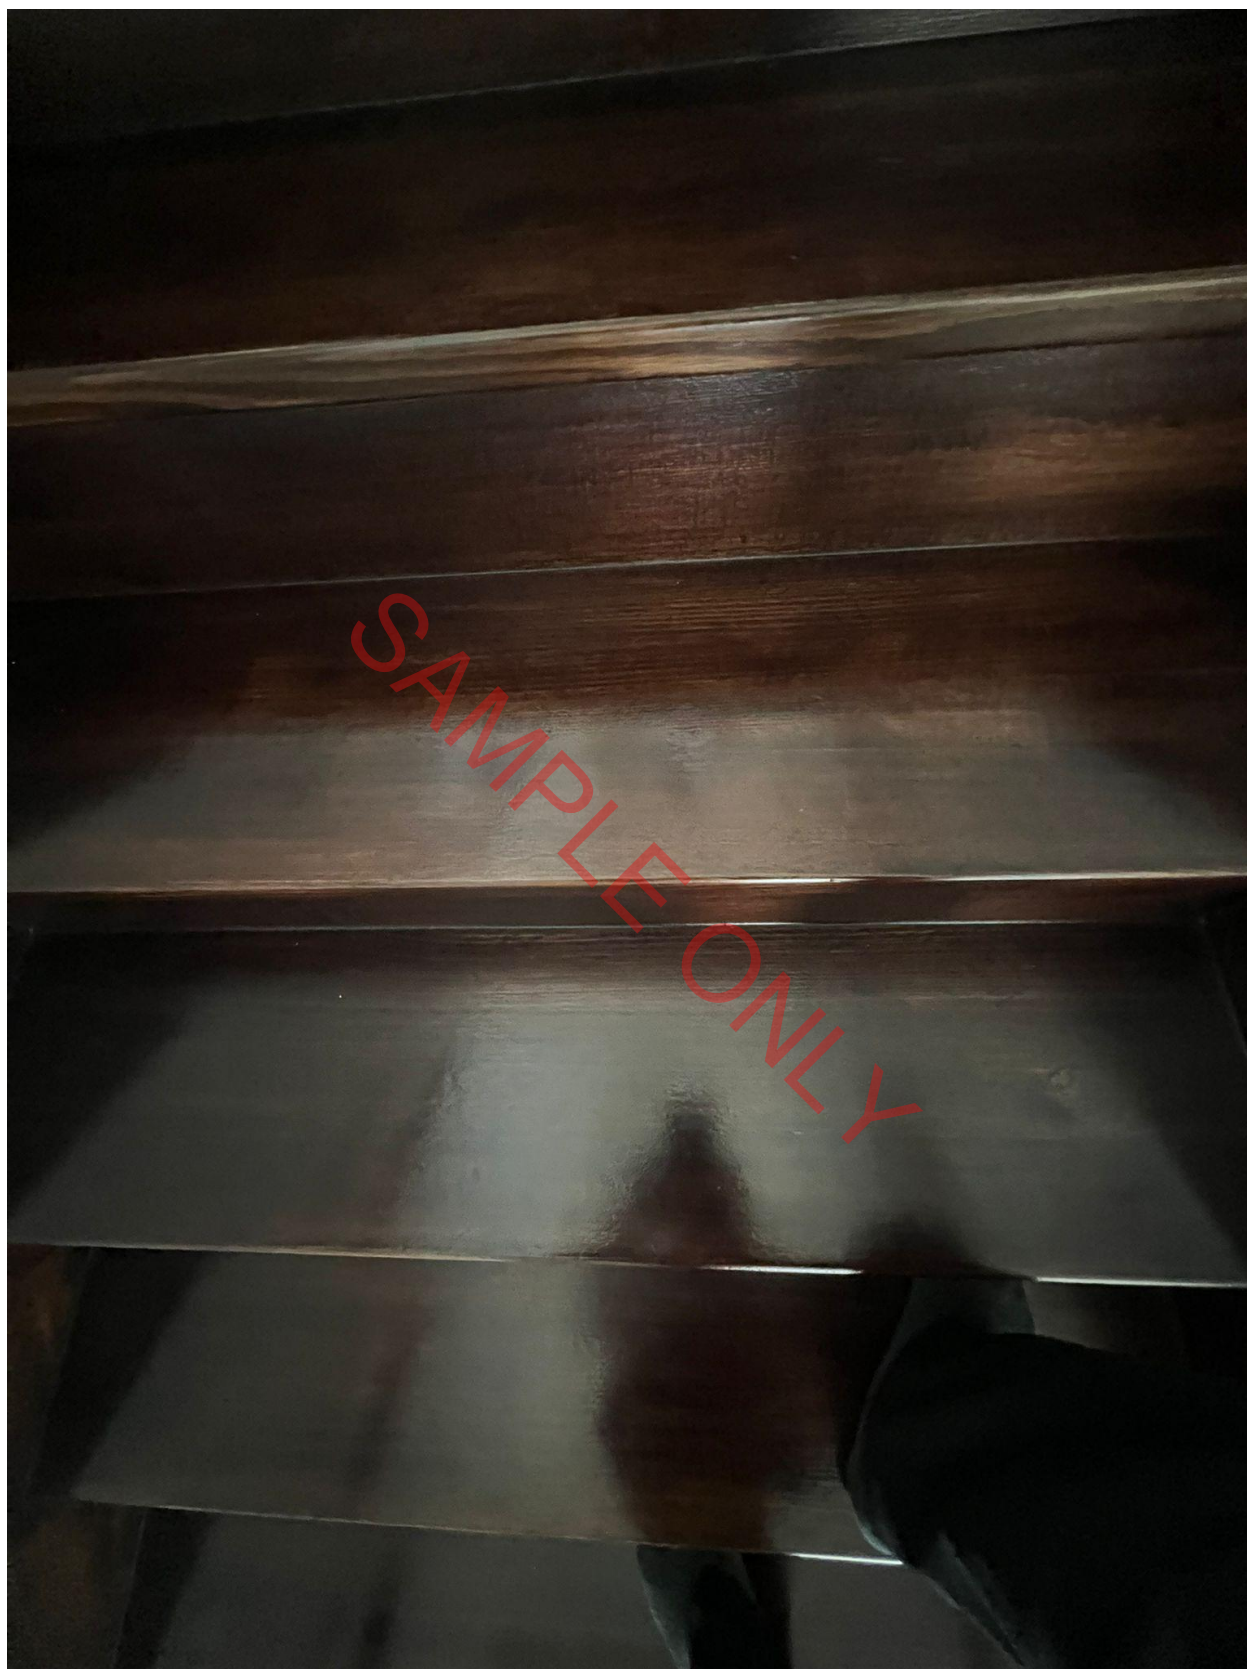
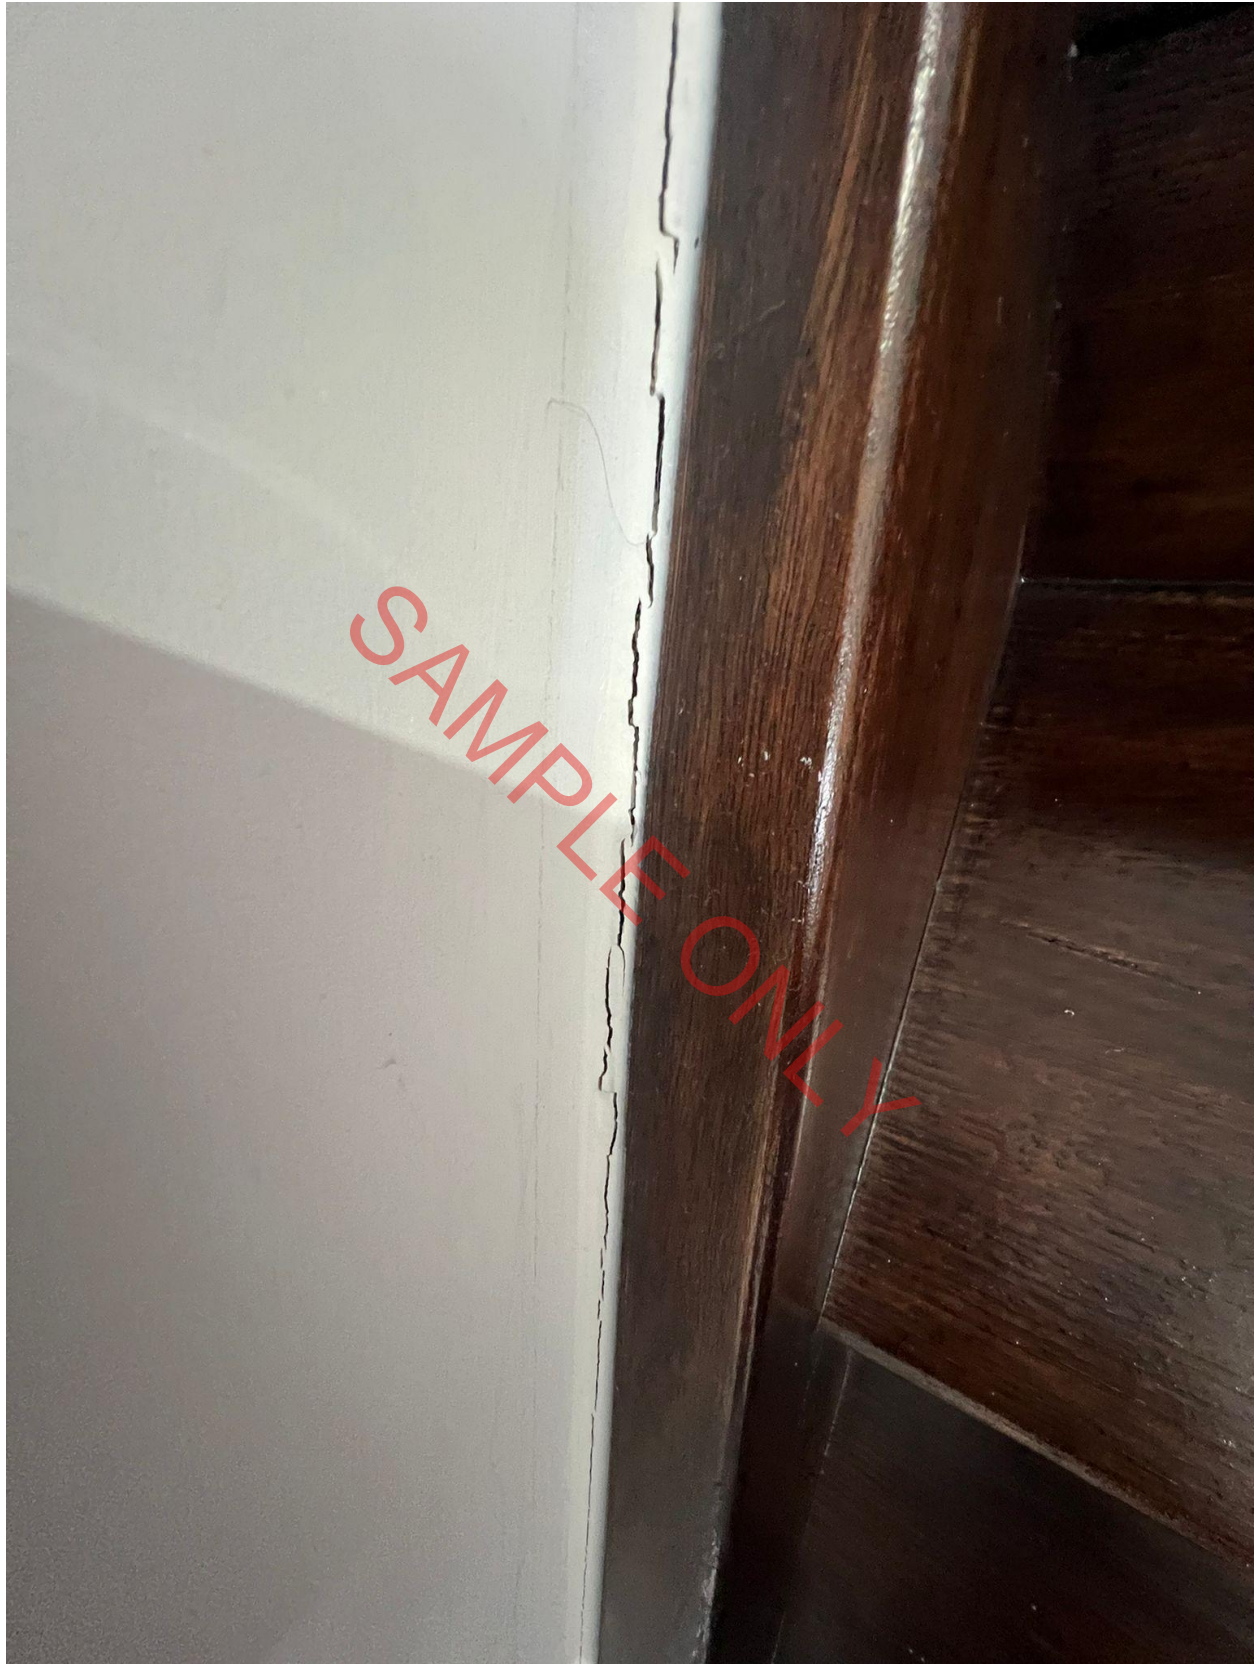
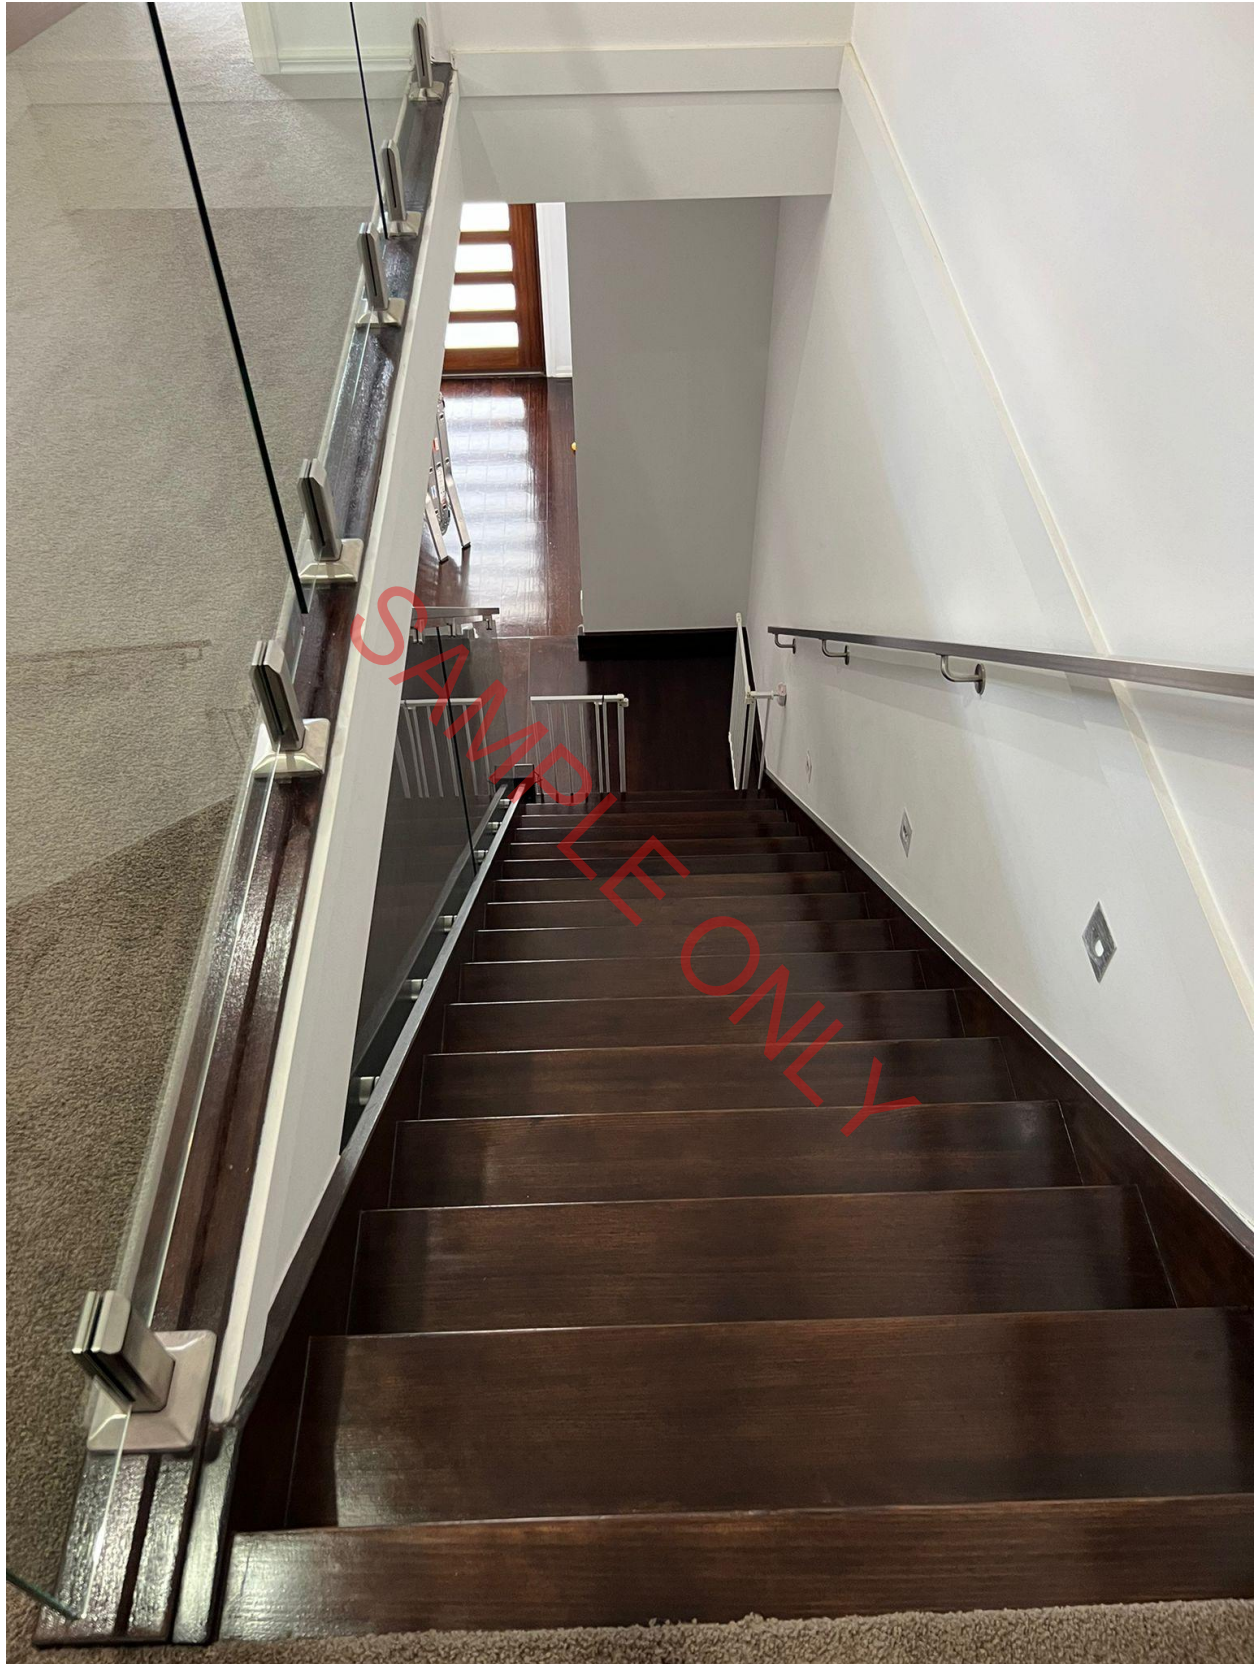
Findings: 10.0

Location: Finding:	Stairs – General report
Information:	<p>During the inspection of the staircase at, it was found to be in generally good condition, with only minor defects observed. These include a hairline gap along the stringer and a small, natural dent in the timber on the landing.</p> <p>Observed Defects:</p> <p>Hairline Gap on Stringer: A small hairline gap was observed on the stringer. This is likely due to natural settlement or minor movement of the structure and does not currently pose any significant risk to the integrity of the stairs.</p> <p>Small Dent in Timber on Landing: A small, natural dent was found in the timber of the landing. This appears to be the result of normal timber profile and does not affect the functionality or safety of the staircase.</p> <p>Overall Condition:</p> <p>Despite these minor imperfections, the overall condition of the stairs is satisfactory. The structure is stable, and no signs of major damage, such as cracks, warping, or rot, were detected.</p> <p>Impact:</p> <p>Aesthetic Impact: Both the hairline gap on the stringer and the small dent in the timber are minor cosmetic issues and do not significantly affect the appearance of the stairs.</p> <p>Structural Impact: Neither of these issues compromises the structural integrity of the staircase at this time.</p> <p>Recommendations:</p> <p>Monitor Hairline Gap: The hairline gap in the stringer should be monitored over time to ensure that it does not widen or become a structural concern. If necessary, it can be filled with a suitable wood filler or sealant to prevent dust and moisture ingress.</p> <p>Leave Dent as Is: The small dent on the timber landing is a natural occurrence and does not require any immediate action unless aesthetics are a concern. If desired, light sanding or filling could be performed to improve the surface finish.</p> <p>Regular Inspection: Continue with regular inspections of the stairs to identify any further wear or structural changes over time, especially if there are any new movements or gaps that develop.</p>

The staircase is in overall good condition with no major structural or safety concerns. The hairline gap on the stringer and the small dent in the timber landing are minor issues that do not require urgent attention but should be monitored during routine maintenance.
