Post- HANDOVER INSPECTION REPORT

Property Address: Greenvale 3059

Stage of Works: Post Handover

Date of this Report: 11/11/2023

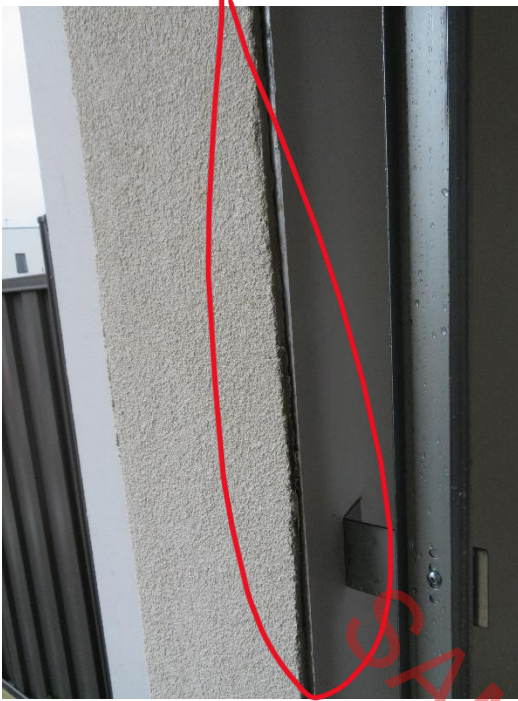
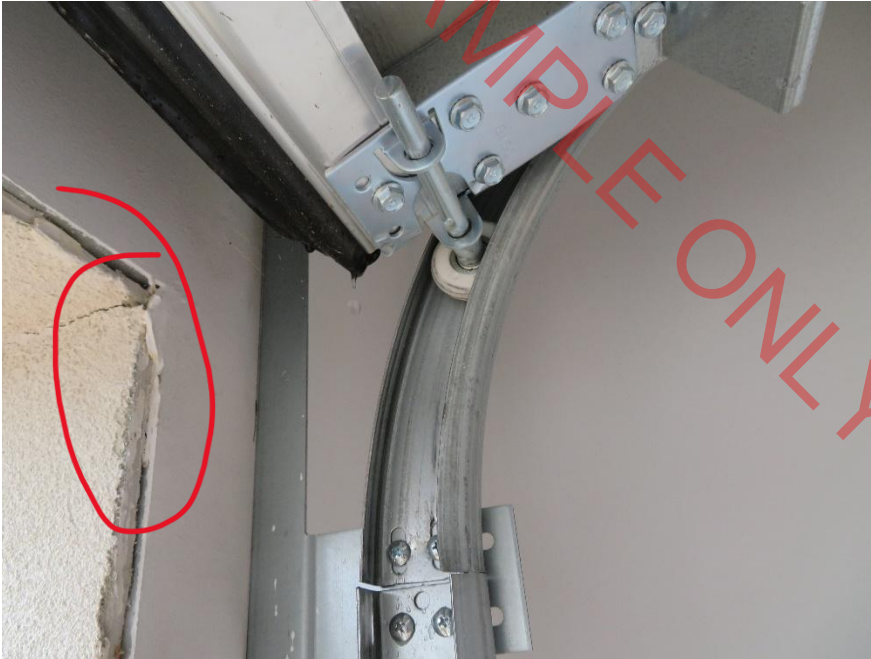
Location:	Sectional Garage Door wall frame
Finding: Information:	<ul style="list-style-type: none">• Cladding is faulty & uneven around the sectional garage door. Uneven gaps are causing water and potential for vermin entry. <p>As per VBA GUIDE TO STANDARDS AND TOLERANCES 2015</p> <p>9.01 Verticality or plumbness of internal and external wall surfaces Wall surfaces are defective if they deviate from vertical by more than 5 mm over a 1.8 m straight edge.</p>
Is this item defective?	YES
Is this item incomplete?	No
Recommendation	The builder to rectify this finding in accordance with section 8(a) of the Act.

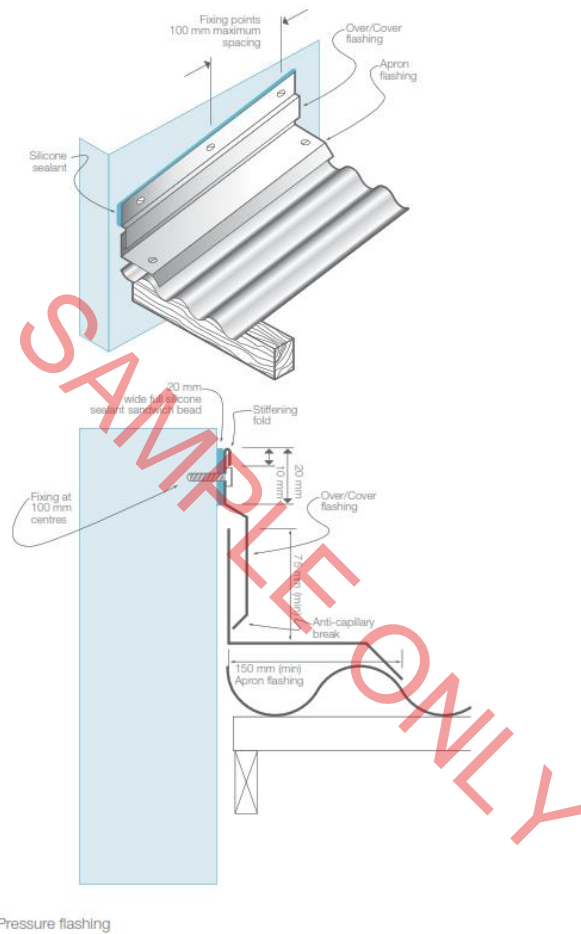
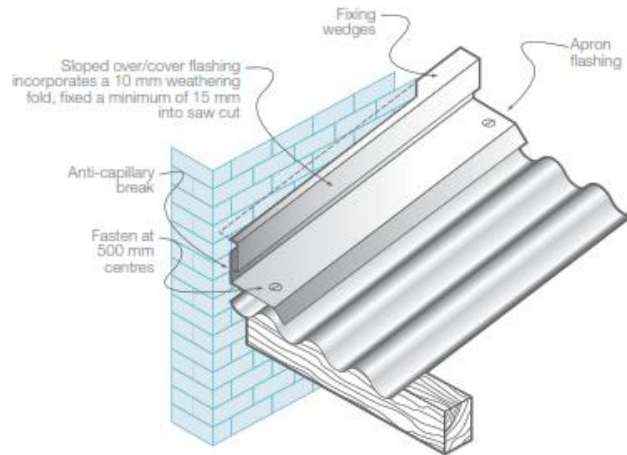
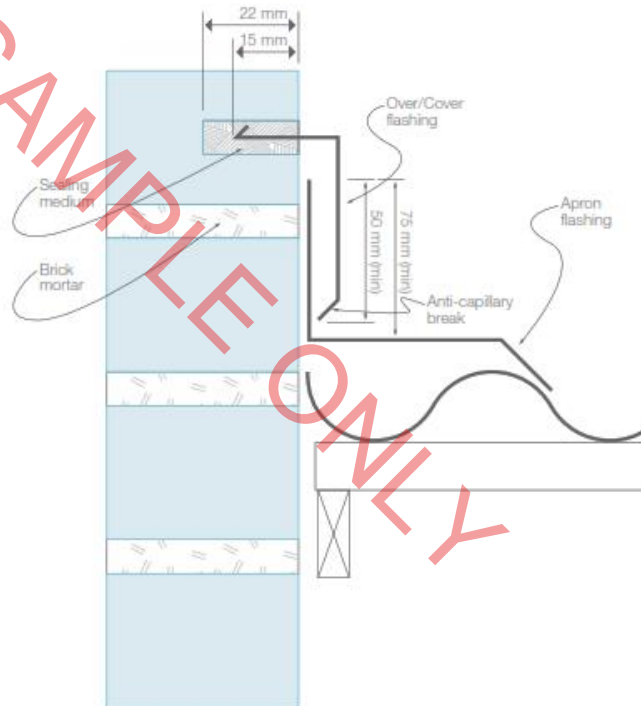
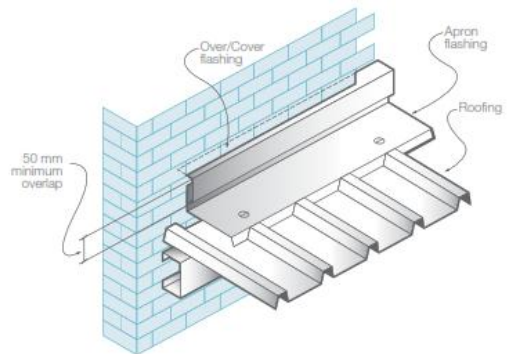
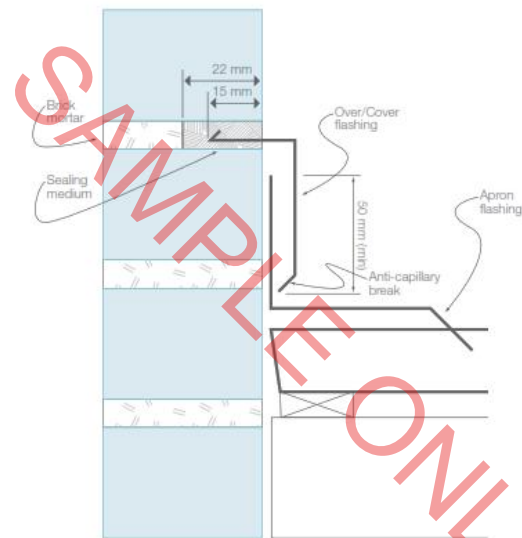
DIAGRAM 7.06 FLASHINGS

masonry walls by at least 15 mm as shown in Diagram 7.06(A) and Diagram 7.06(B).
Pressure flashings are defective if they are not fixed on appropriate surfaces, or are not fixed in accordance with Diagram 7.06(C).

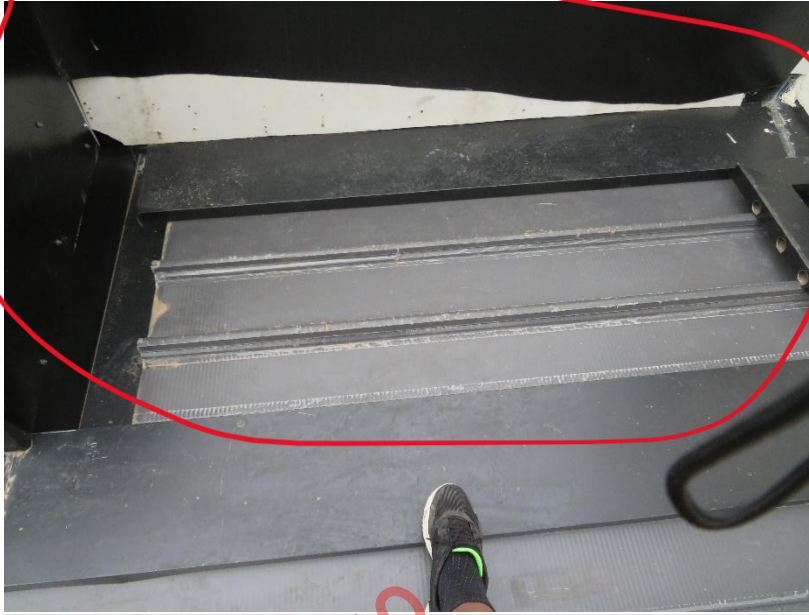
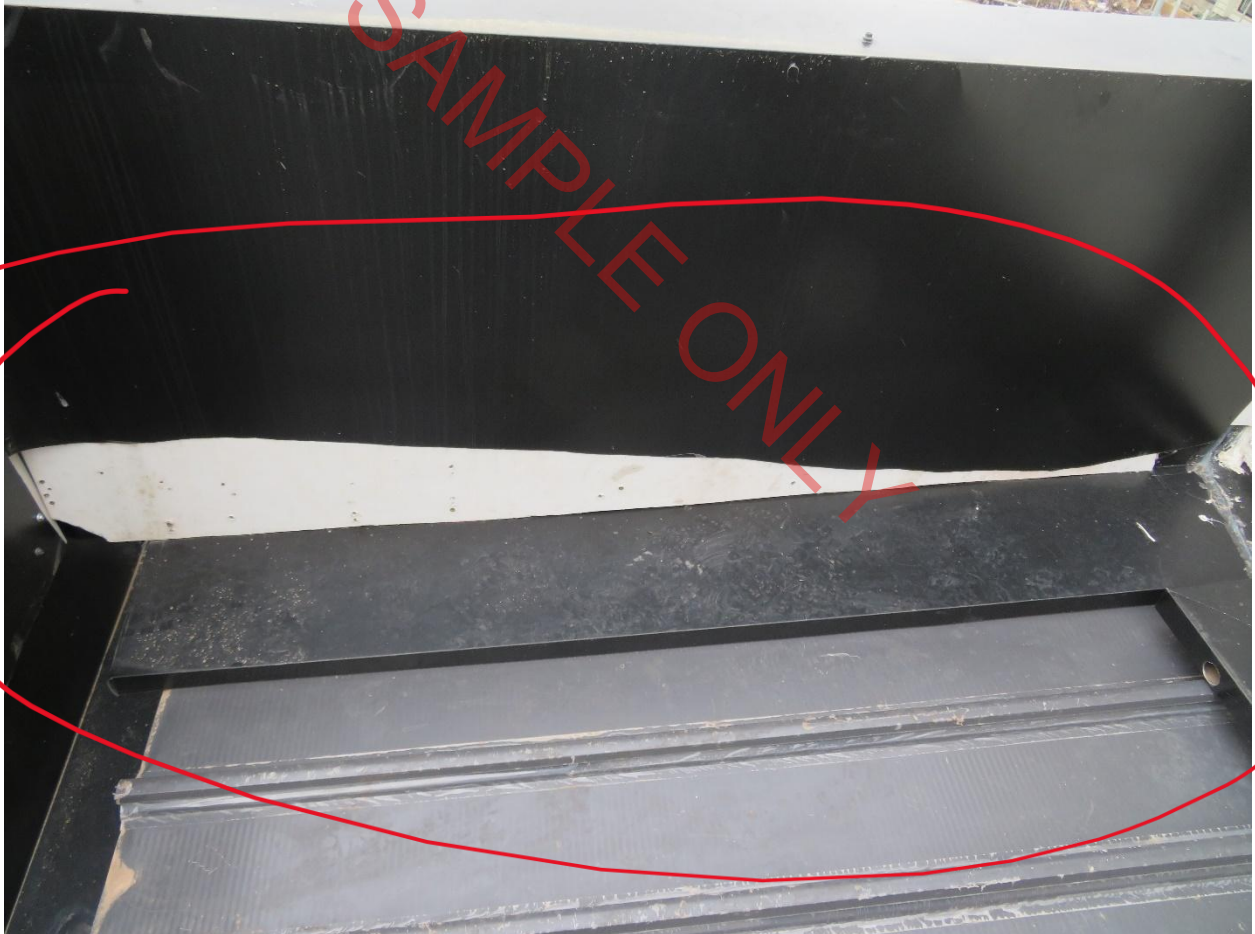
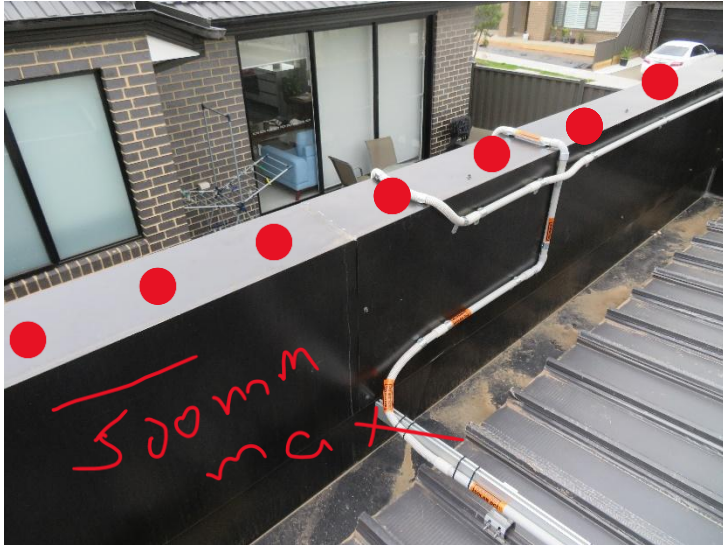
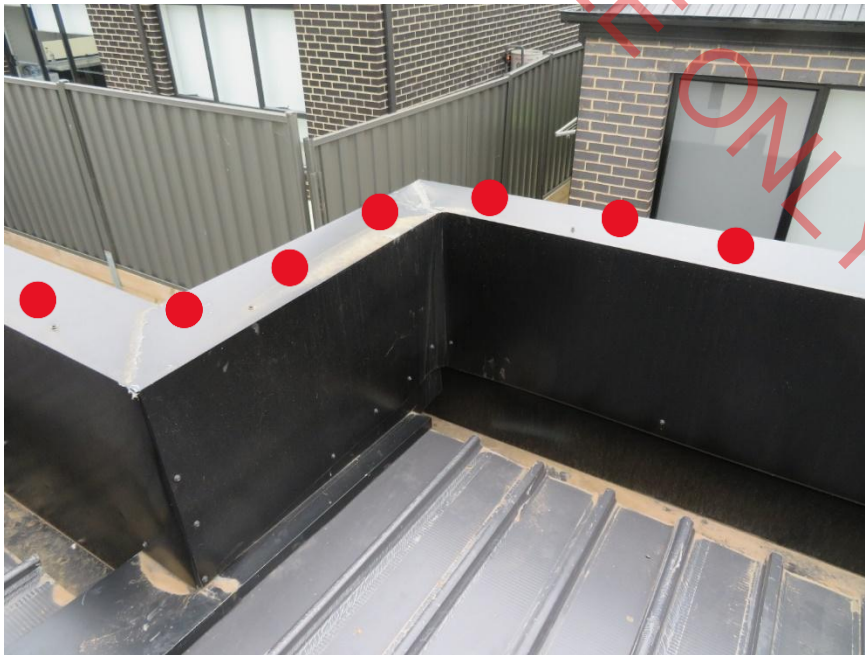
Location:	Roof (Capping, flashing and protective film)
Finding: Information:	<ul style="list-style-type: none">• Protective film is not removed• Capping is defective & missing• Flashings are defective• Joints are not sealed as per the requirement• Downpipes are not secured properly• Downpipe is damaged and incorrectly installed• Building material is left behind in gutters and roof• Poor rectification worked carried out by a handyman organised by the builder.• Inadequate screws on capping and flashing <p>As per VBA GUIDE TO STANDARDS AND TOLERANCES 2015</p> <p>7.01 Plumbing: Plumbing work is defective if it does not comply with the relevant plumbing regulations and the contract documents. The builder shall provide the owner with a compliance certificate from the plumber when a certificate is required to be issued.</p> <p>7.02 Positioning of gutters: Unless documented otherwise, installation of gutters is defective if the fascia, when viewed from a normal viewing position, is:</p> <ul style="list-style-type: none">a) visible above a gutterb) not concealed by a flashing finished to match the gutter. <p>7.03 Water retention in gutters: Gutters are defective if they retain a depth of more than 10 mm of water.</p> <p>7.04 Joints in gutters: Unless documented otherwise, gutters are defective if they have joints lapped less than 25 mm. Laps that are not in the direction of flow to the outlet are defective. Joints that leak are defective.</p> <p>7.05 Fixing of gutters and downpipes: Gutters and downpipes are defective if they are not securely fixed.</p> <p>7.06 Flashings: Flashings are defective if they are not provided in accordance with the requirements of the Building Code of Australia.</p> <p>Wall and step flashings, and sloping flashings cut into walls are defective if they do not incorporate weathering folds, anti-capillary breaks and sealing, or do not enter the</p>

The barge capping is only fixed down at approx. 1600mm or more centres in lieu of the plumbing regulated 500mm. Parapet capping have not been fixed to the building at intervals as per SA/HB 39-2015 Clause 8.7 (b)– This appears constant throughout the entire home and needs to be addressed at each stage. This work is non-compliant, rectification is required.

Is this item defective?	YES
Is this item incomplete?	Yes
Recommendation	The builder to rectify this finding in accordance with section 8(a) of the Act.
