Post- HANDOVER INSPECTION REPORT

Property Address: Greenvale 3059

Stage of Works: Post Handover

Date of this Report: 11/11/2023

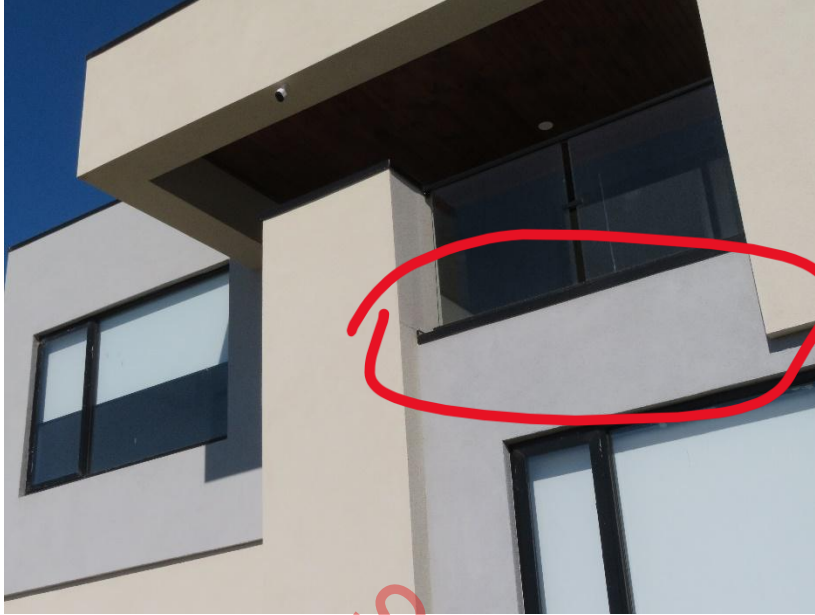
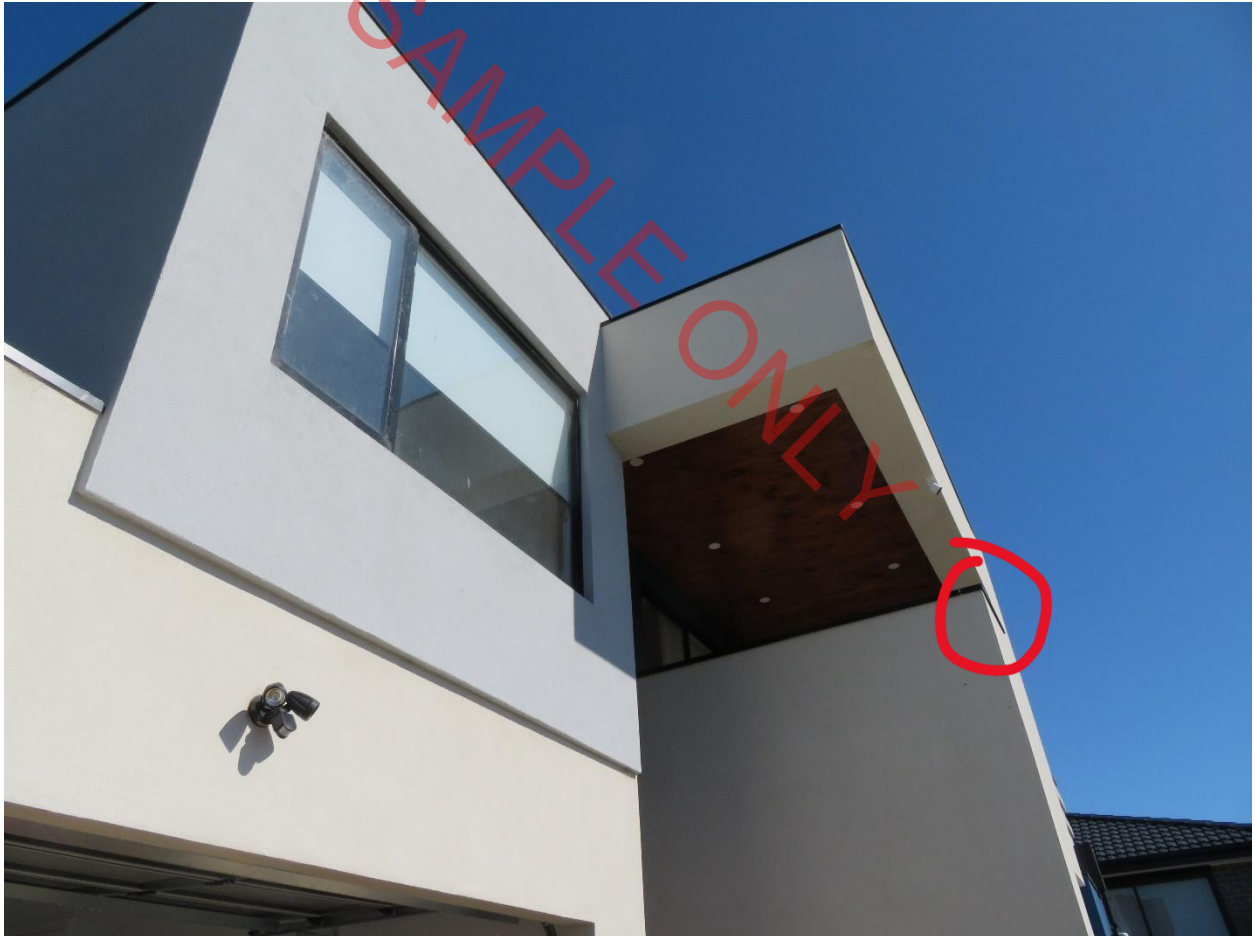
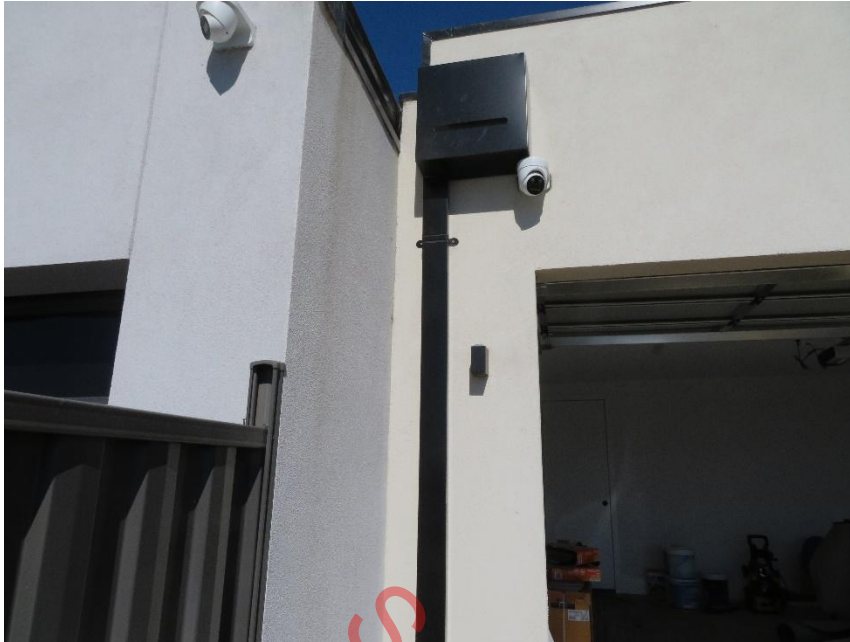
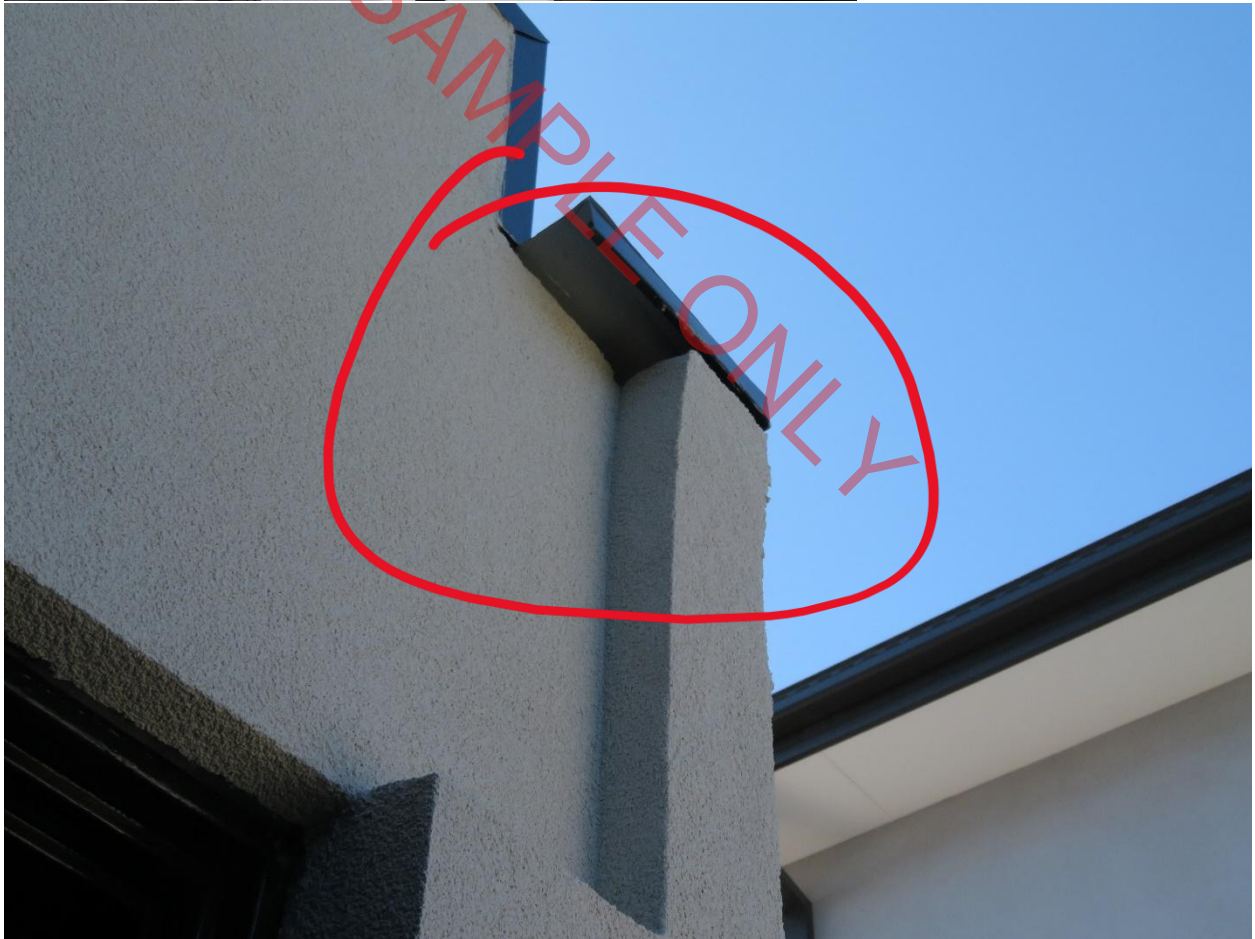
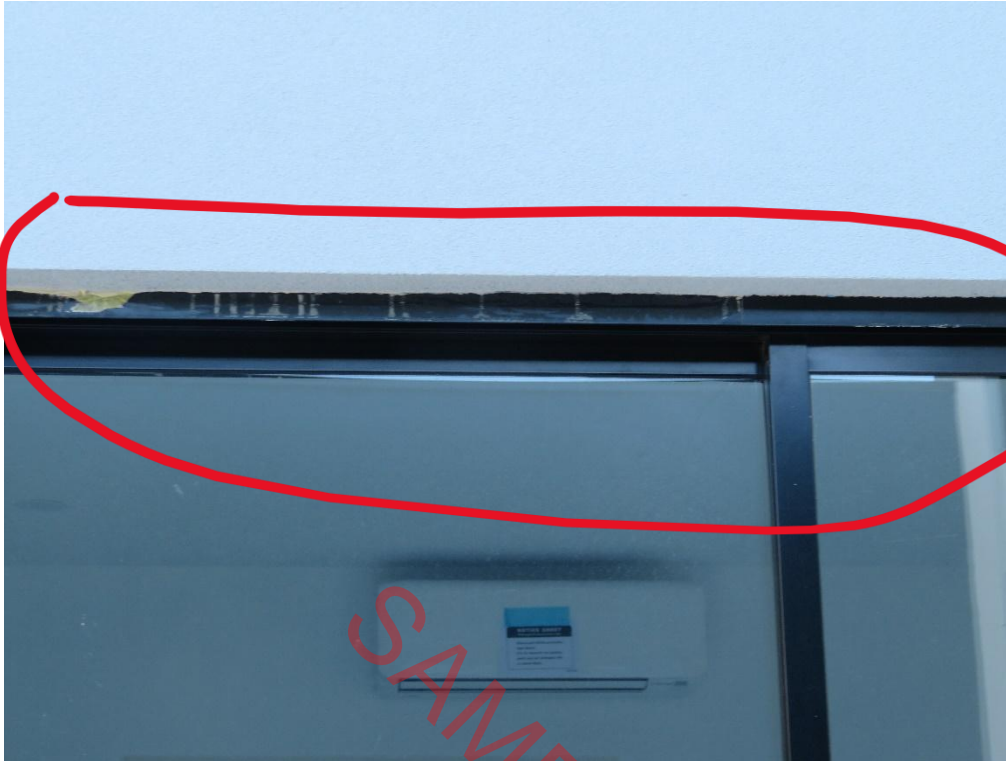
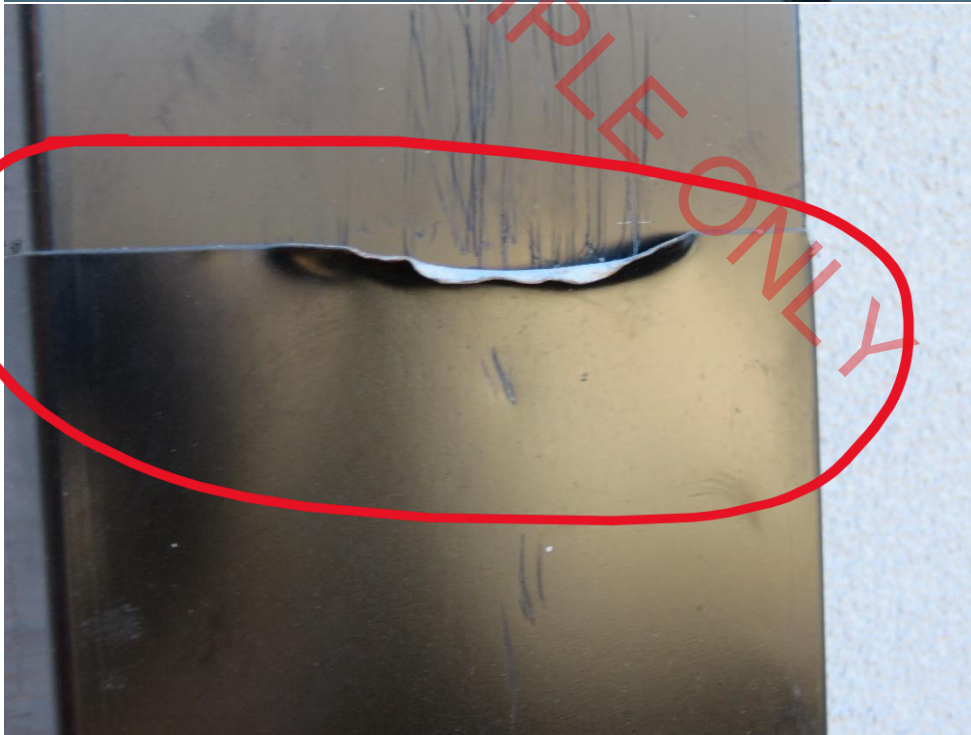
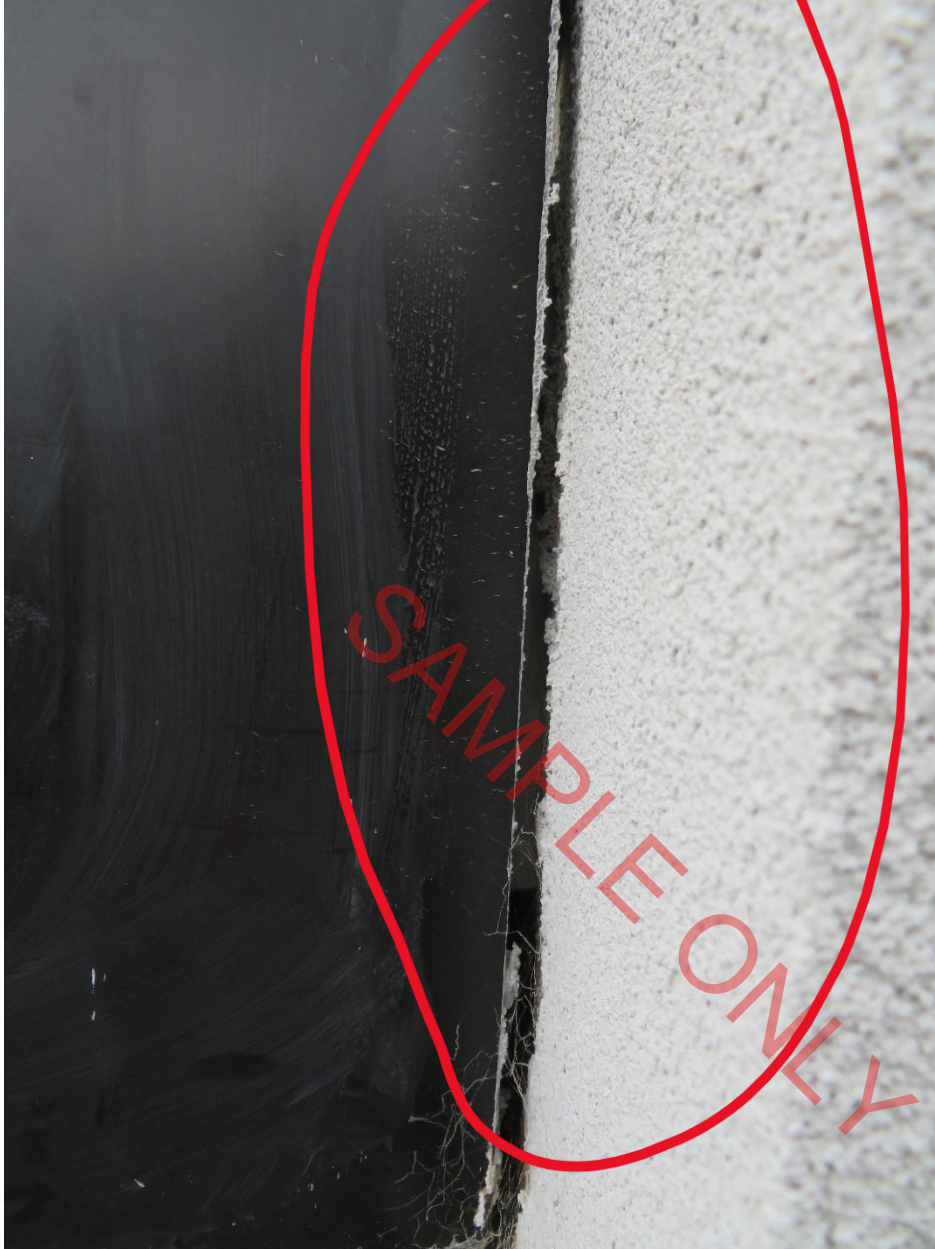
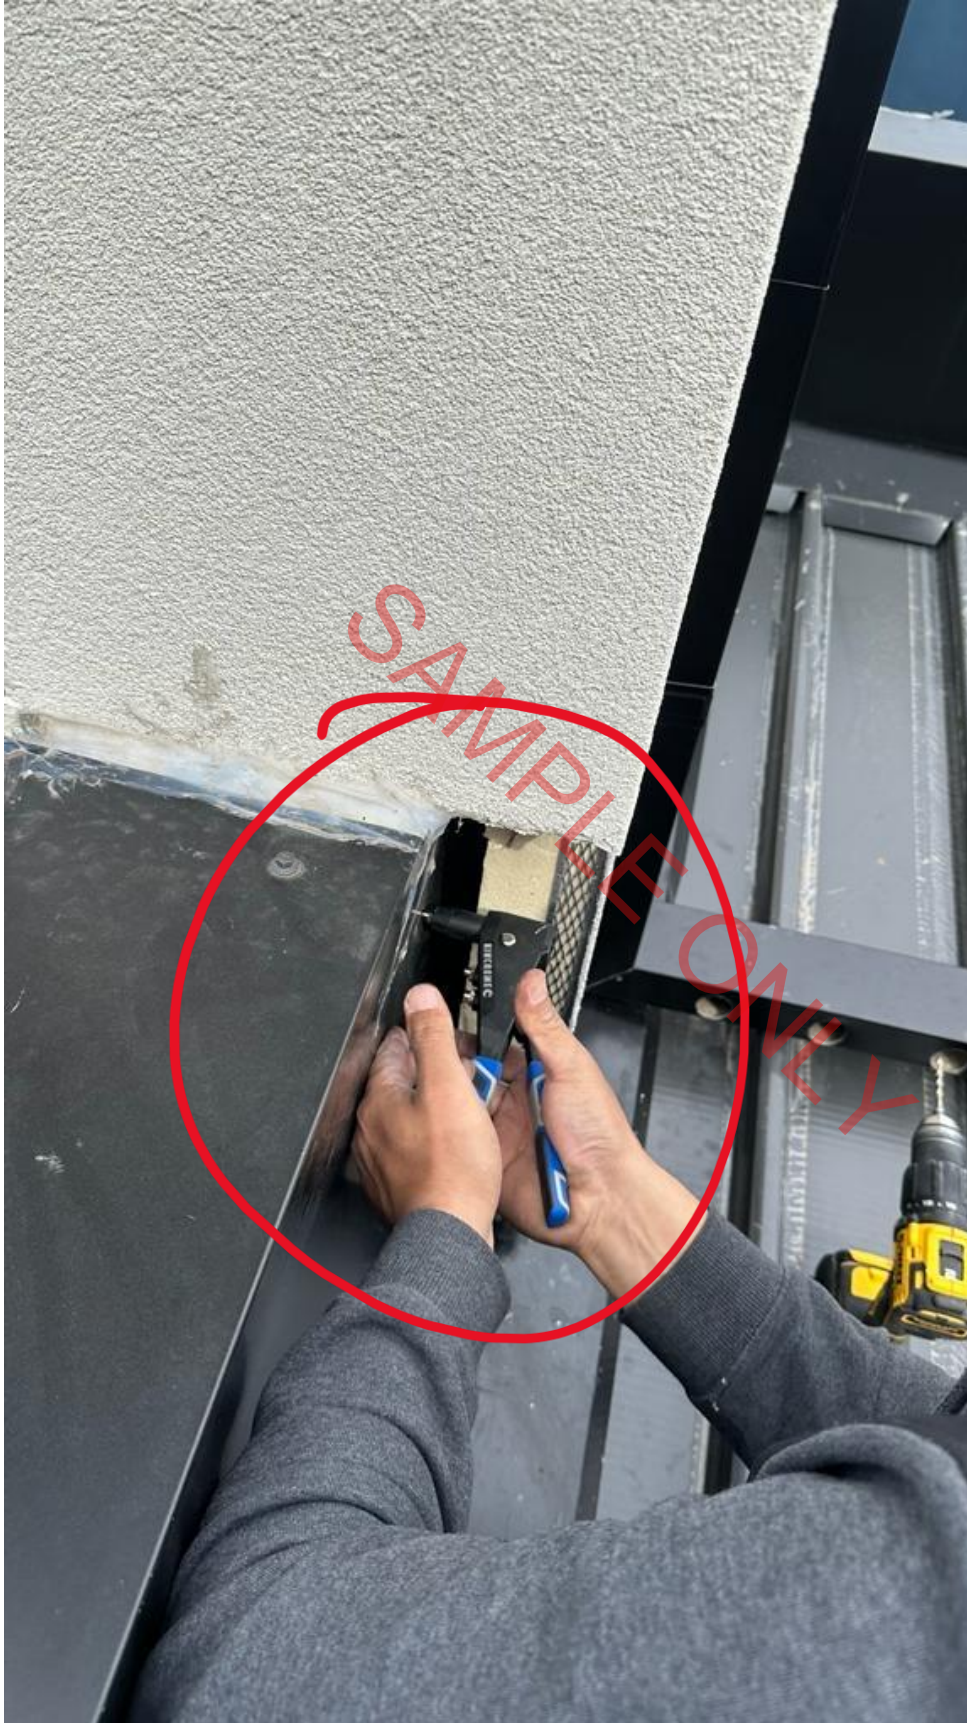
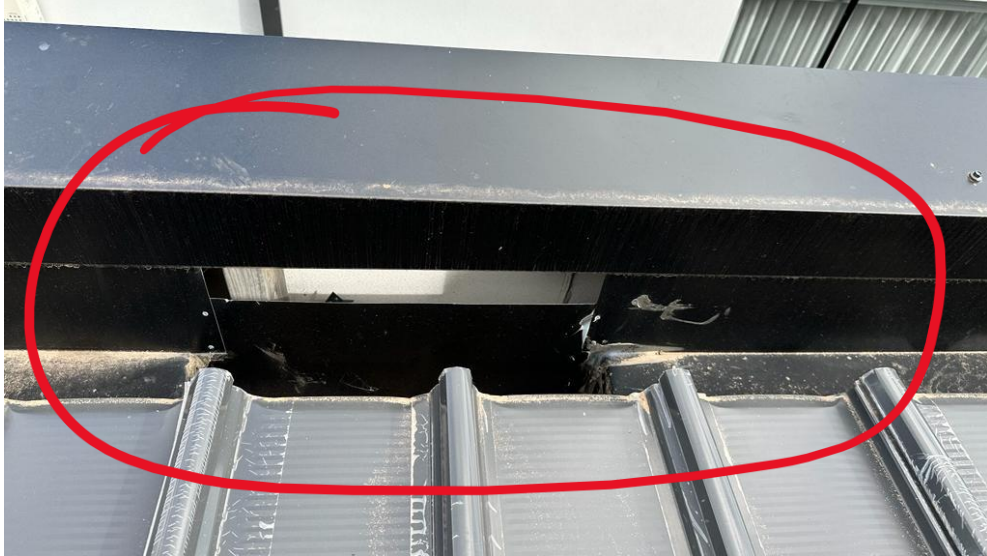
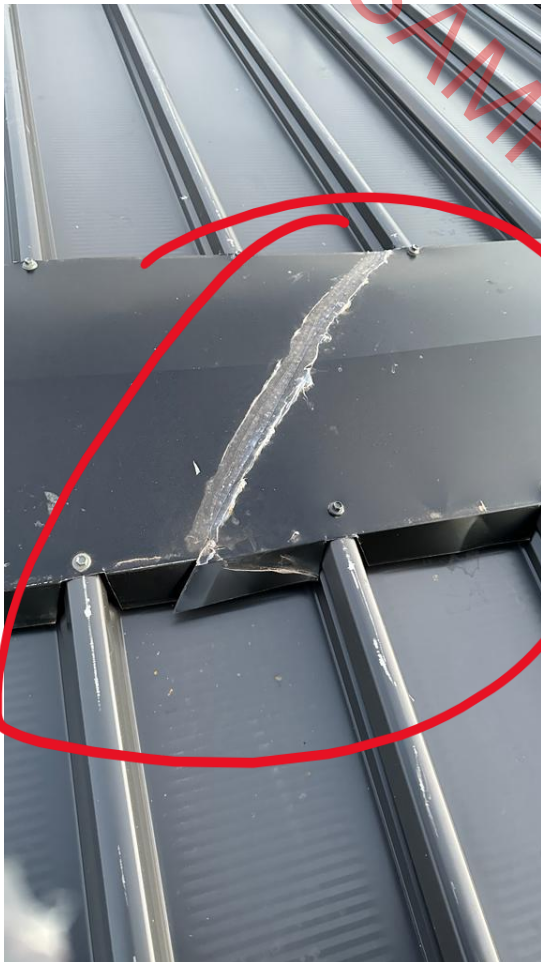
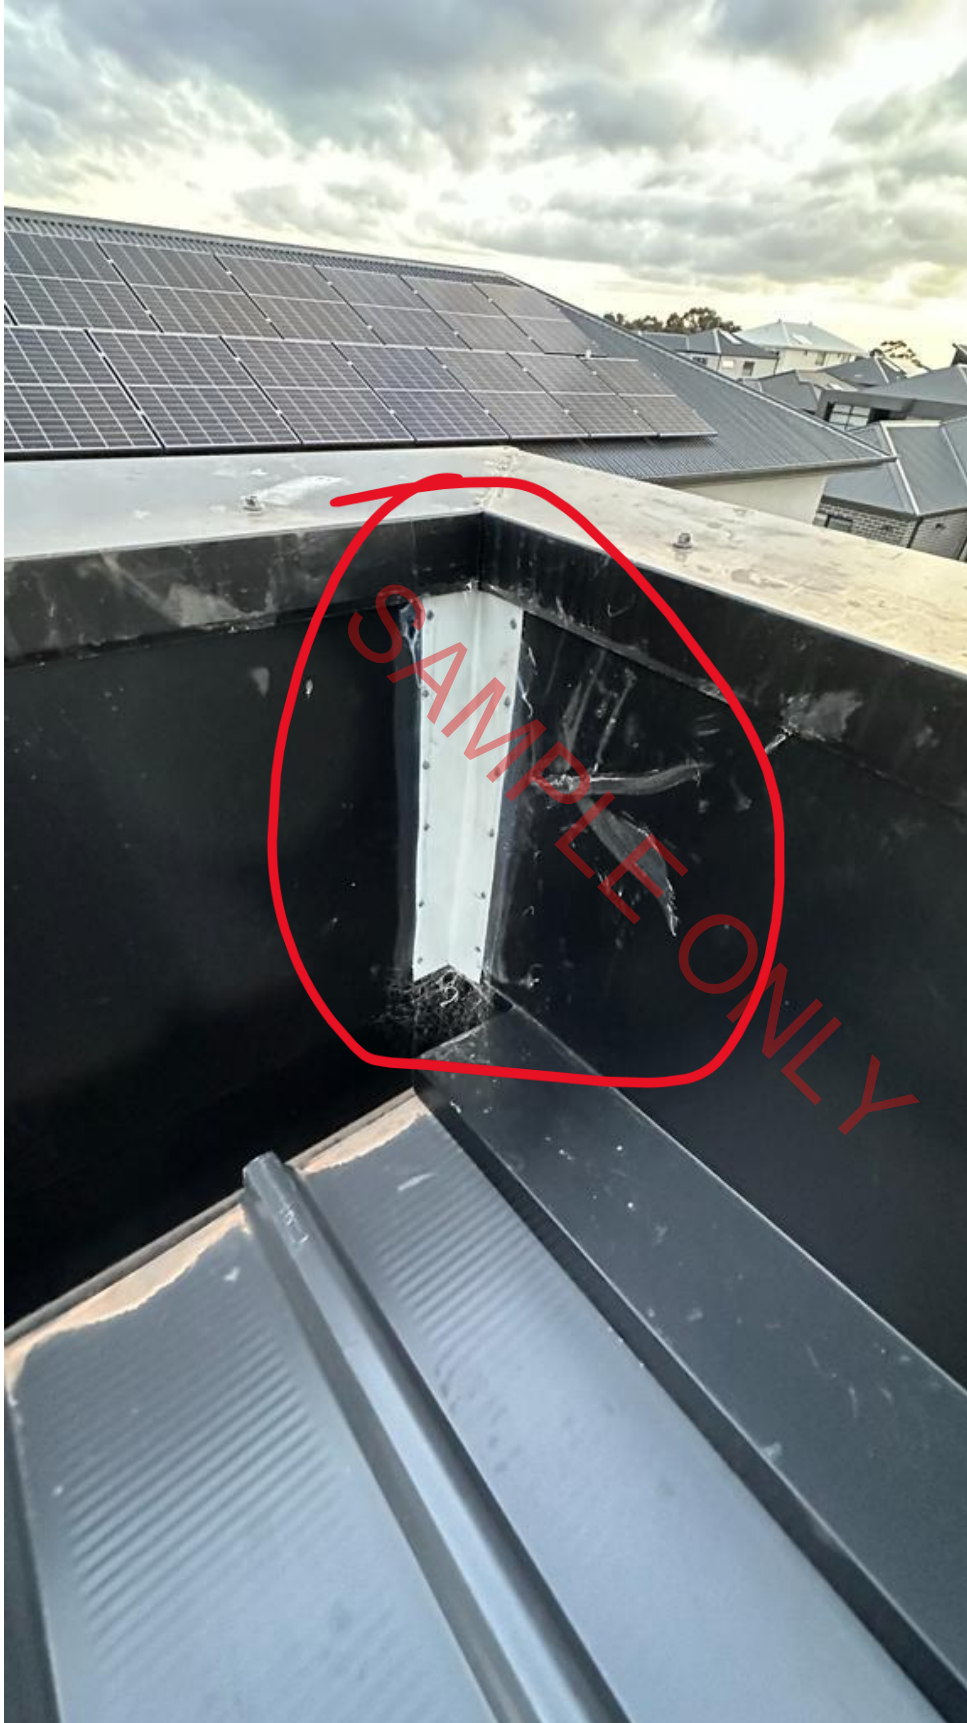
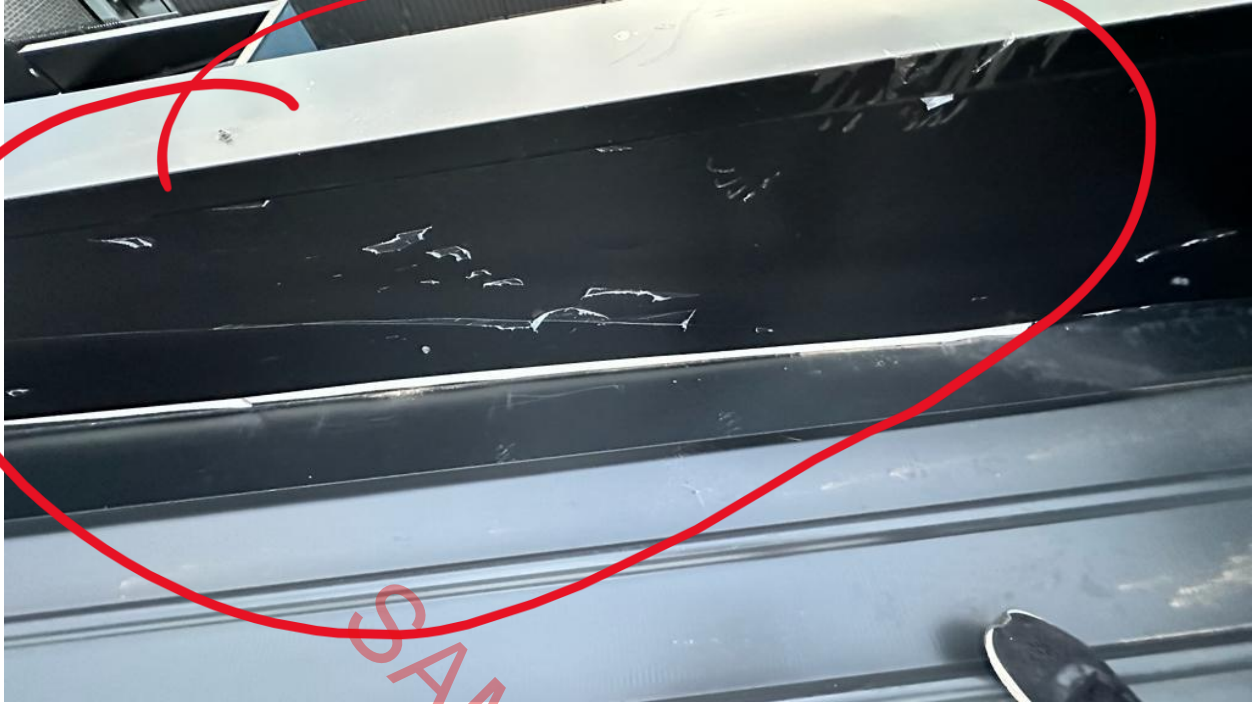
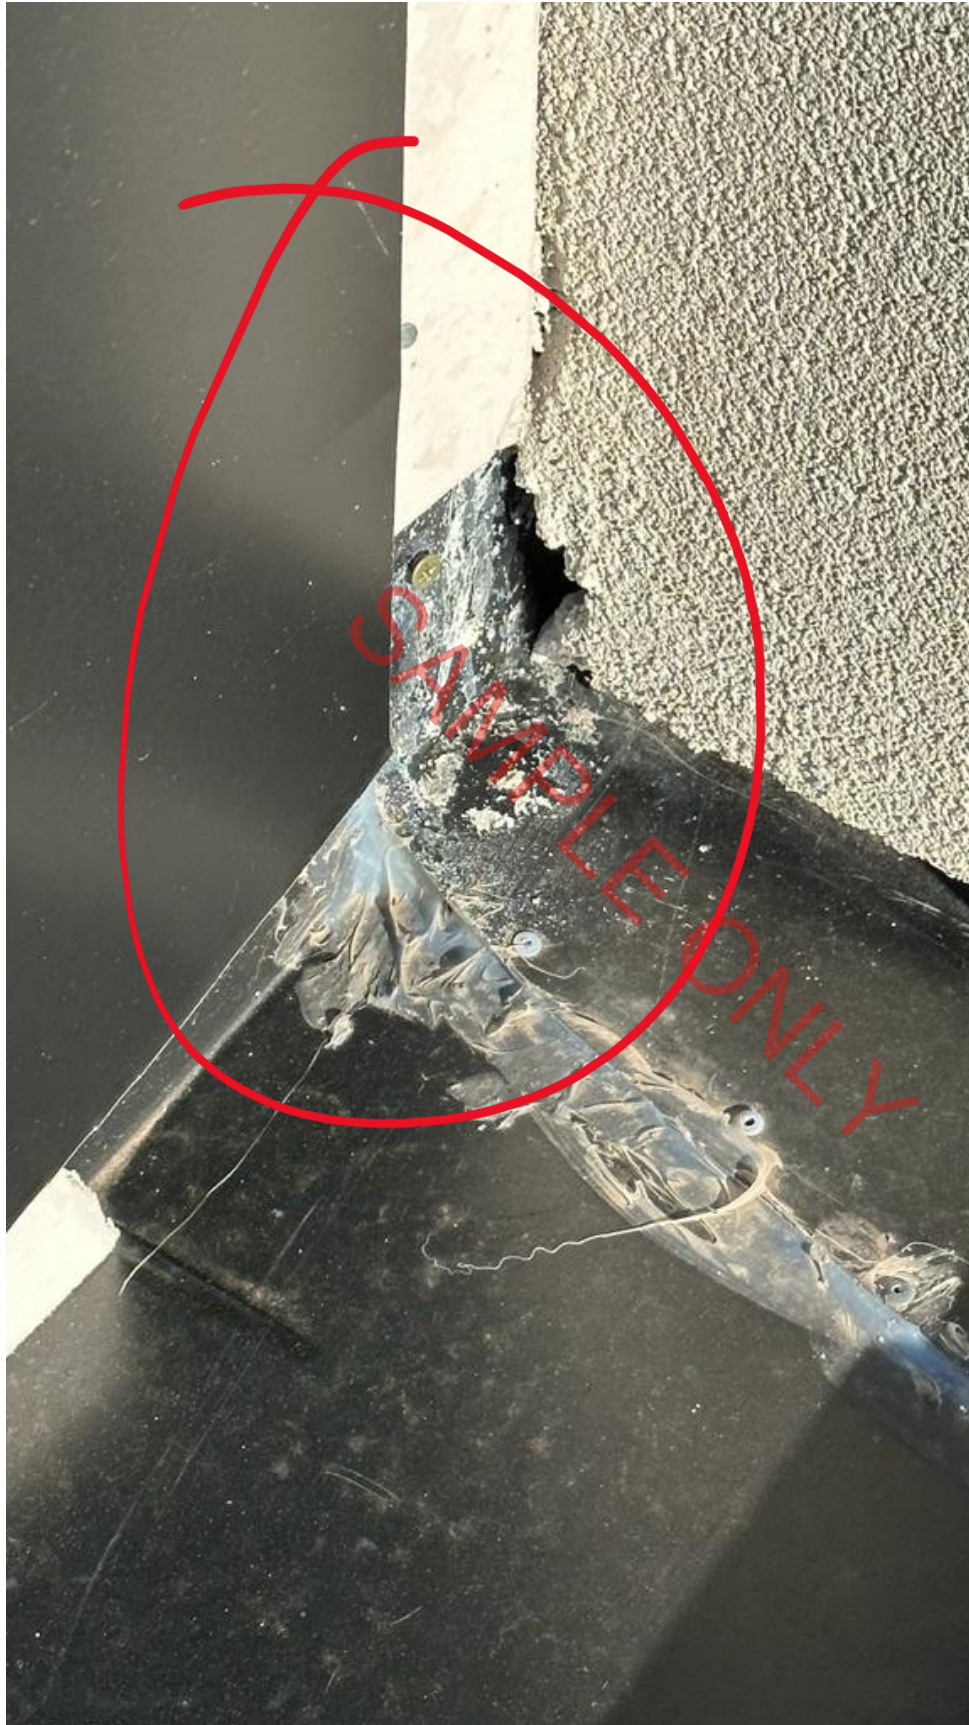
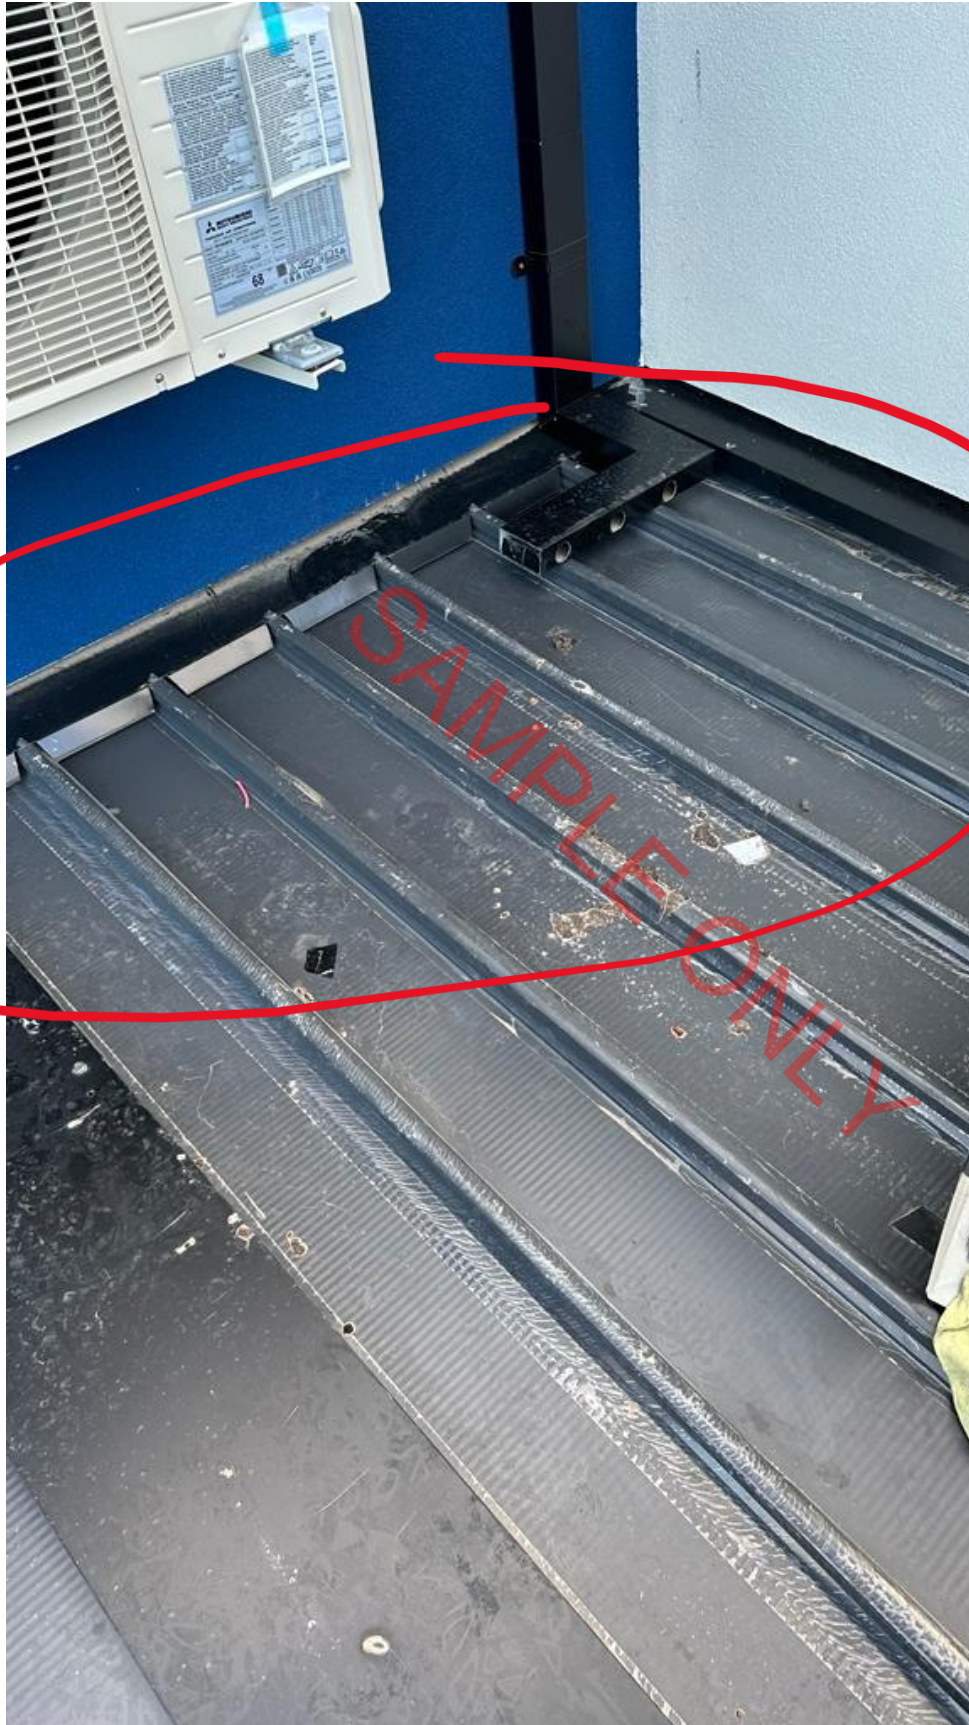
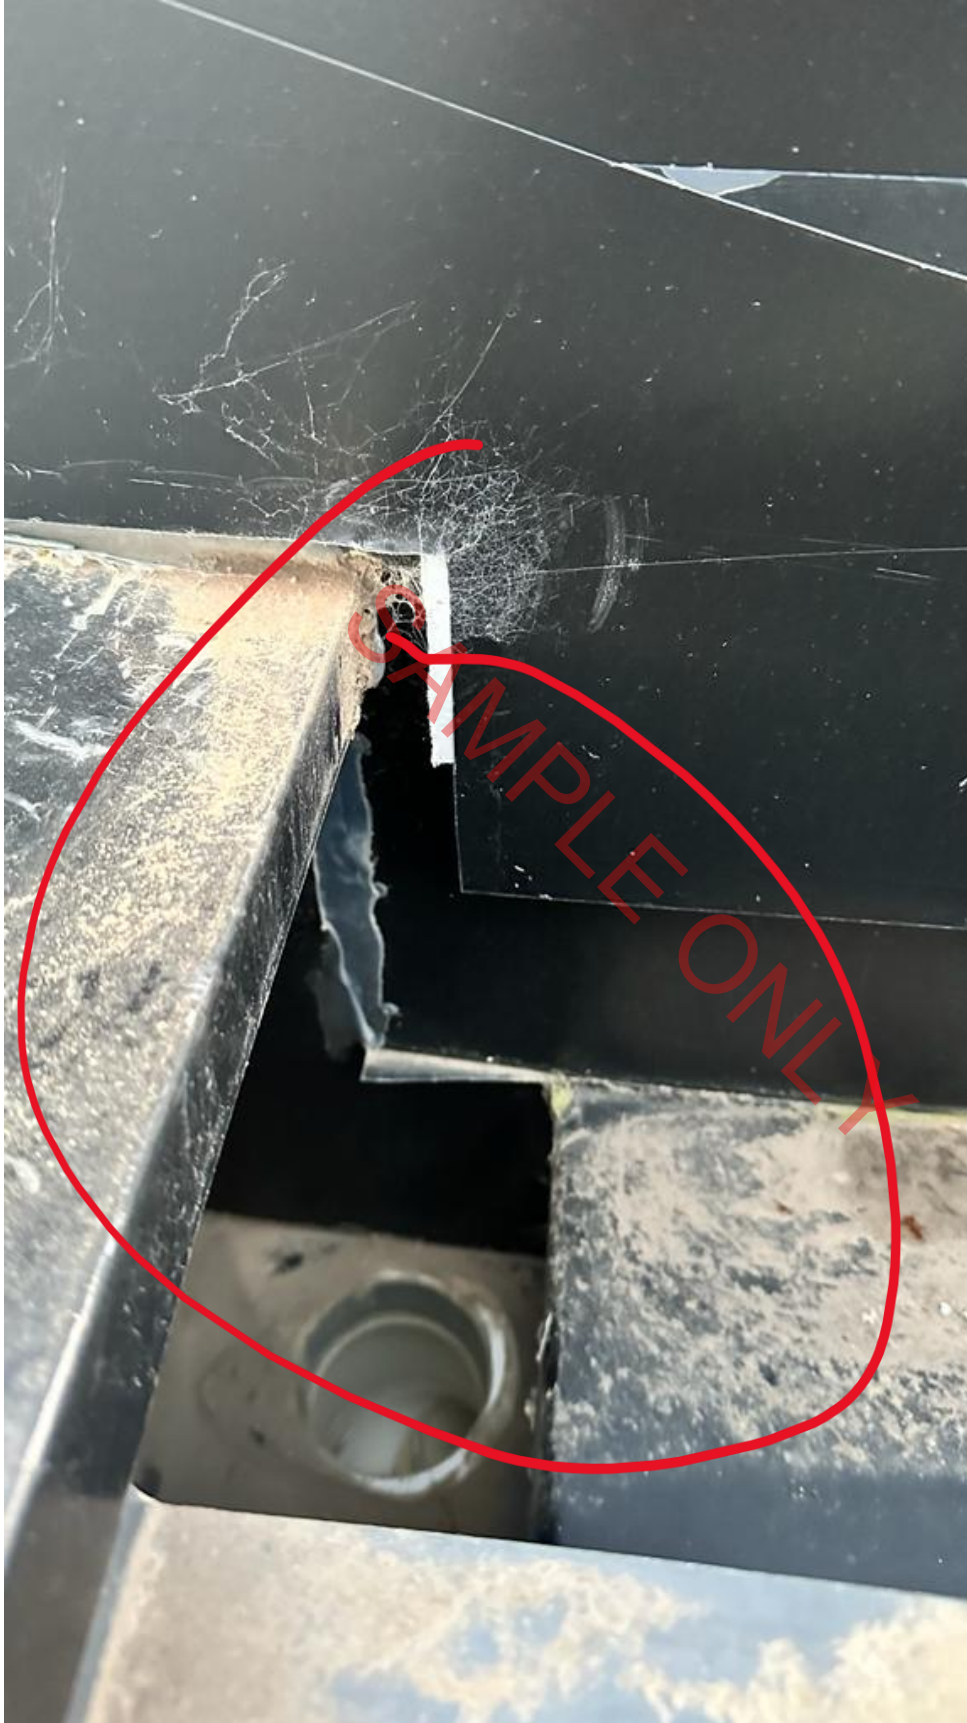
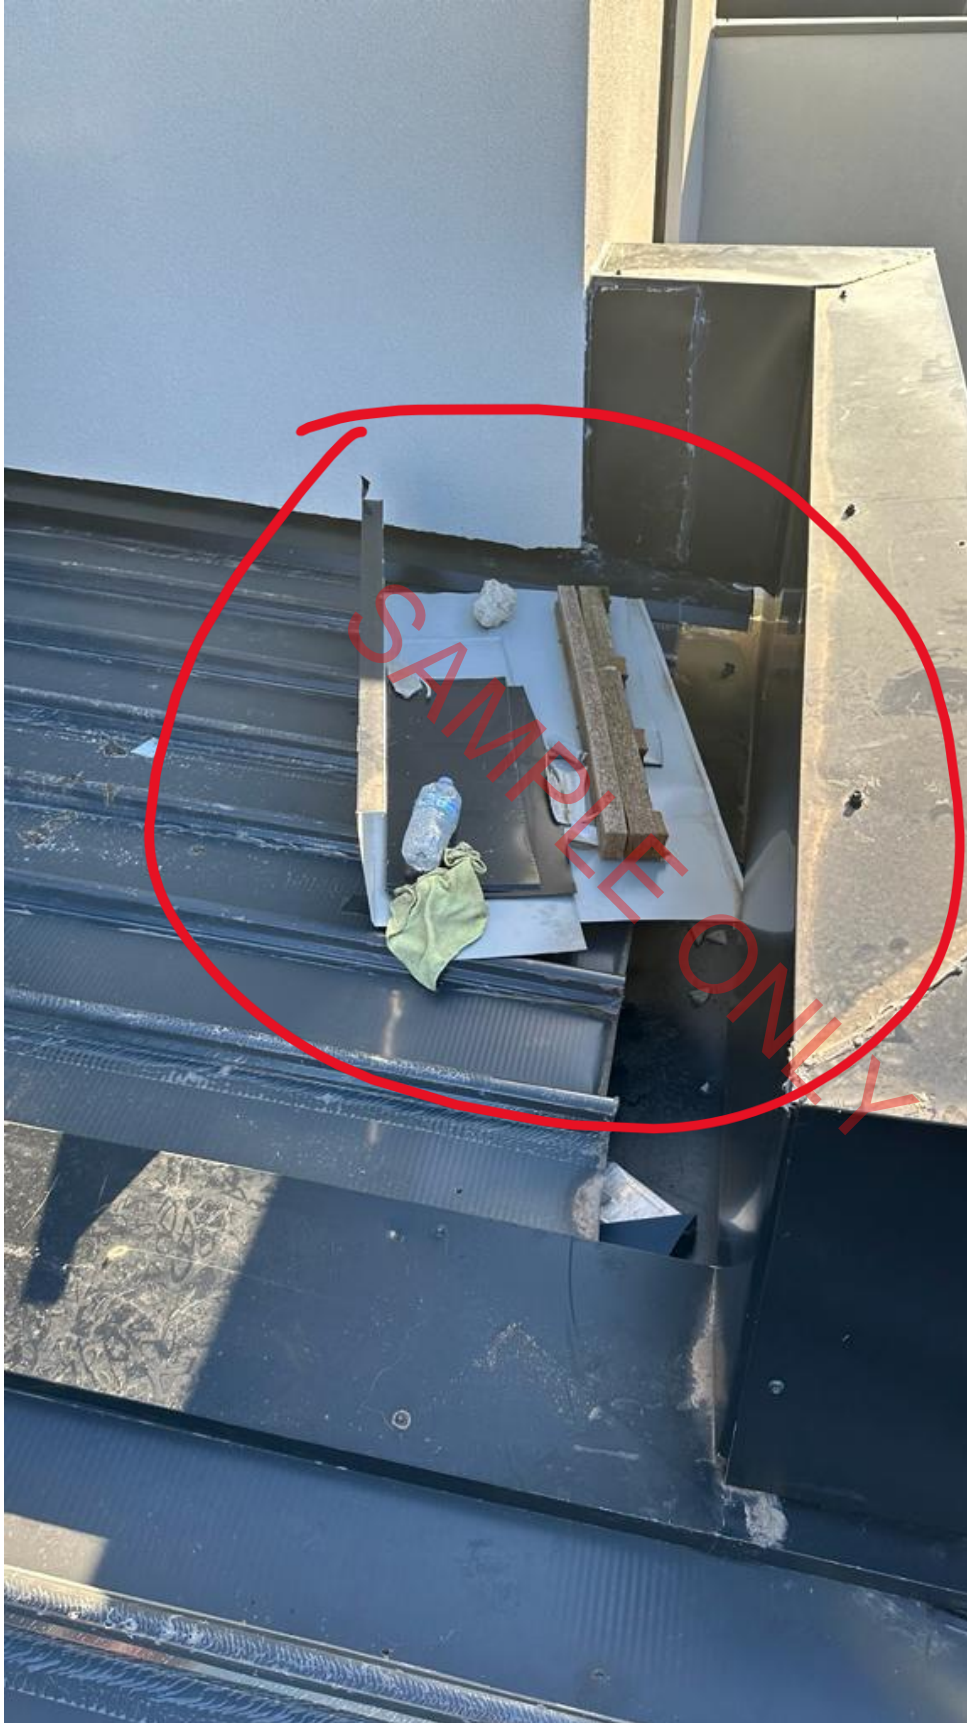
Location:	Roof (Capping, flashing and protective film)
Finding: Information:	<ul style="list-style-type: none">• Protective film is not removed• Capping is defective & missing• Flashings are defective• Joints are not sealed as per the requirement• Downpipes are not secured properly• Downpipe is damaged and incorrectly installed• Building material is left behind in gutters and roof• Poor rectification worked carried out by a handyman organised by the builder.• Inadequate screws on capping and flashing <p>As per VBA GUIDE TO STANDARDS AND TOLERANCES 2015</p> <p>7.01 Plumbing: Plumbing work is defective if it does not comply with the relevant plumbing regulations and the contract documents. The builder shall provide the owner with a compliance certificate from the plumber when a certificate is required to be issued.</p> <p>7.02 Positioning of gutters: Unless documented otherwise, installation of gutters is defective if the fascia, when viewed from a normal viewing position, is:</p> <ul style="list-style-type: none">a) visible above a gutterb) not concealed by a flashing finished to match the gutter. <p>7.03 Water retention in gutters: Gutters are defective if they retain a depth of more than 10 mm of water.</p> <p>7.04 Joints in gutters: Unless documented otherwise, gutters are defective if they have joints lapped less than 25 mm. Laps that are not in the direction of flow to the outlet are defective. Joints that leak are defective.</p> <p>7.05 Fixing of gutters and downpipes: Gutters and downpipes are defective if they are not securely fixed.</p> <p>7.06 Flashings: Flashings are defective if they are not provided in accordance with the requirements of the Building Code of Australia.</p> <p>Wall and step flashings, and sloping flashings cut into walls are defective if they do not incorporate weathering folds, anti-capillary breaks and sealing, or do not enter the</p>

masonry walls by at least 15 mm as shown in Diagram 7.06(A) and Diagram 7.06(B).
Pressure flashings are defective if they are not fixed on appropriate surfaces, or are not fixed in accordance with Diagram 7.06(C).

Is this item defective?	YES
Is this item incomplete?	Yes
Recommendation	The builder to rectify this finding in accordance with section 8(a) of the Act.

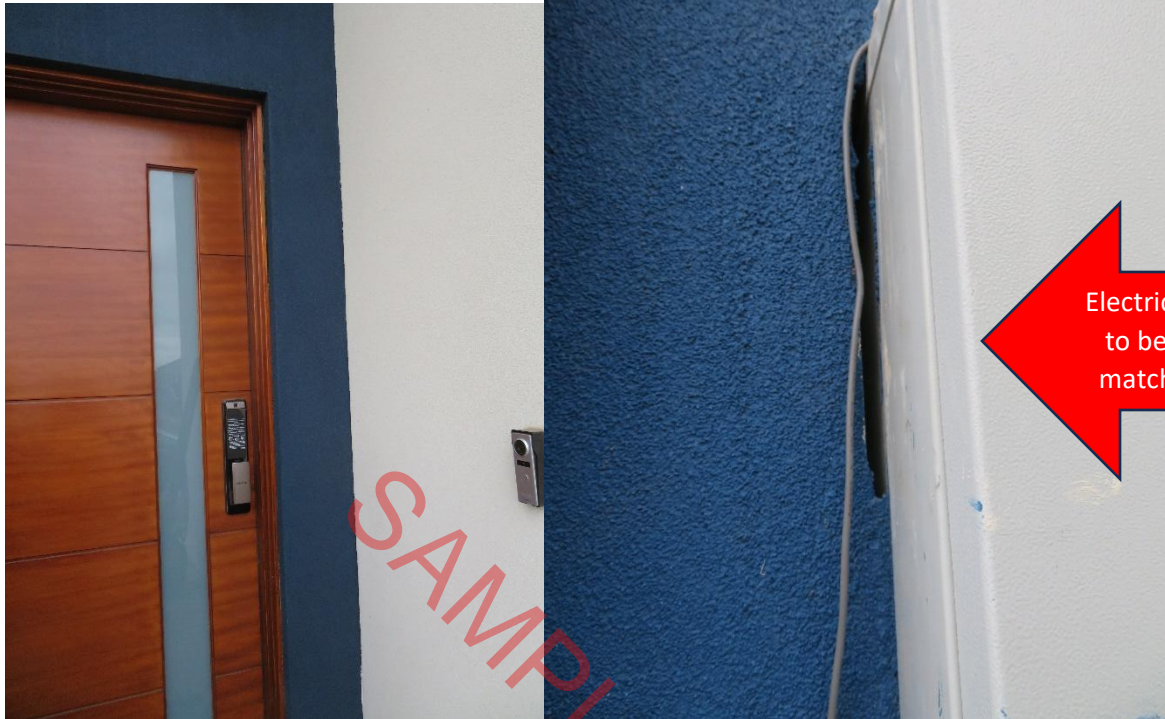
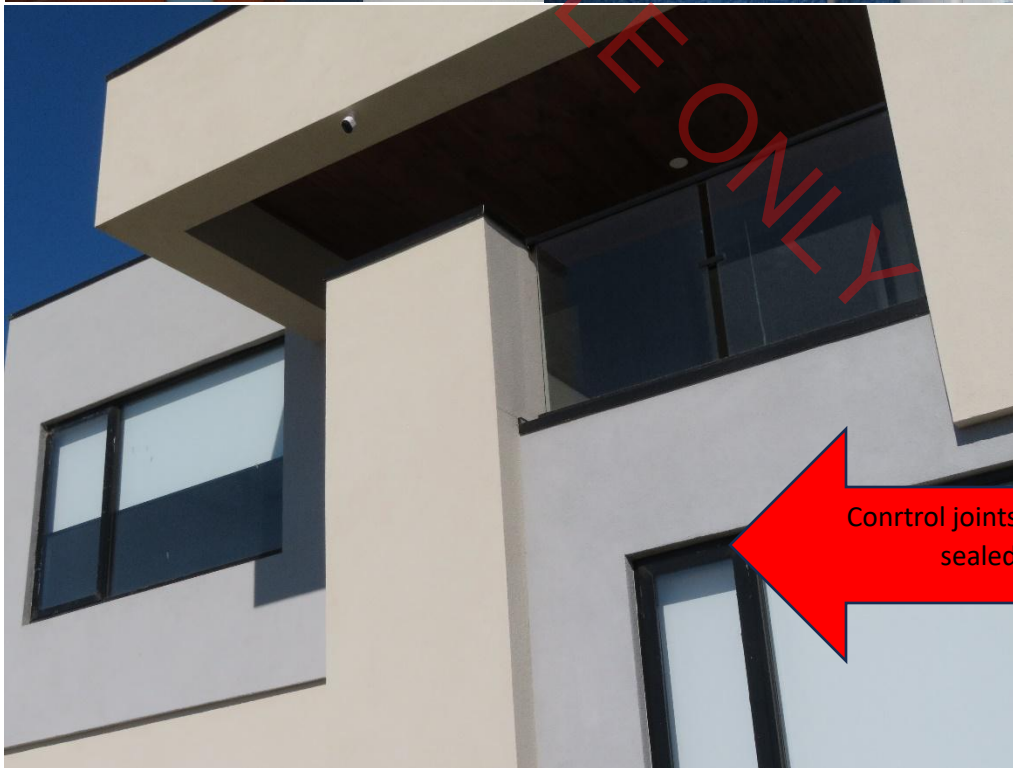
Location:	Control joints, rendering on Hebel
Finding: Information:	<ul style="list-style-type: none">• Control joints are not installed as per the approved drawings, BCA and manufacturer guide.• Render blemishes, cracks and damage <p>As per VBA GUIDE TO STANDARDS AND TOLERANCES 2015</p> <p>3.03 Movement; control joints in masonry walls Where required, control joints are defective if not installed as required by the Building Code of Australia or in accordance with the contract documents.</p>

Control joints are defective if they do not extend through the full thickness of masonry skin.

Where required, control joints are defective if they are not sealed in accordance with AS 3700.

Control joints are not sealed
