Post- HANDOVER INSPECTION REPORT

Property Address: Greenvale 3059

Stage of Works: Post Handover

Date of this Report: 11/11/2023

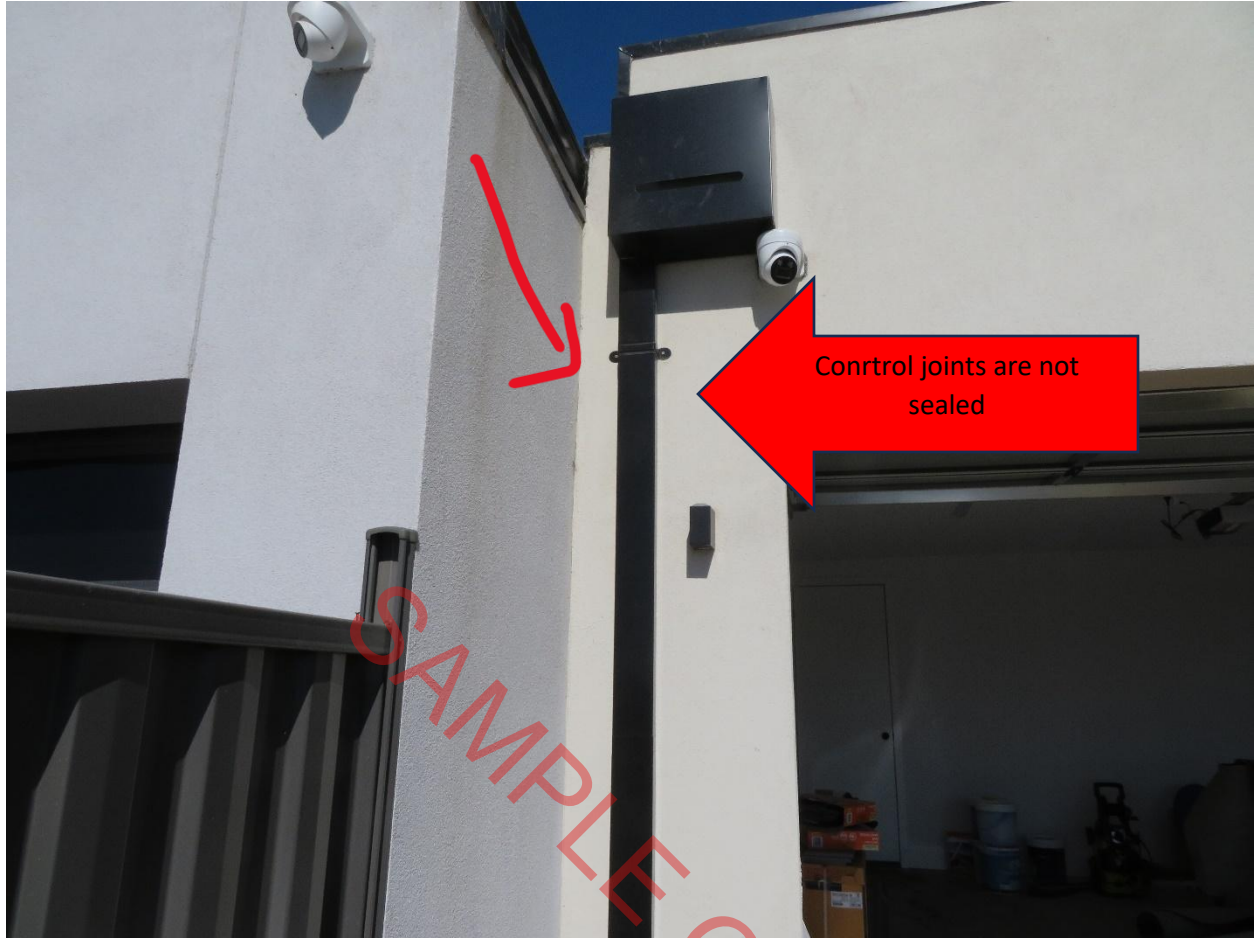
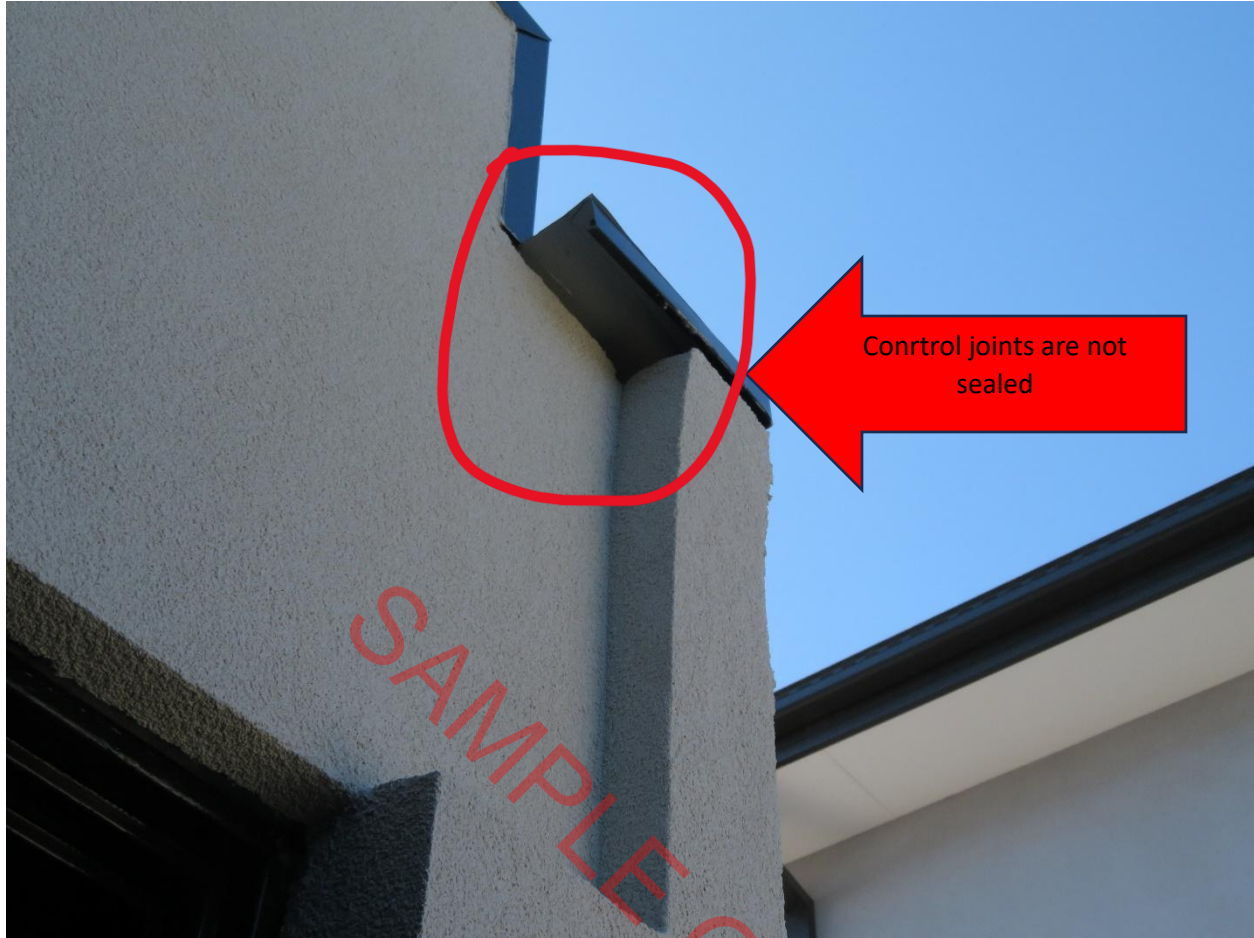
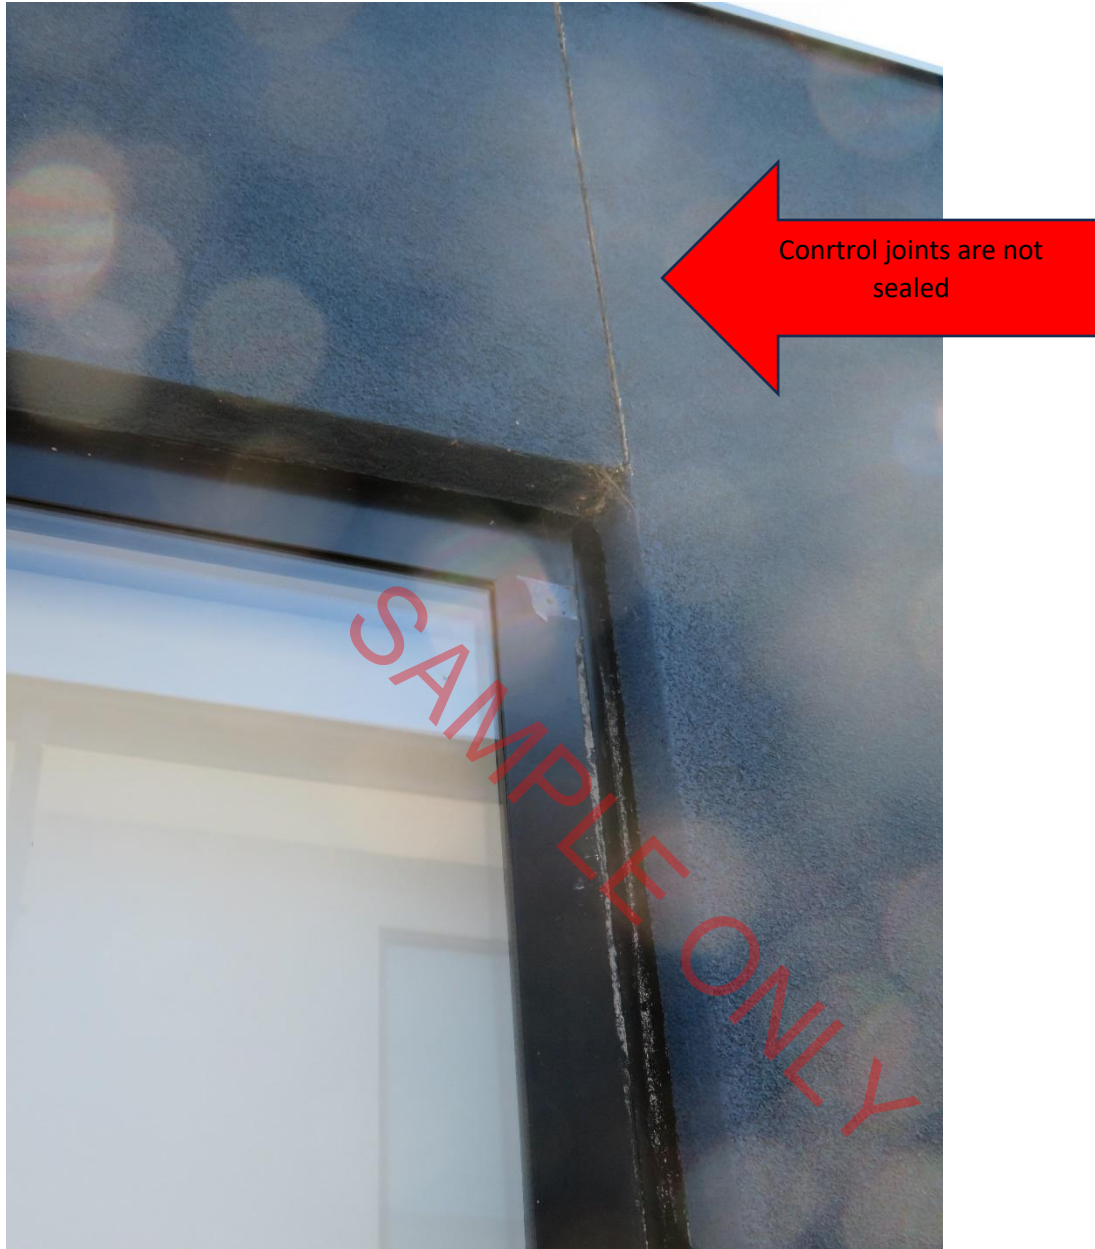
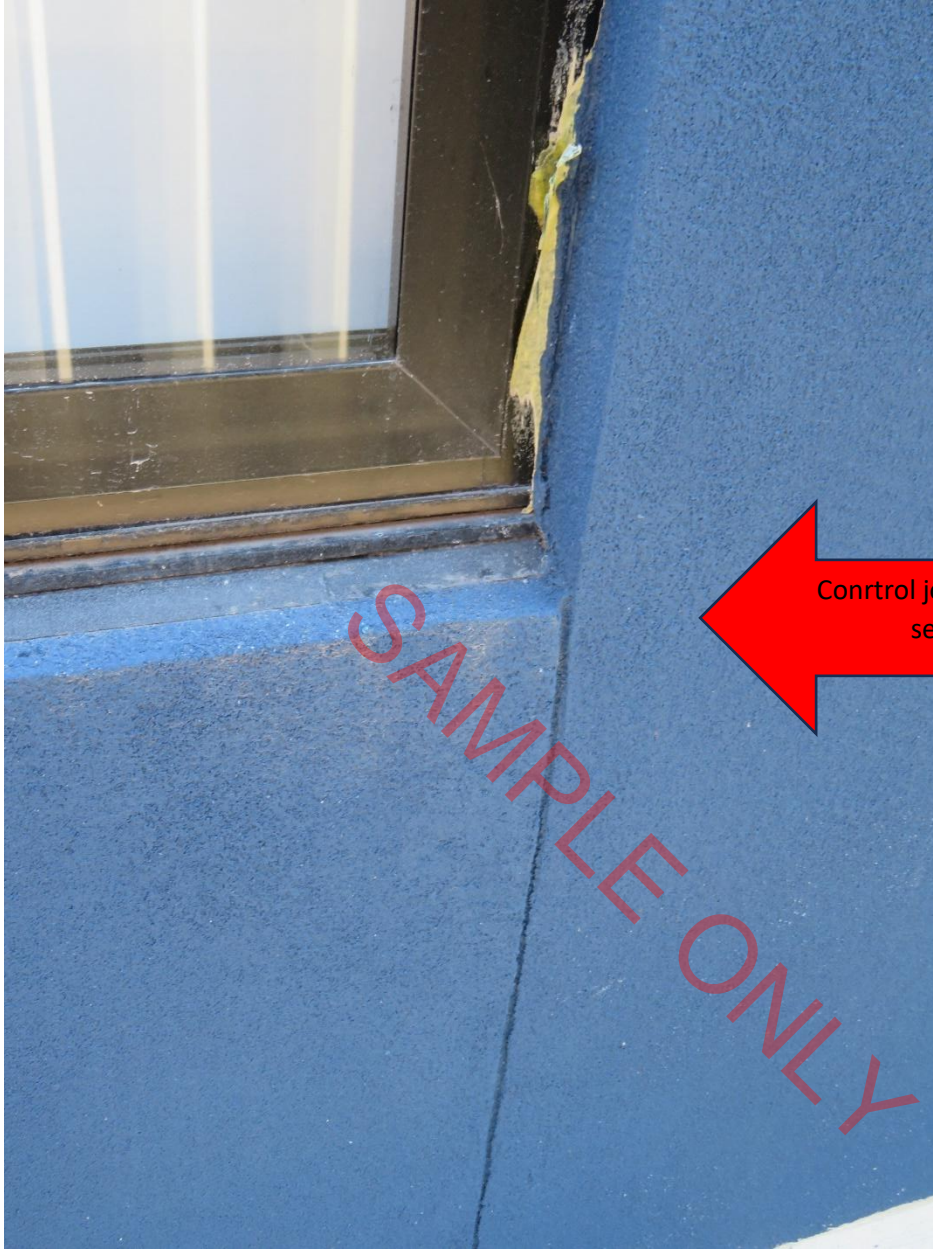
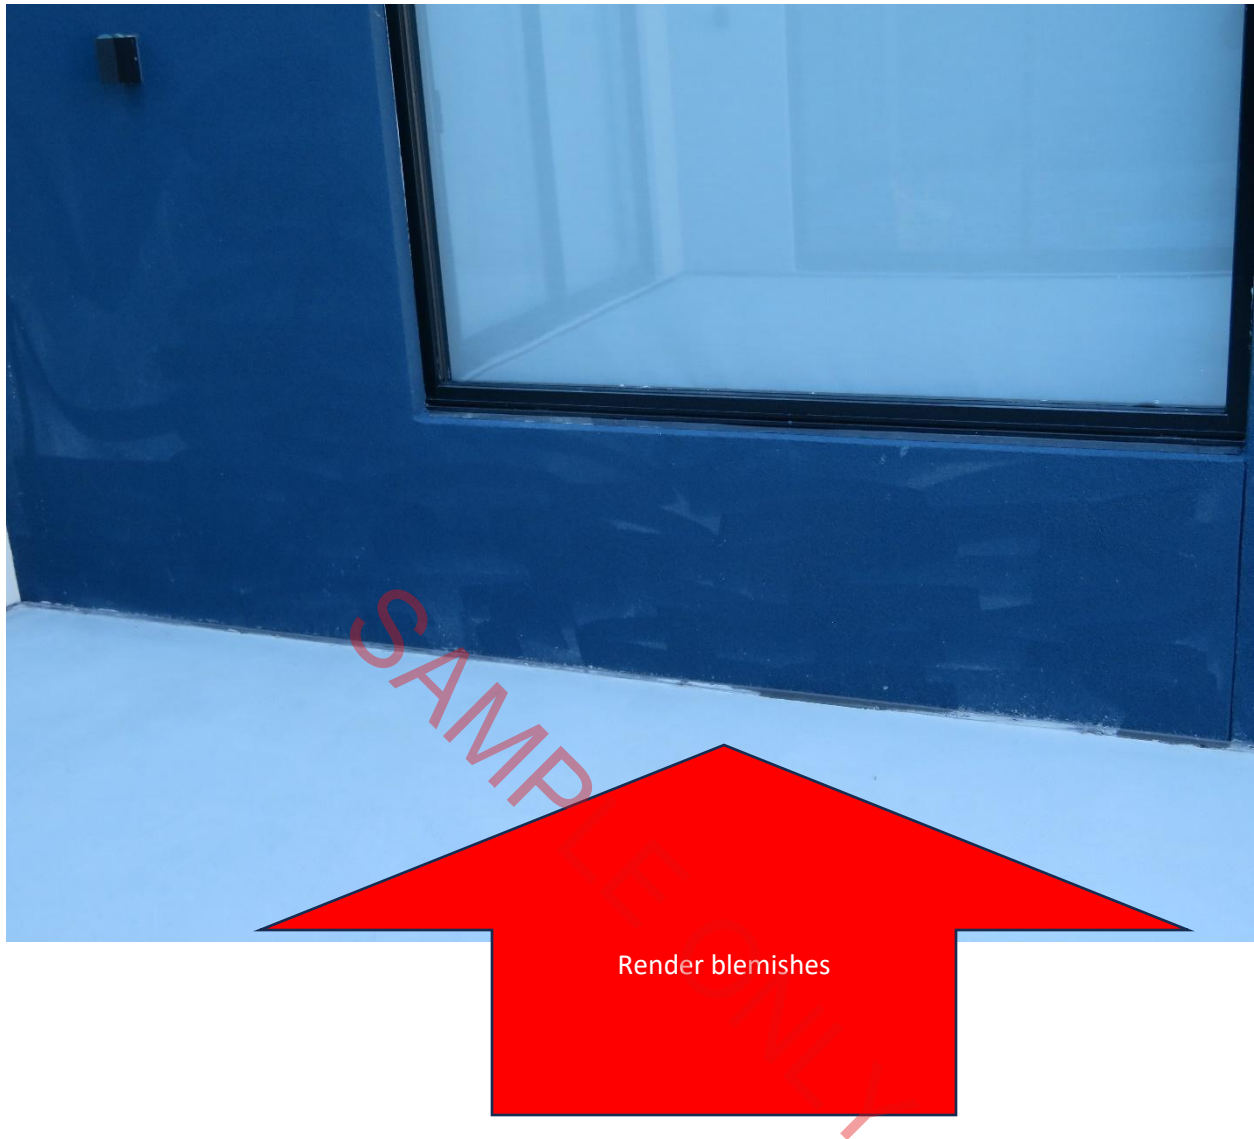
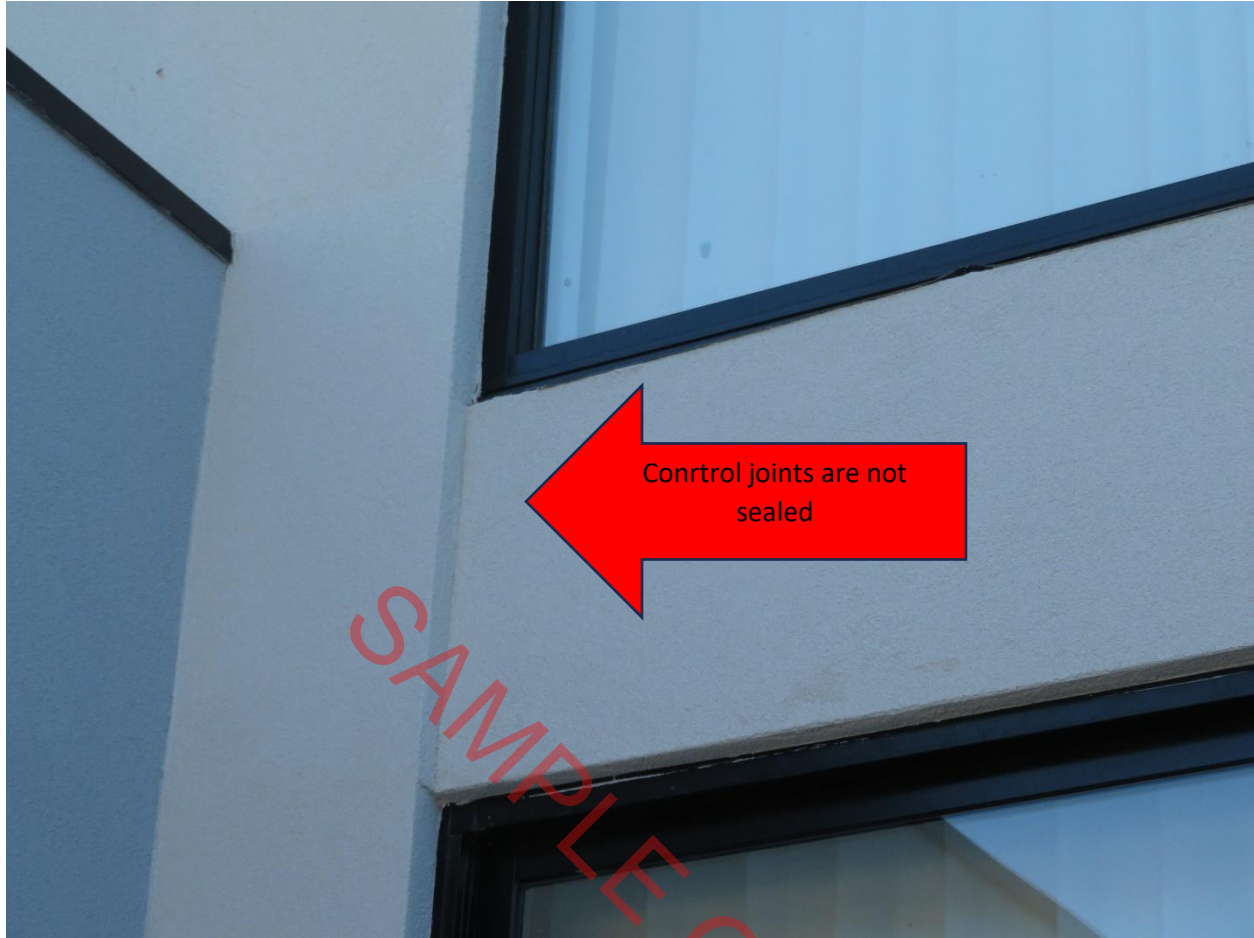
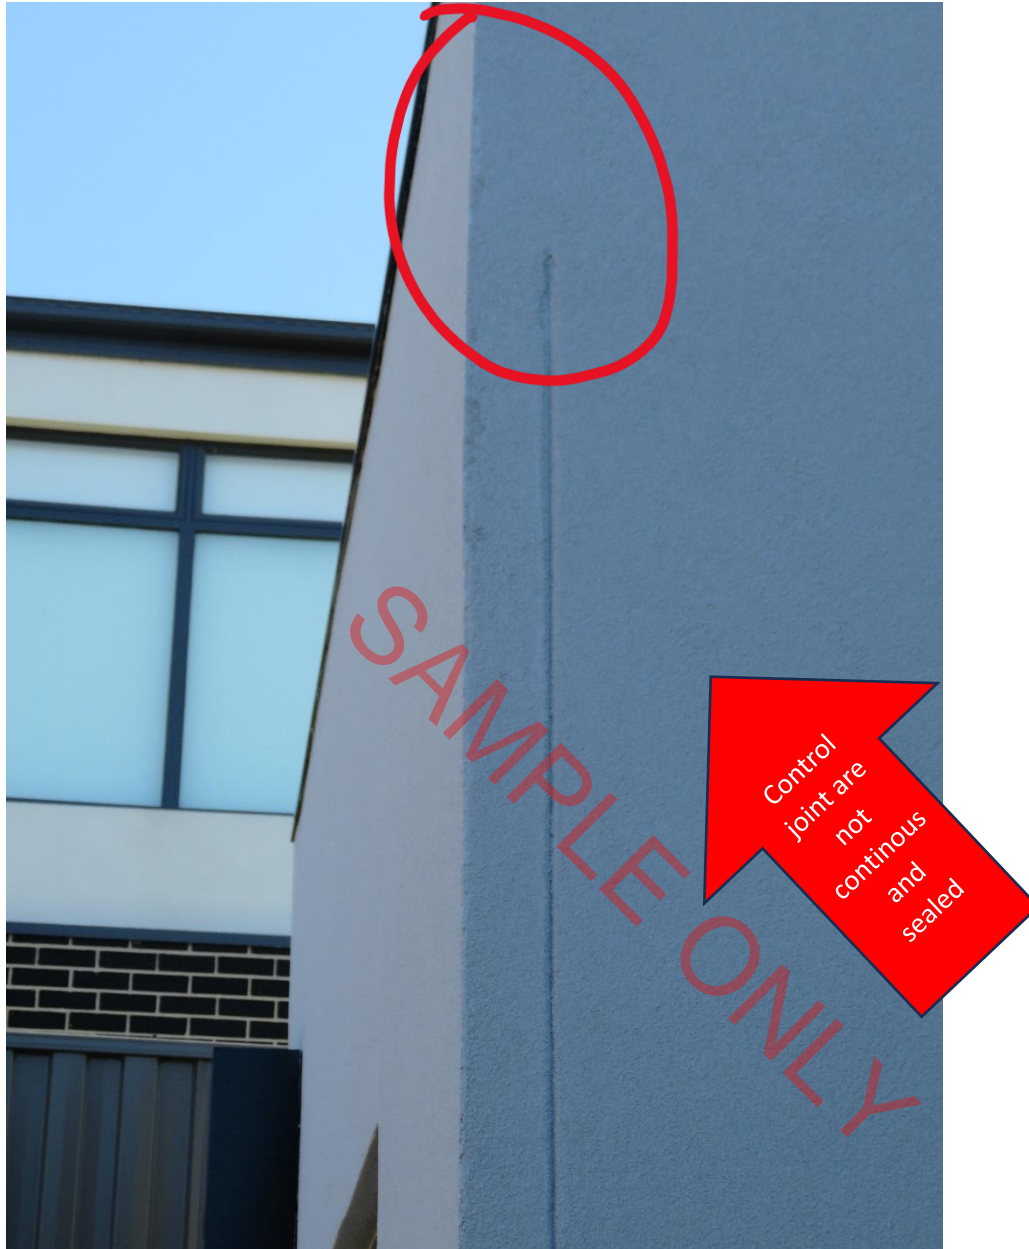
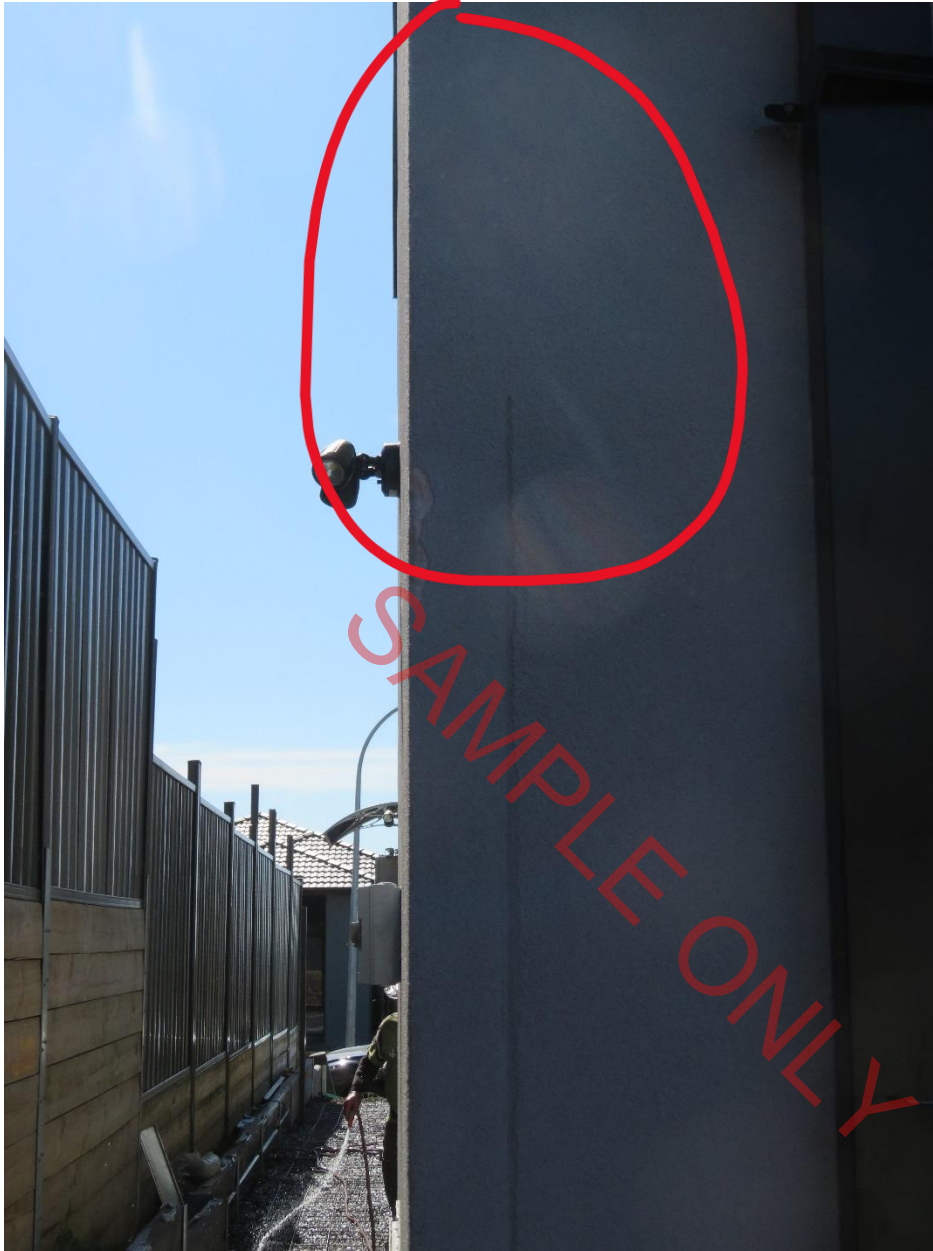
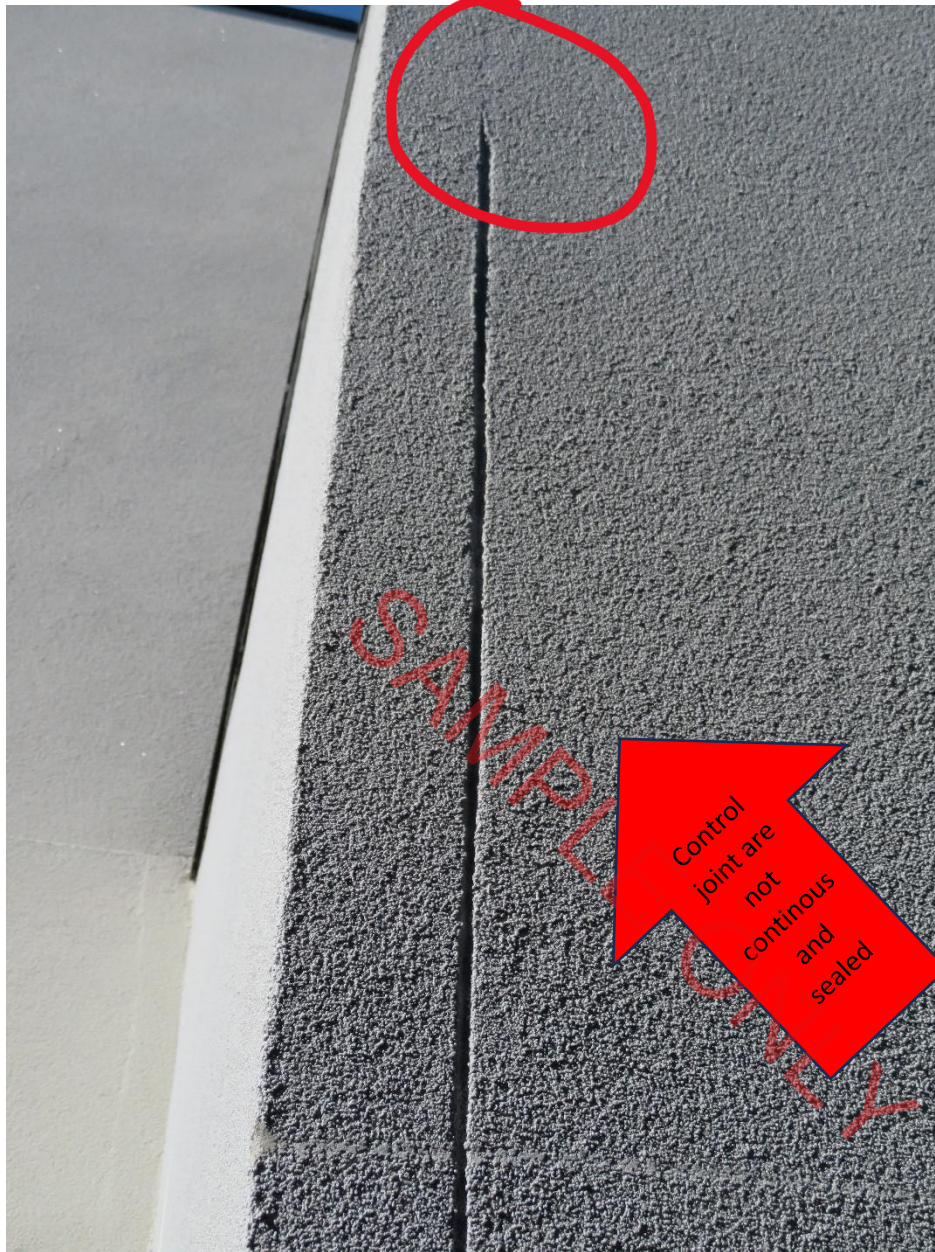
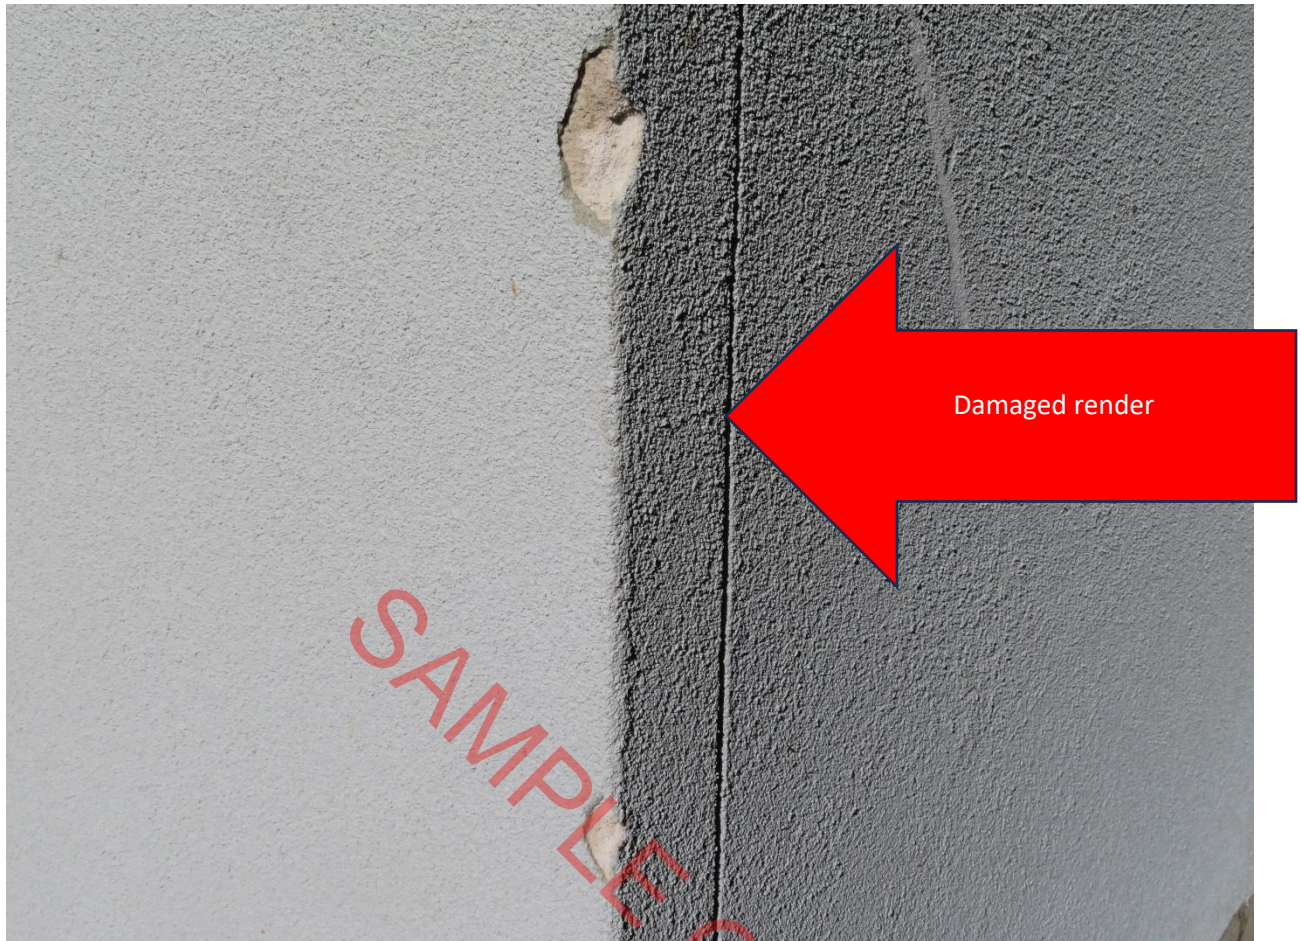
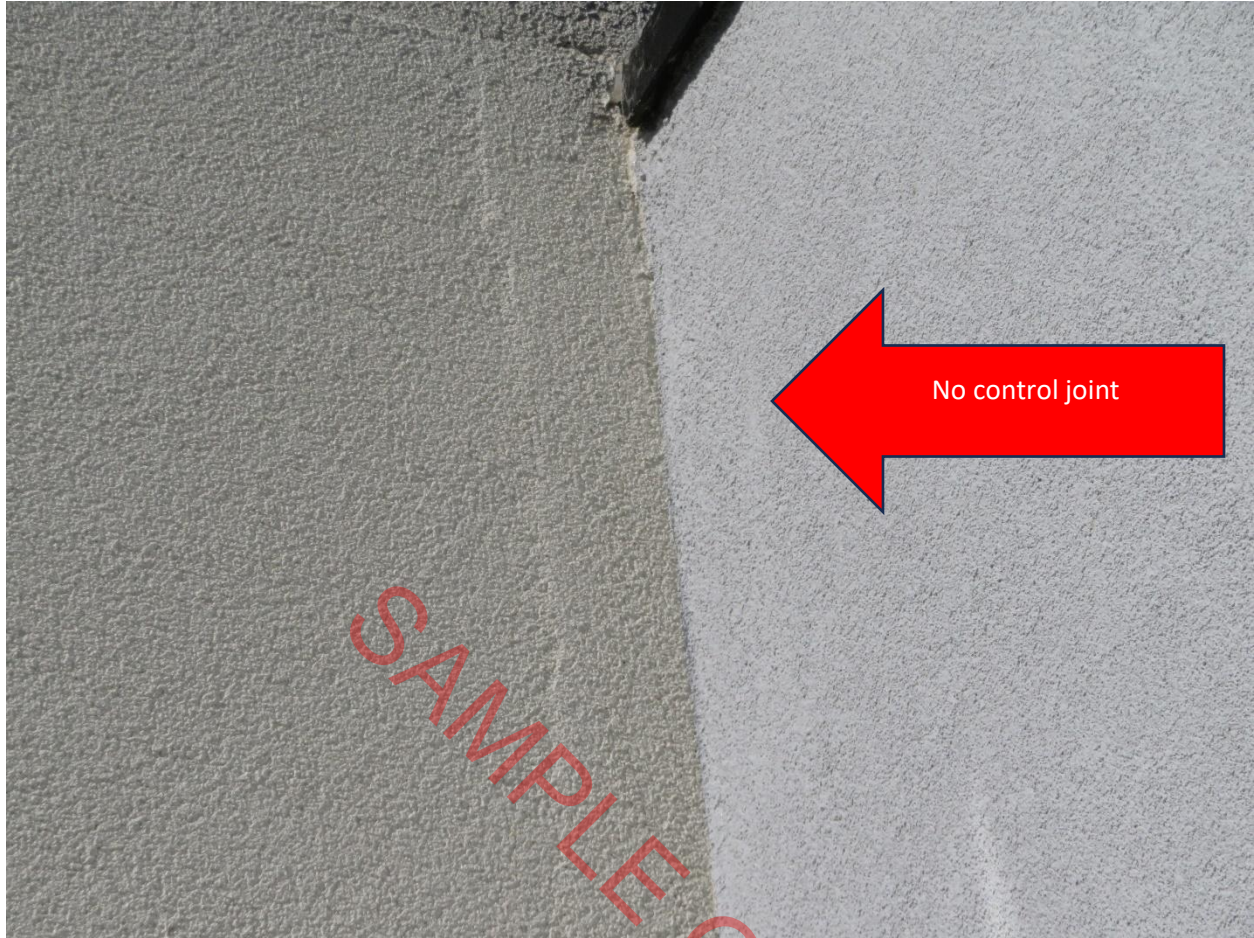
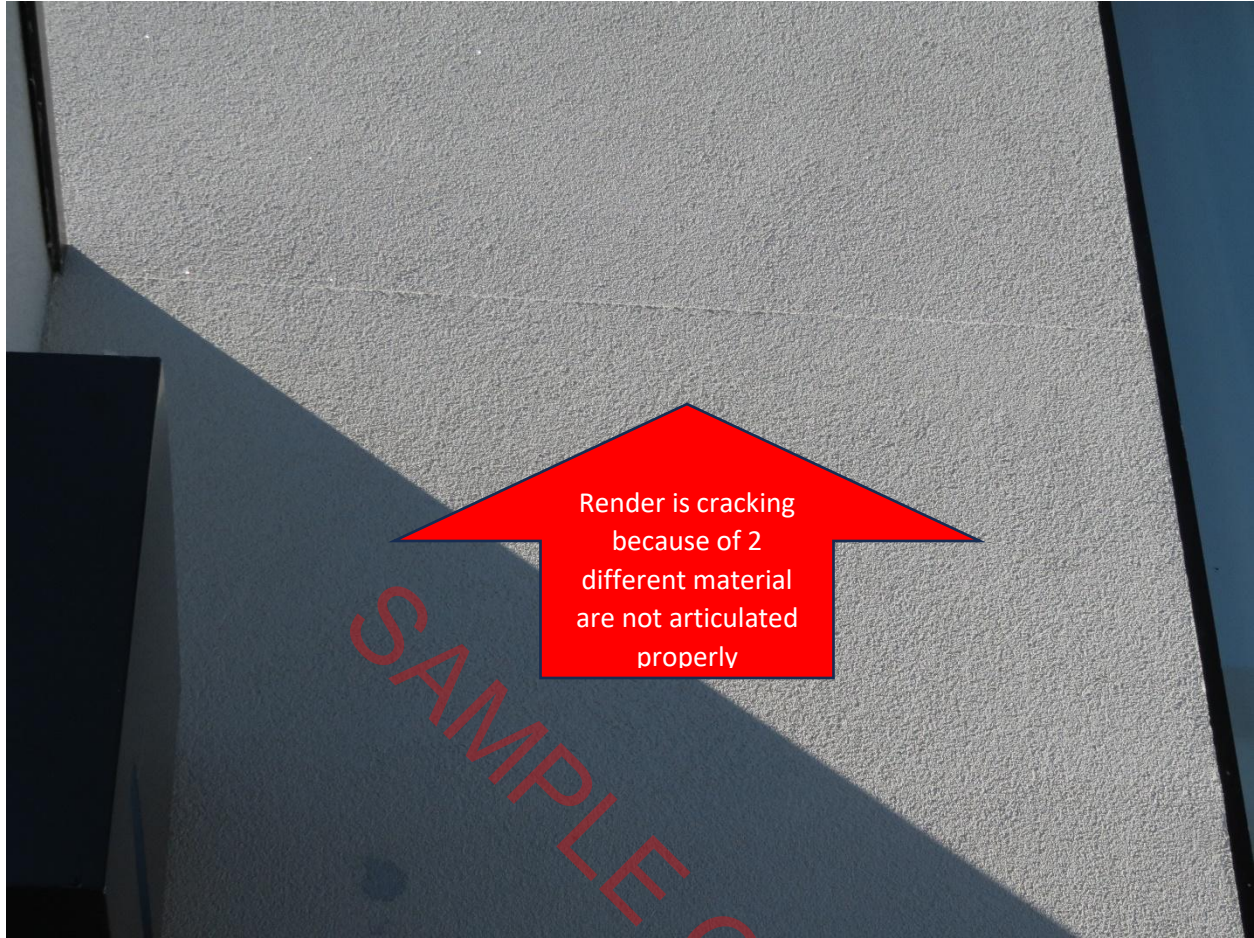
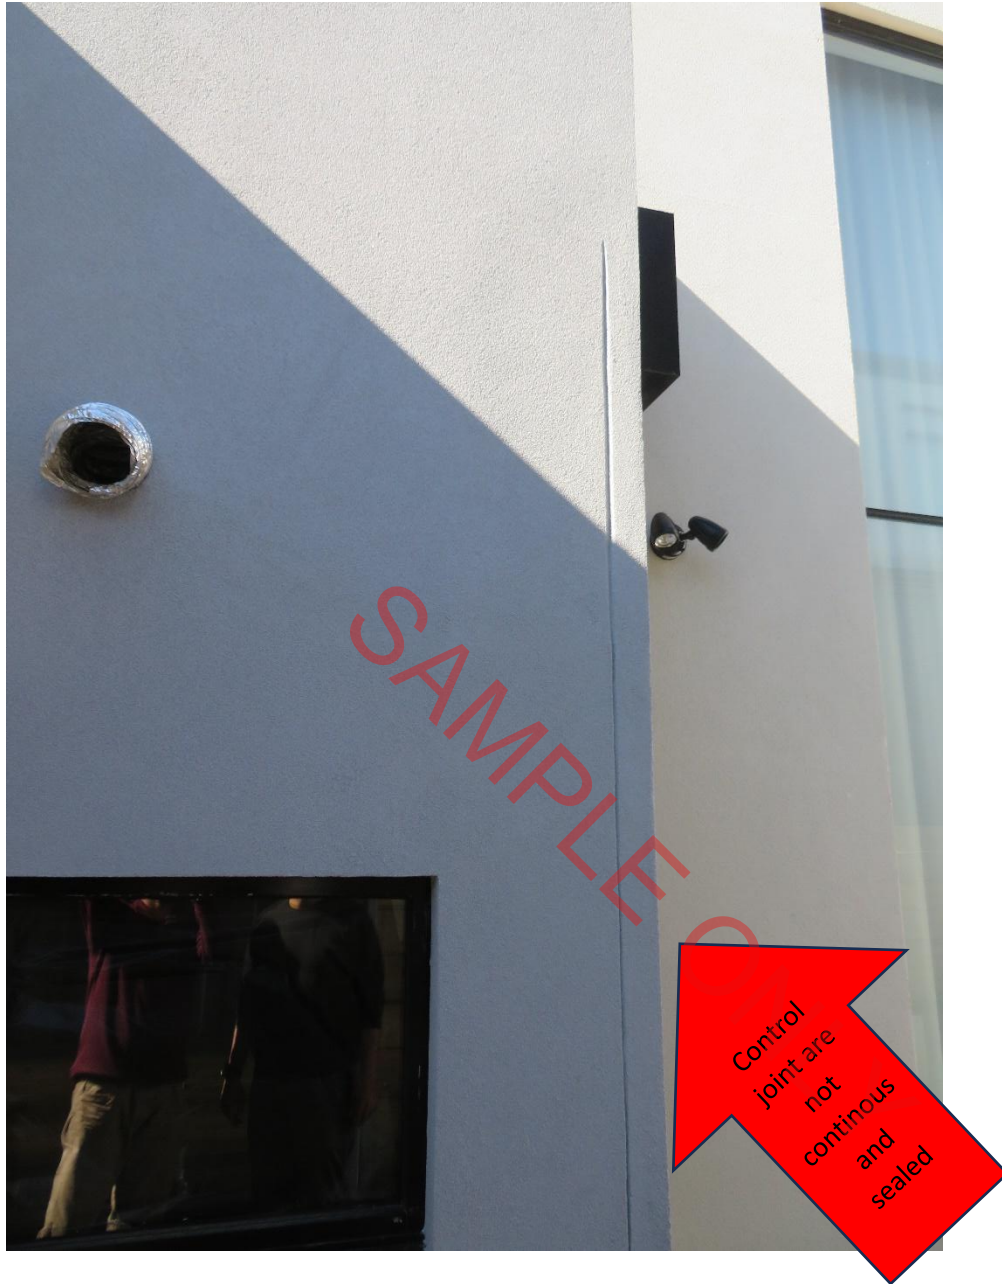
Location:	Control joints, rendering on Hebel
Finding: Information:	<ul style="list-style-type: none">• Control joints are not installed as per the approved drawings, BCA and manufacturer guide.• Render blemishes, cracks and damage <p>As per VBA GUIDE TO STANDARDS AND TOLERANCES 2015</p> <p>3.03 Movement; control joints in masonry walls Where required, control joints are defective if not installed as required by the Building Code of Australia or in accordance with the contract documents.</p>

<p>As per VBA GUIDE TO STANDARDS AND TOLERANCES 2015 9.04 Cracking and other blemishes in rendered or hard plastered surfaces on a masonry substrate Assess damage categories and defects in rendered or hard plastered surfaces on a masonry substrate, in accordance with Item 3.02.</p> <p>Obvious spot rust marks, due to the composition of the material and other blemishes are defective if they are visible from a normal viewing position.</p>
Is this item defective?	YES
Is this item incomplete?	Yes
Recommendation	The builder to rectify this finding in accordance with section 8(a) of the Act.

Control joints are not
sealed

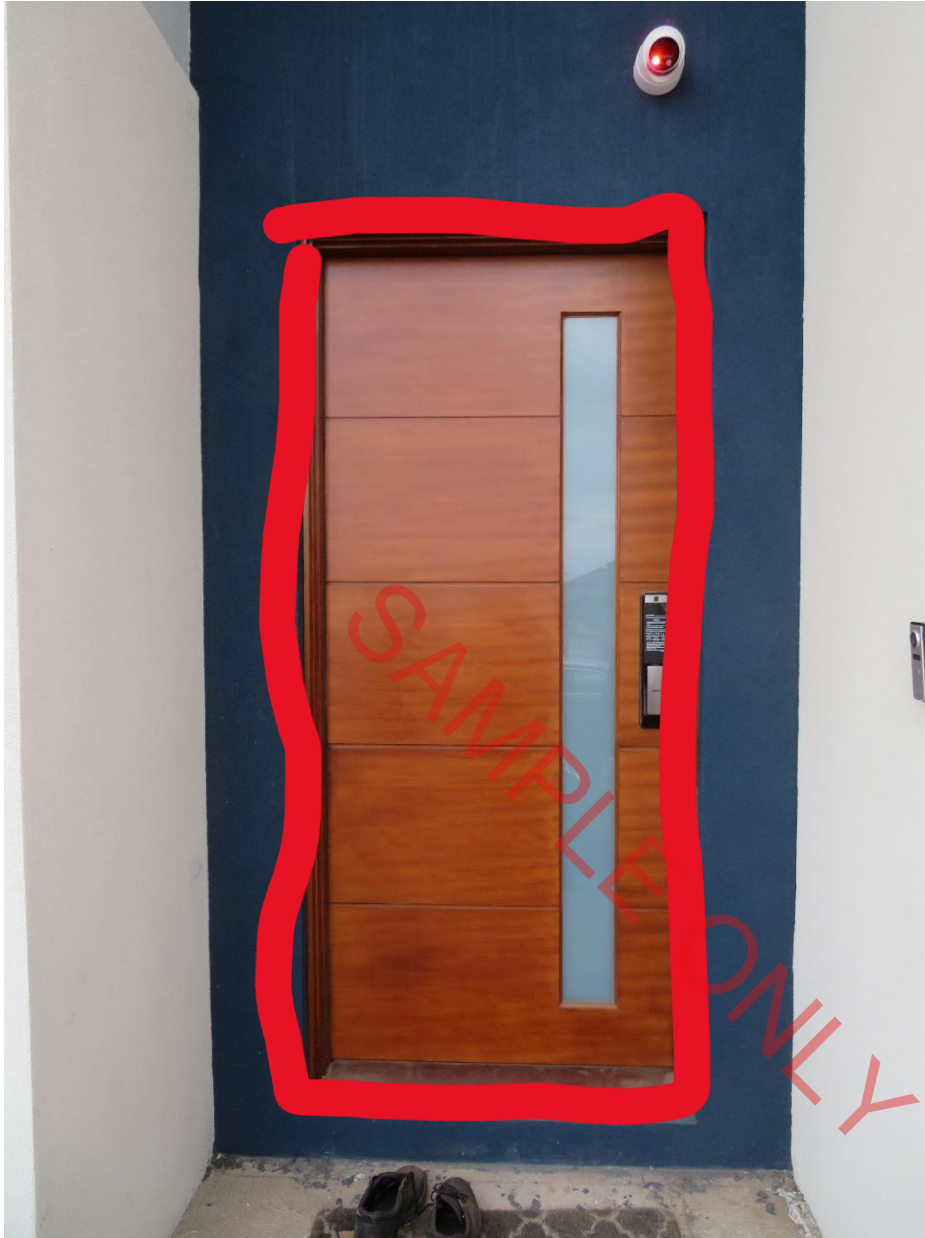
Location:	Main door
Finding: Information:	<ul style="list-style-type: none">• Bottom of the main door is not sealed• Door frame is not sealed <p>As per VBA GUIDE TO STANDARDS AND TOLERANCES 2015</p> <p>8.06 Sealing of door edges</p> <p>Door leaves are defective if they do not have all sides, top and bottom edges sealed/painted in accordance with the manufacturer's specifications.</p>
Is this item defective?	YES
Is this item incomplete?	Yes
Recommendation	The builder to rectify this finding in accordance with section 8(a) of the Act.

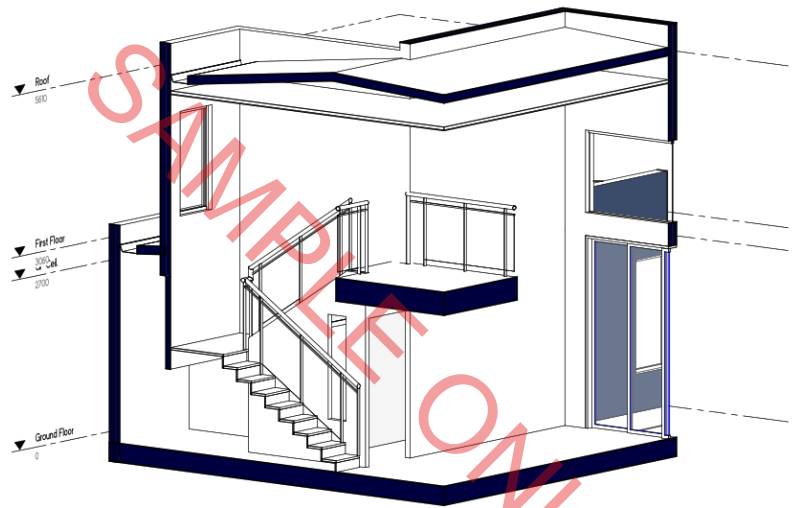
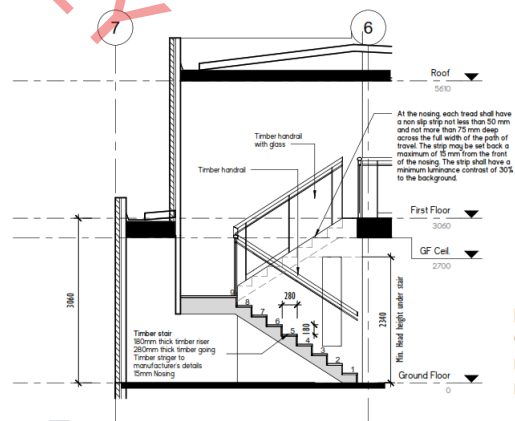
Location:	Staircase
Finding: Information:	<ul style="list-style-type: none">Staircase is not finished as per the plan and installer specs. As per the manufacturer, it's a concealed stringer which need double plaster to conceal the gaps between treads and stringer. Builder has failed to follow their specs and poorly finished the stairs. <p>As per VBA GUIDE TO STANDARDS AND TOLERANCES 2015</p> <p>4.06 Treads and risers in timber stairs Timber stairs are defective if they do not comply with the requirements of the Building Code of Australia.</p>

stair case to comply with NCC Part 3.9.13.

Is this item defective?	YES
Is this item incomplete?	Yes
Recommendation	The builder to rectify this finding in accordance with section 8(a) of the Act.
