Building and Timber Pest Inspection Report

Inspection Date: Wednesday, September 18, 2024
Property Address: Truganina 3029

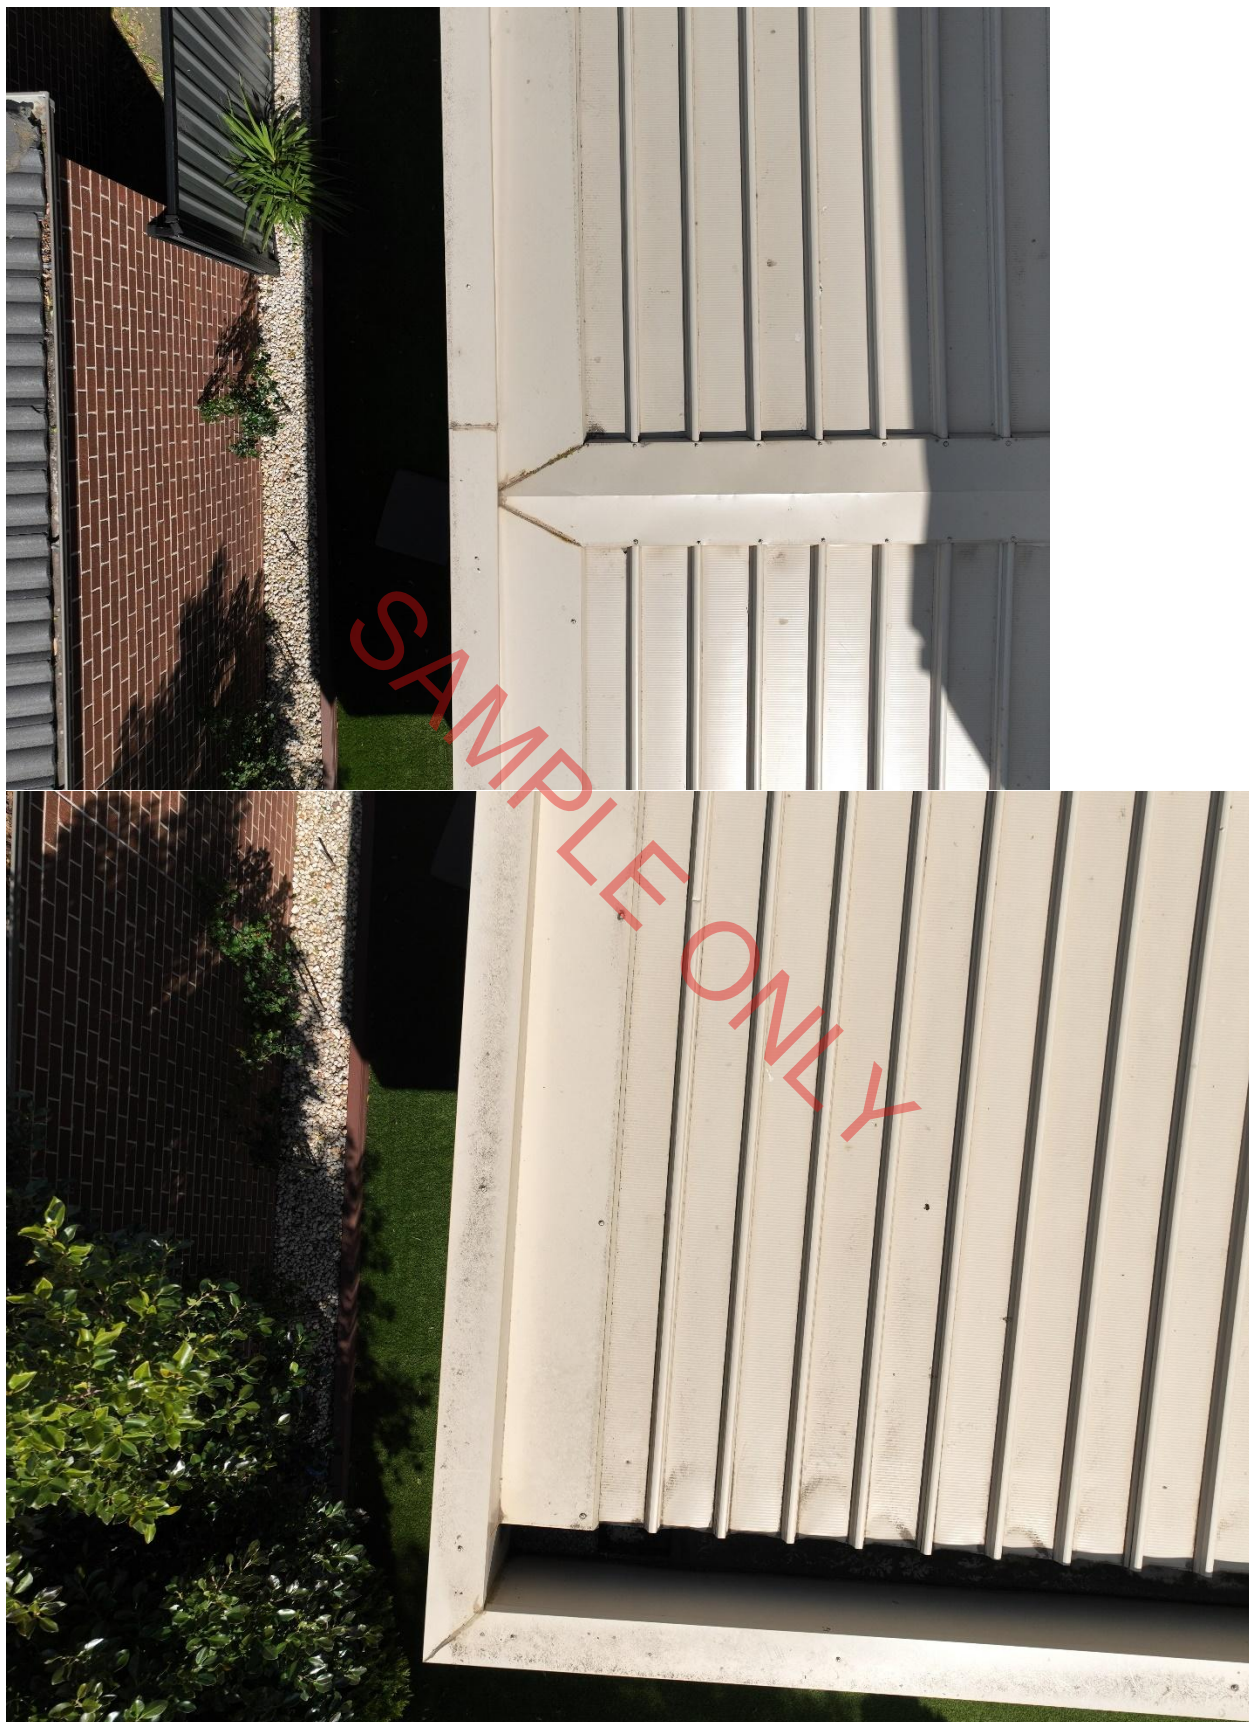
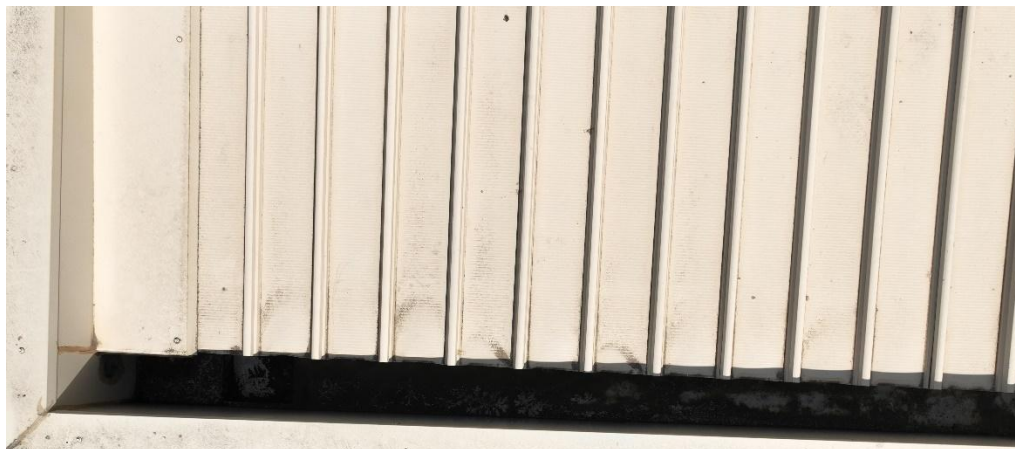
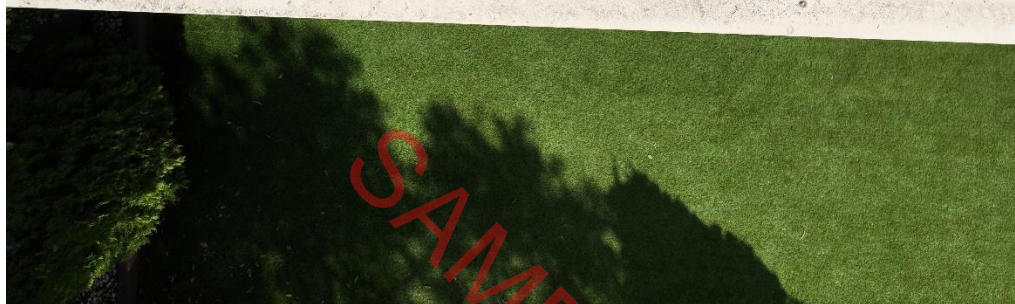
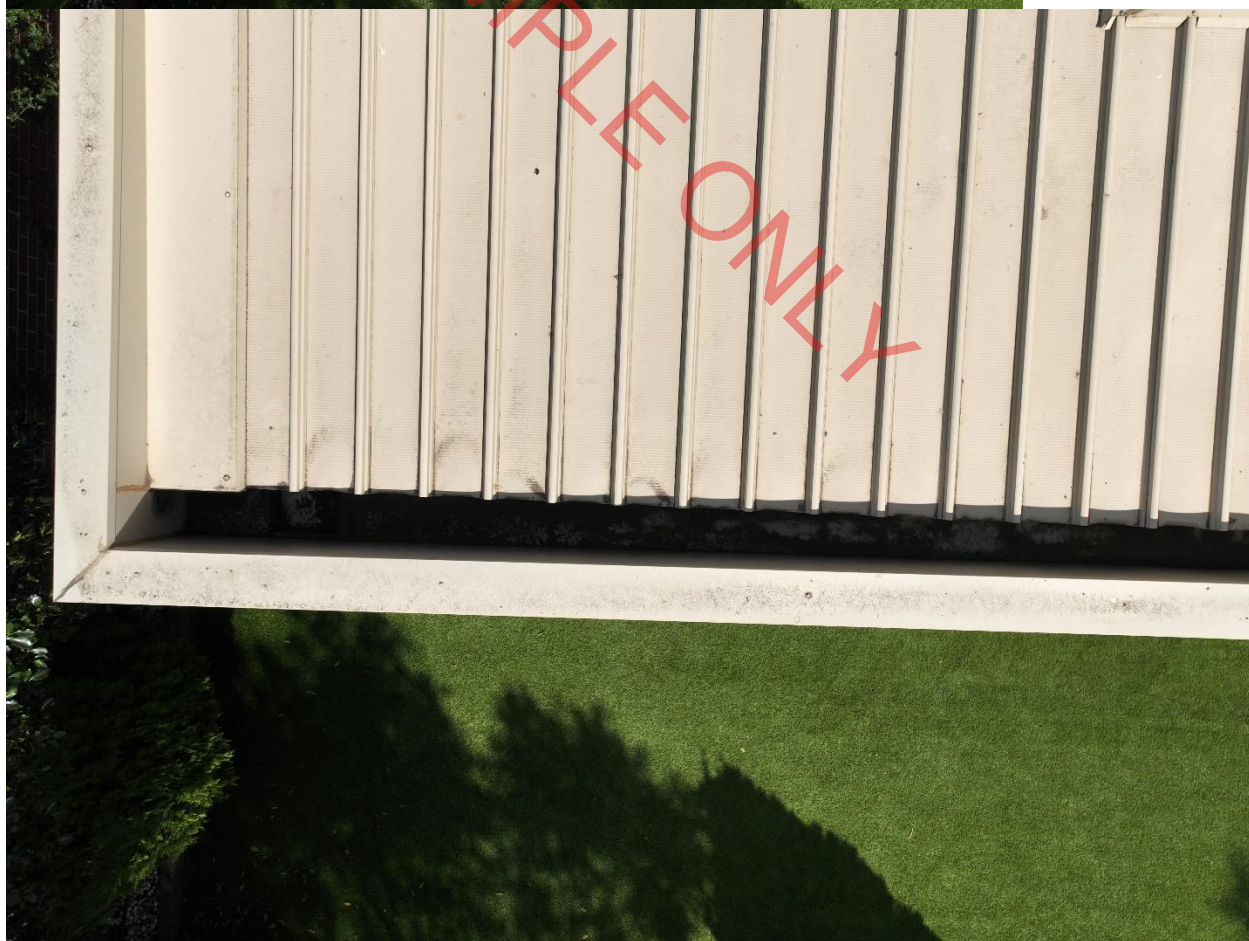
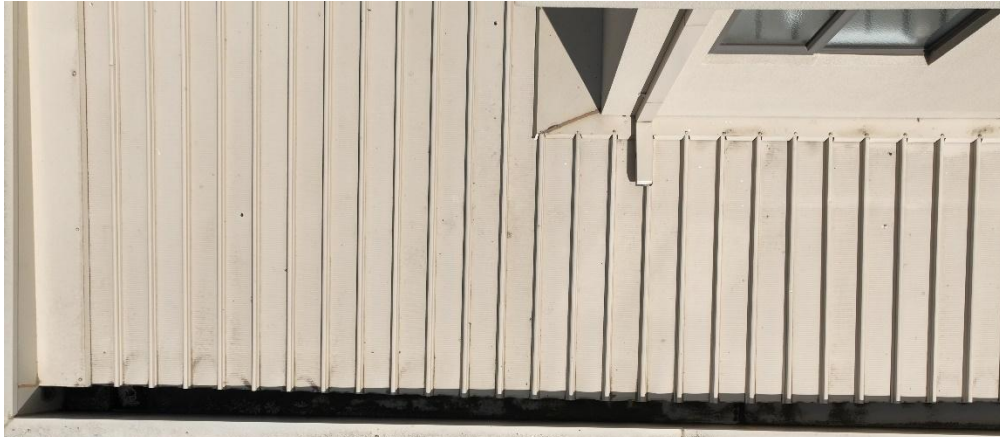
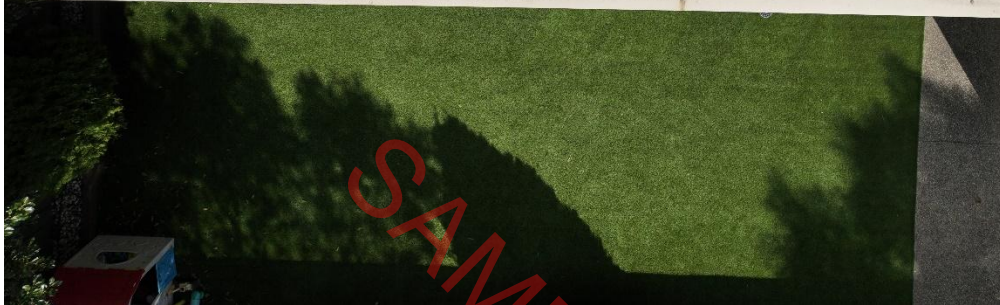
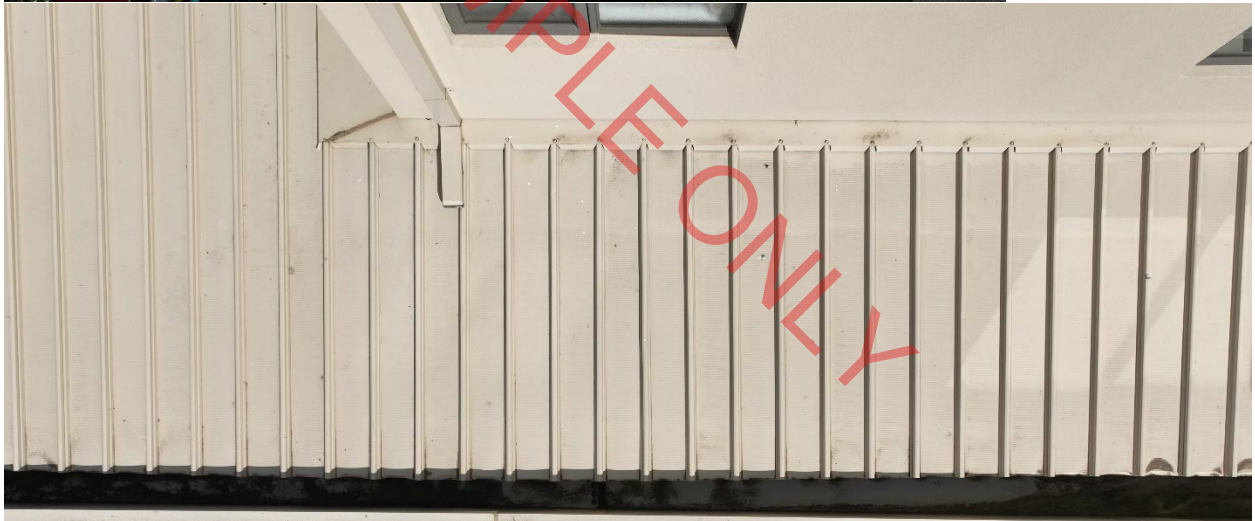
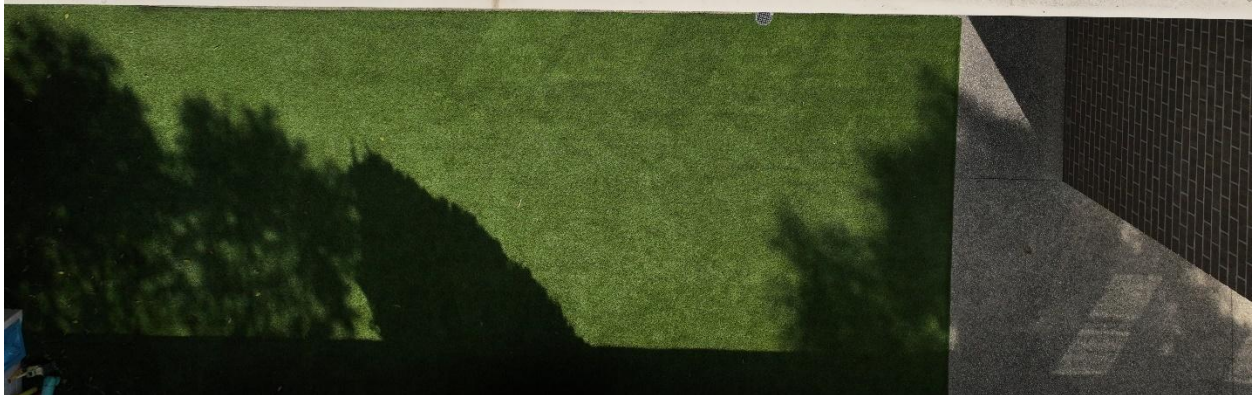
Location: Finding:	Roof Inspection by Drone
Information:	<p>1. Roof Covering Condition: The roof covering appears to be in generally good condition. There are no visible signs of major damage such as cracks or missing tiles. Minor wear and tear consistent with the age of the roof was observed, but no immediate repairs are required.</p> <p>2. Box Gutters Observation: The box gutters were found to be holding some water, which may indicate poor drainage or slight sagging in some areas.</p> <p>Condition: The gutters are also filled with dirt and debris, which is likely contributing to the water retention issue.</p> <p>Recommendation: It is recommended to clean the gutters and check for any obstructions. If water pooling persists after cleaning, further inspection for slope and drainage problems should be conducted.</p> <p>3. Capping and Flashings:</p> <p>Observation: The capping and flashings are in good structural condition, with no signs of rust or damage.</p> <p>Condition: However, the silicone applied at joints and seams appears to be distorted in some areas.</p> <p>Recommendation: The distorted silicone should be checked and replaced where necessary to ensure a watertight seal and prevent potential water ingress.</p> <p>Overall Condition: Overall, the roof is in functional condition, but some minor maintenance tasks such as cleaning the gutters and addressing the silicone in the capping and flashings are recommended to maintain its integrity.</p> <p>Conclusion: While no significant issues were identified during this inspection, routine maintenance should be carried out to prevent small issues from developing into larger problems. Addressing the</p>

Please consult a registered roof plumber to address the concerns.
--	---
