Building and Timber Pest Inspection Report

Inspection Date: Wednesday, September 18, 2024
Property Address: Truganina 3029

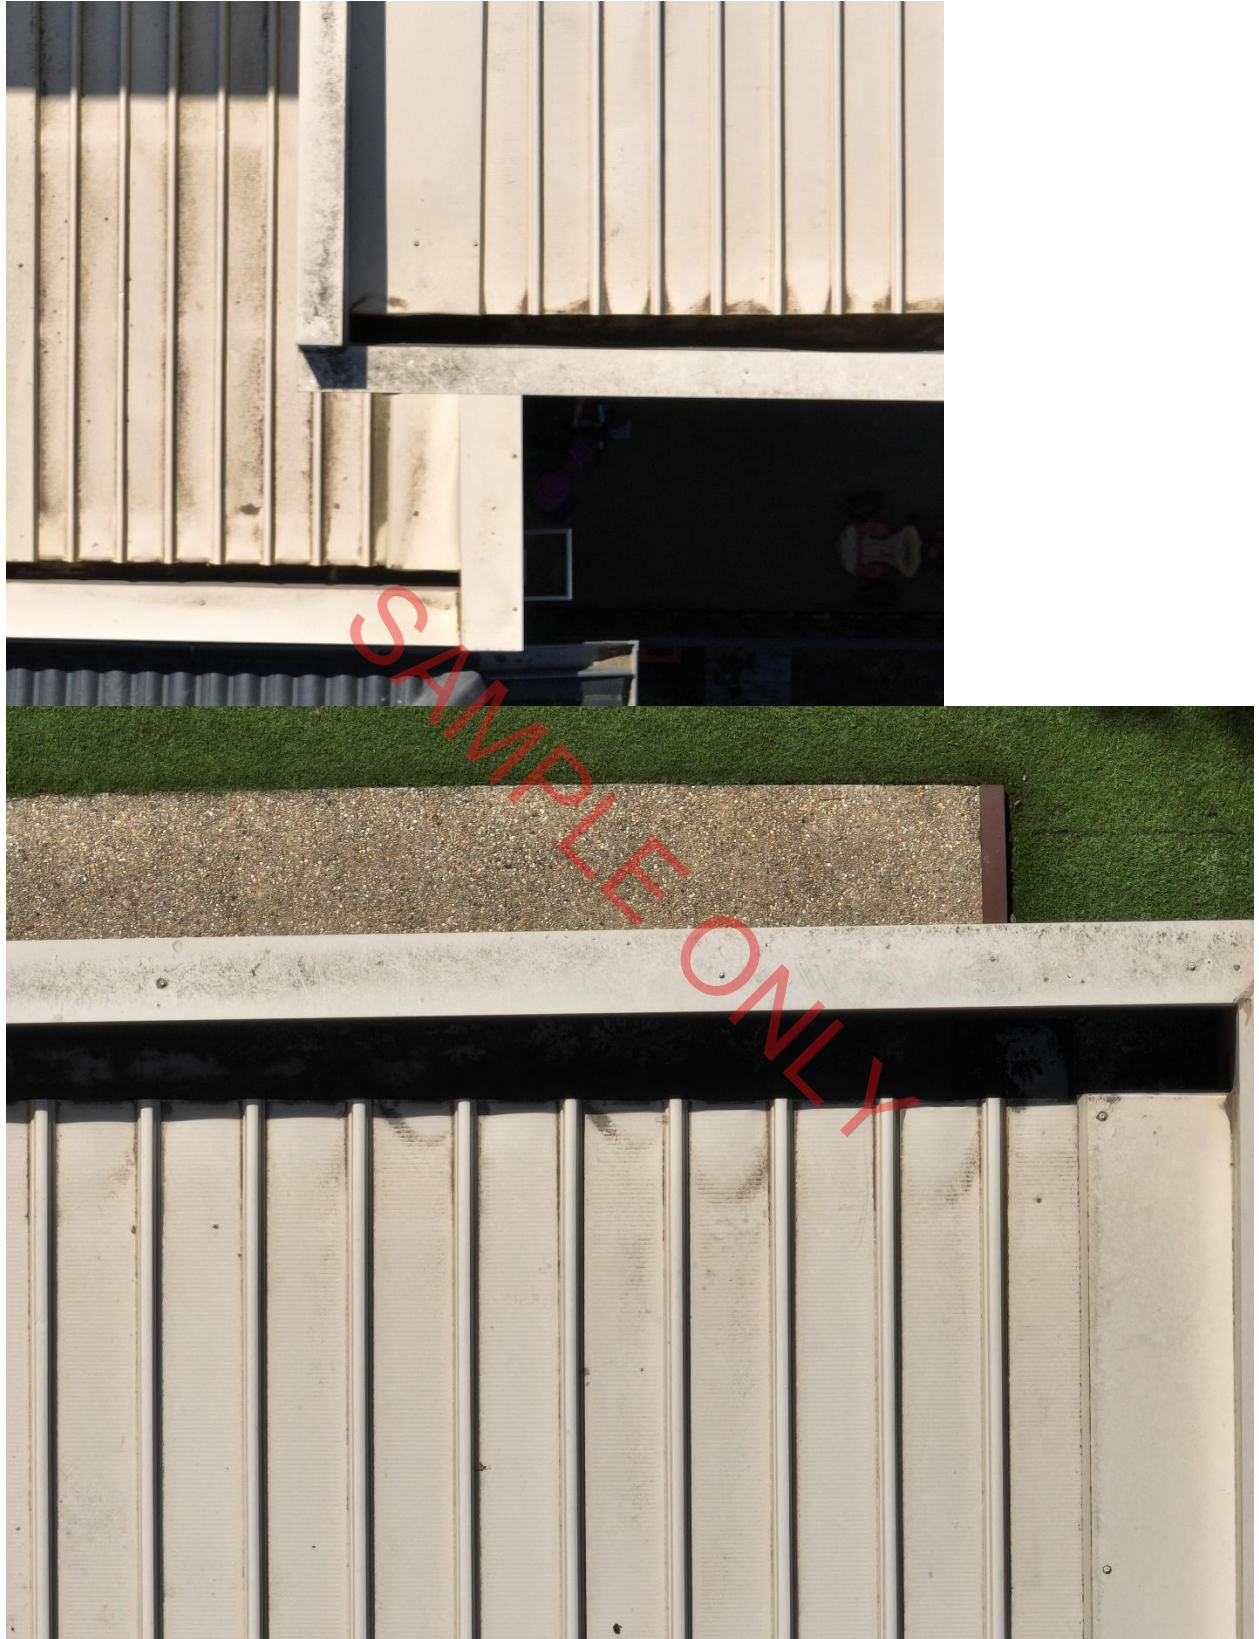
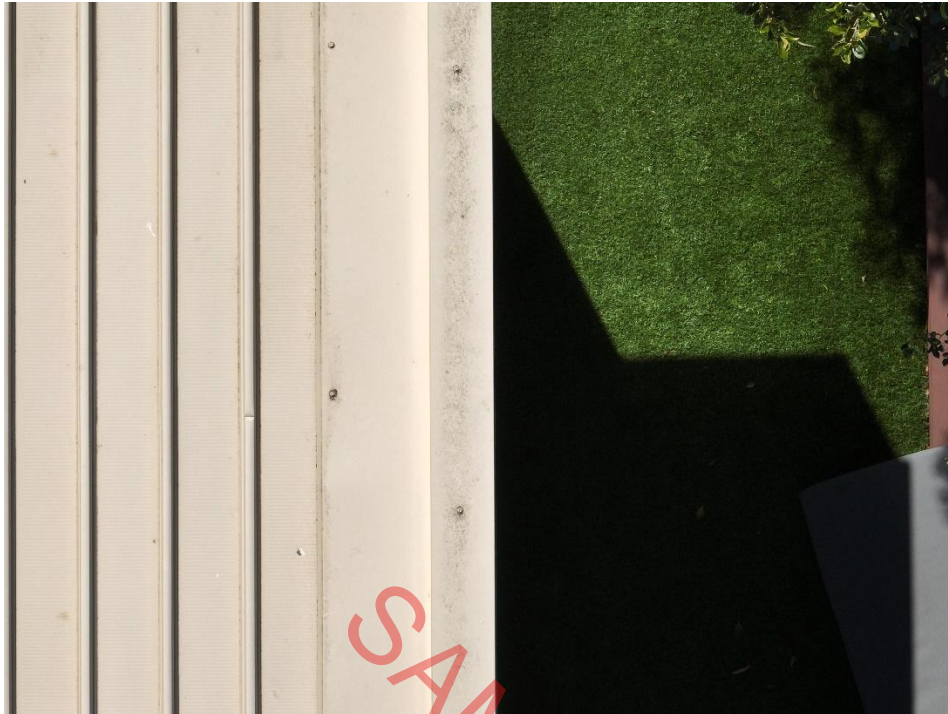
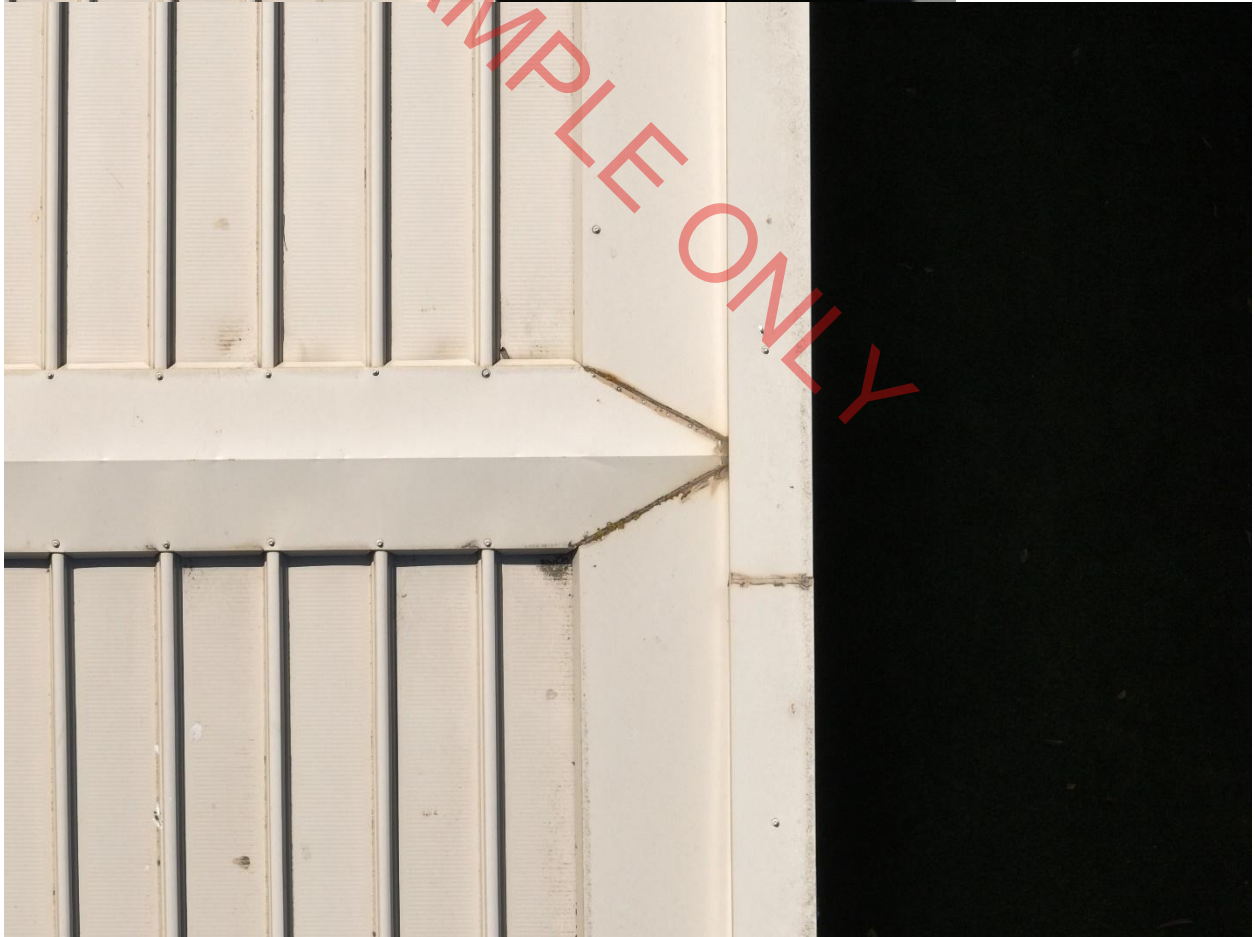
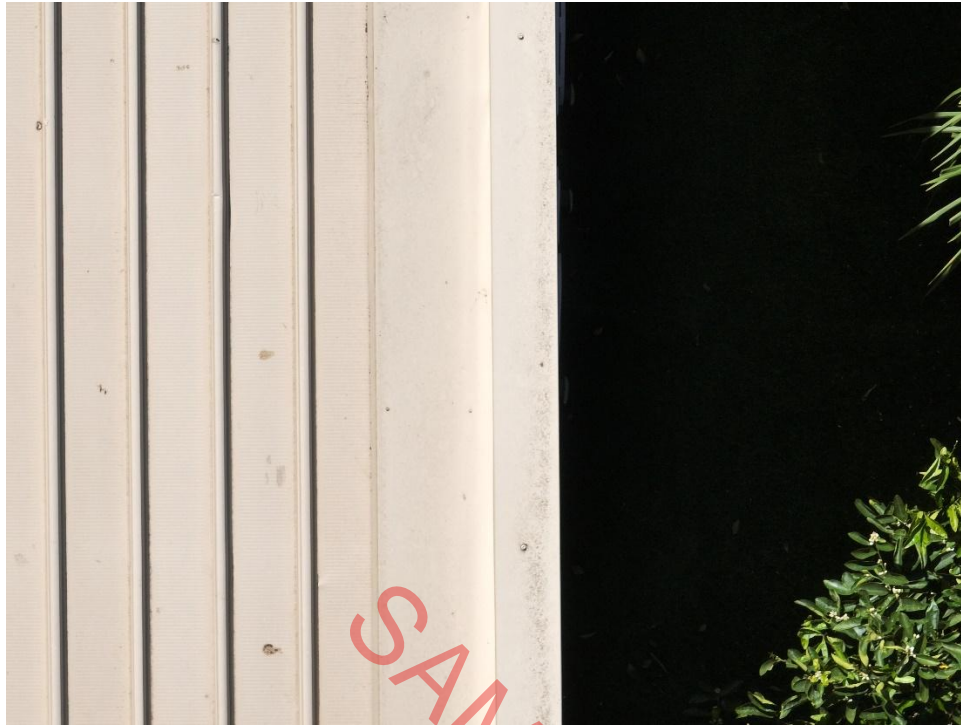
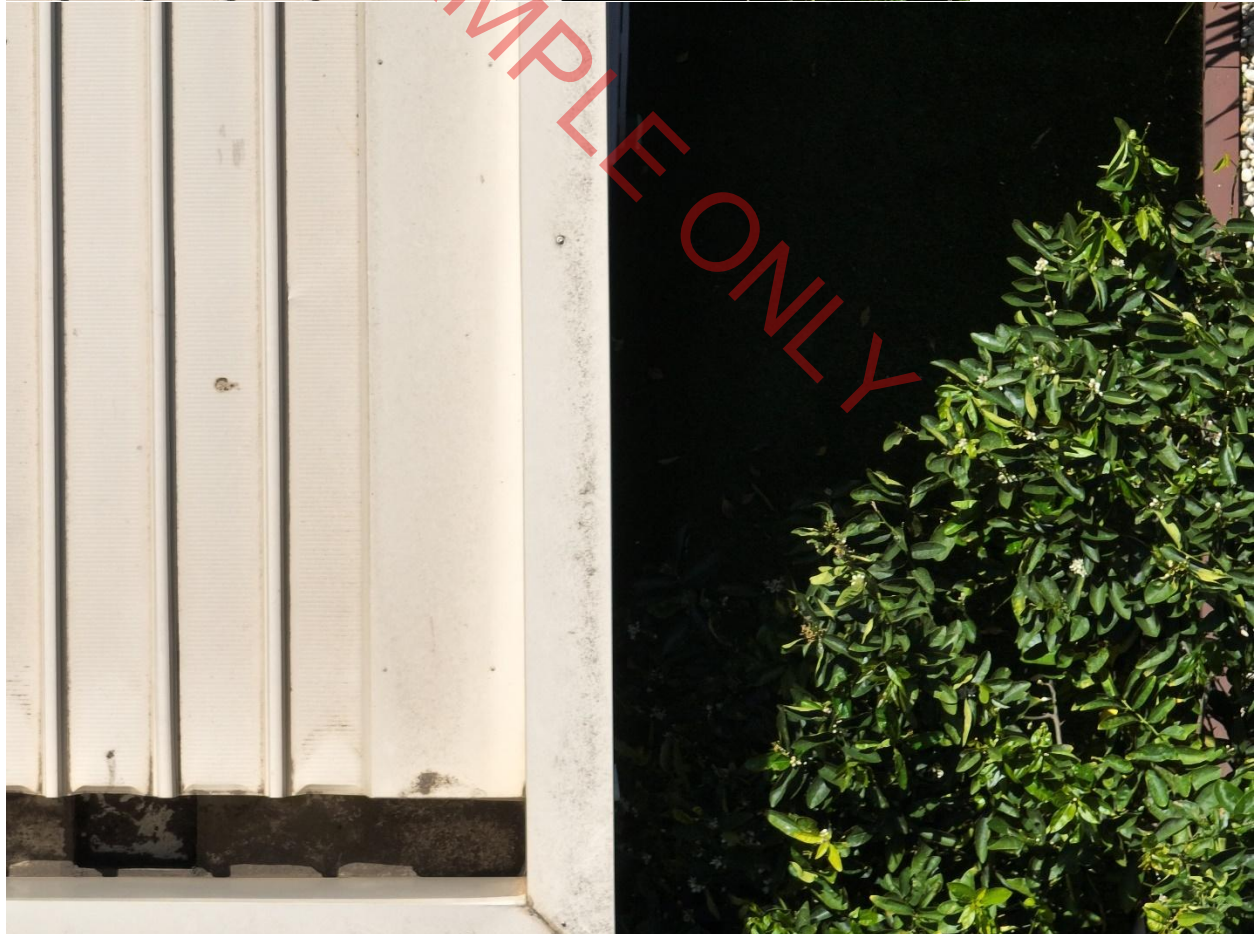
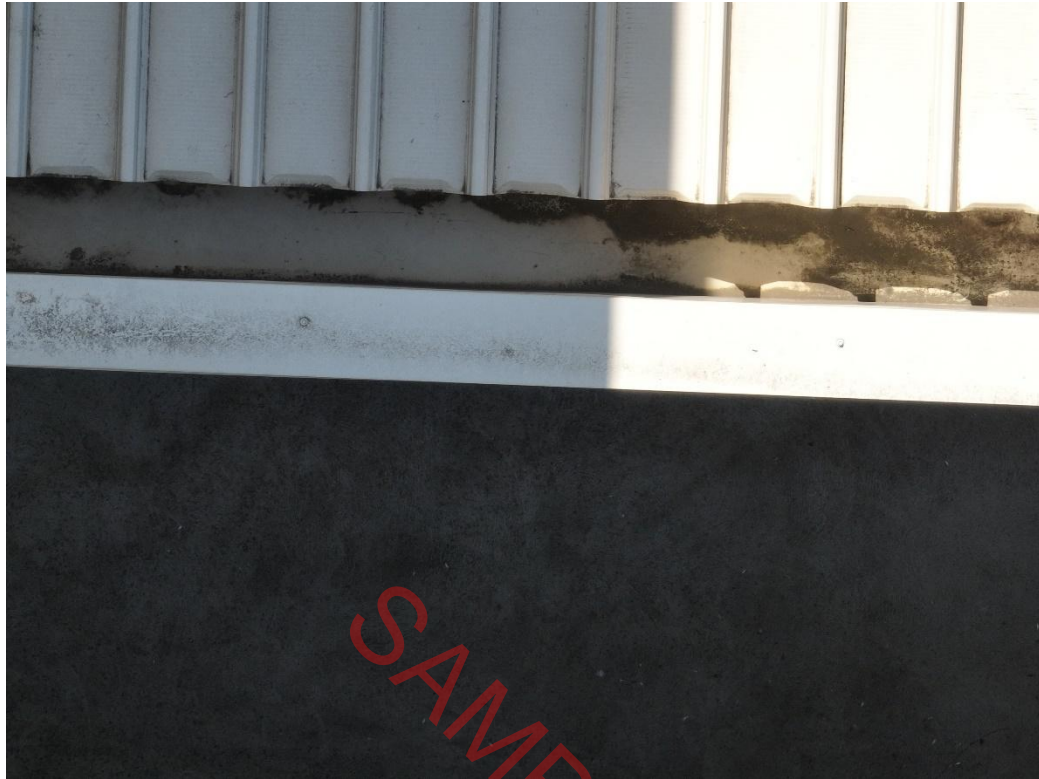
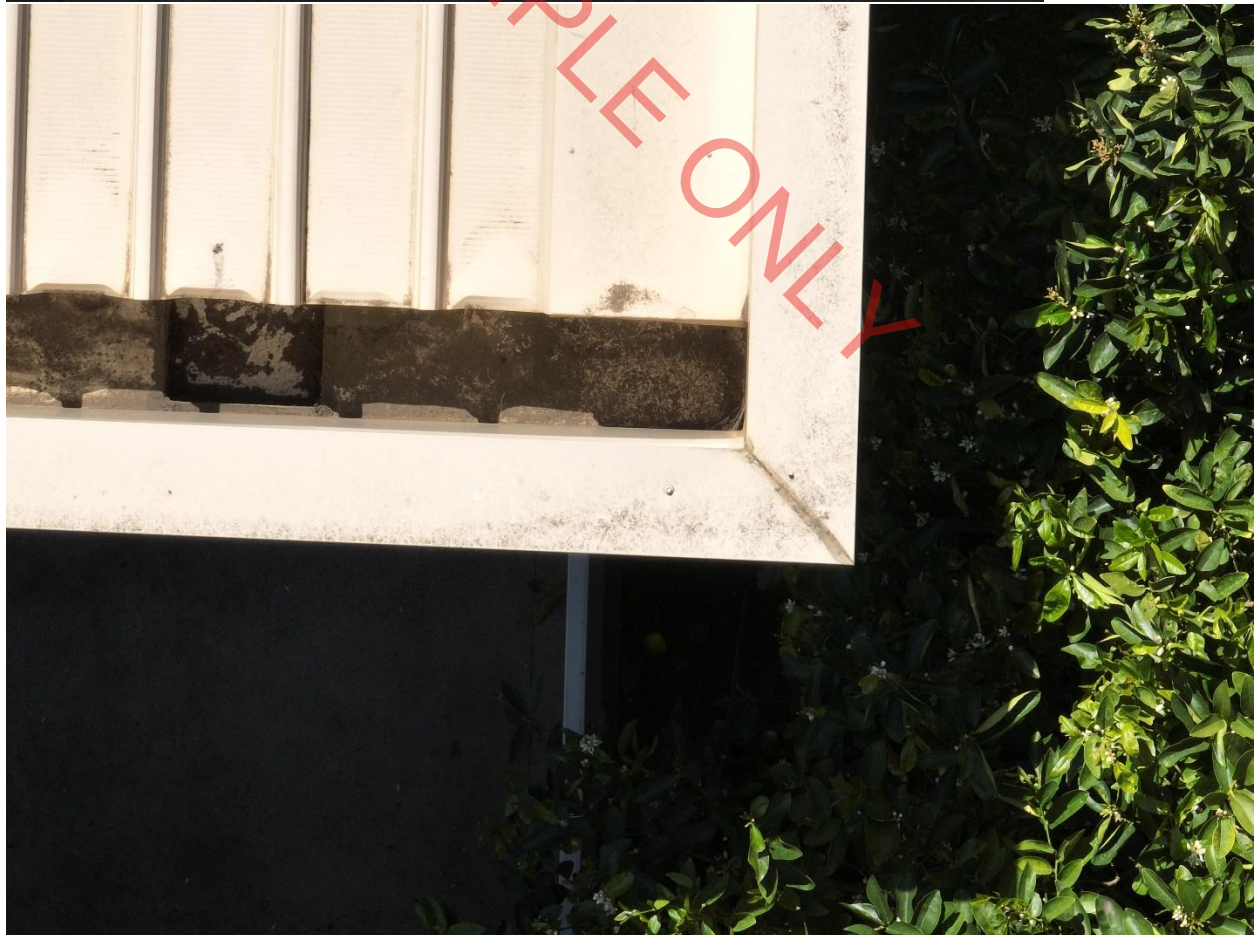
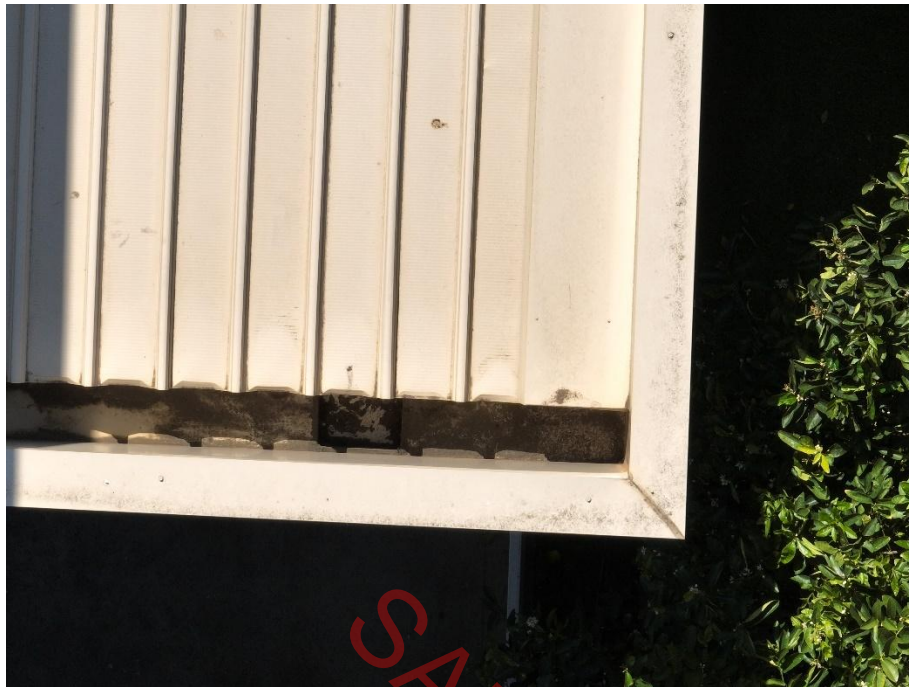
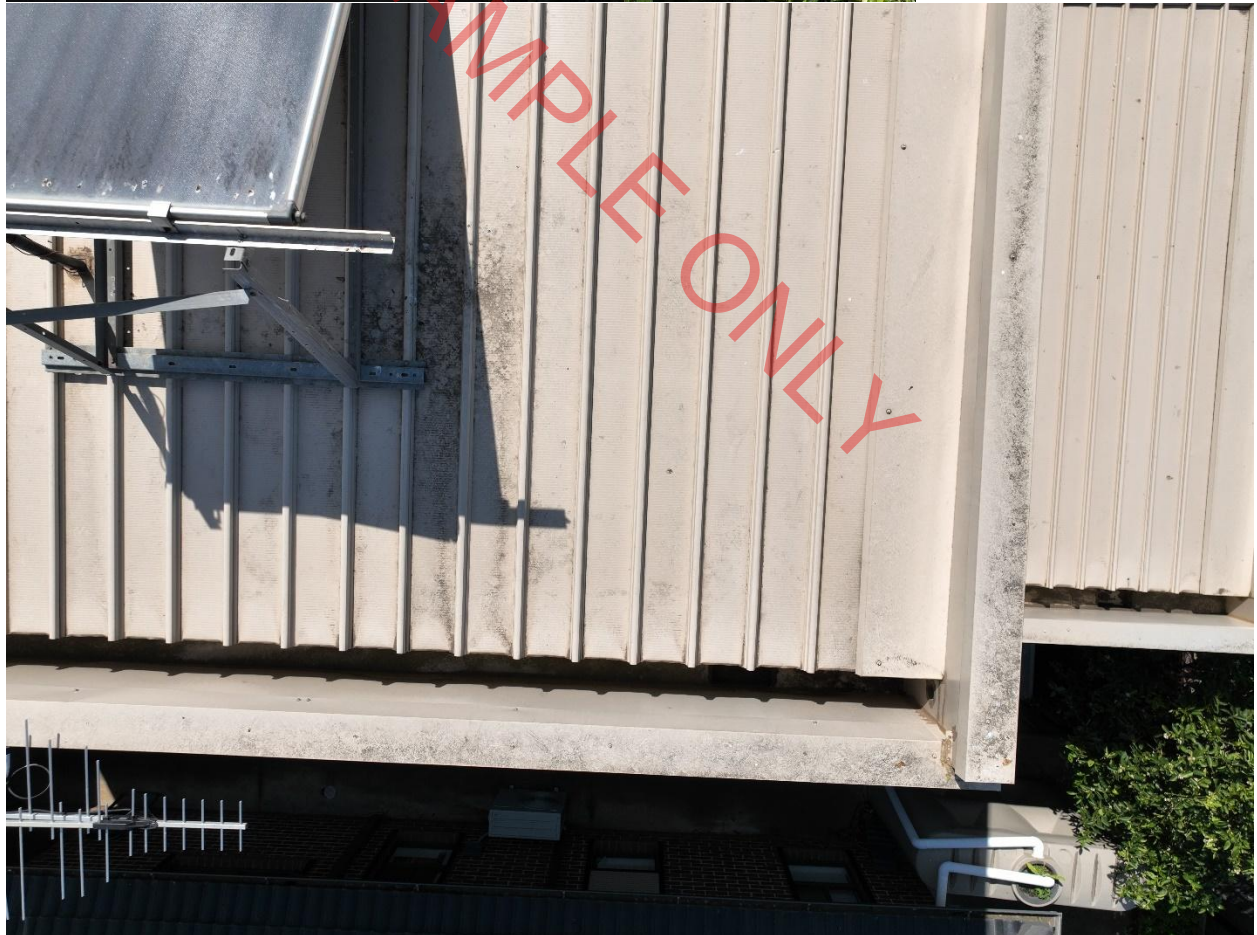
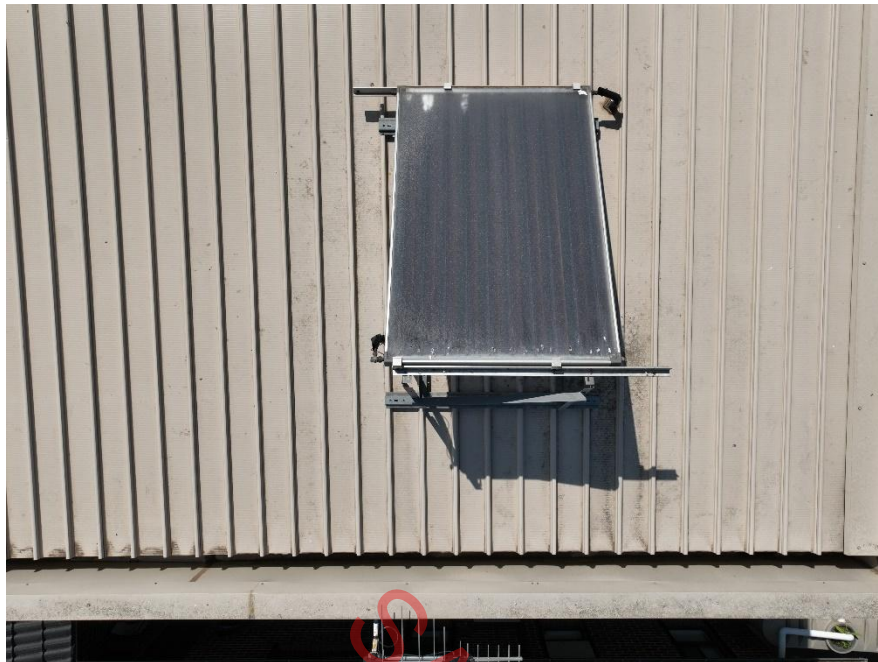
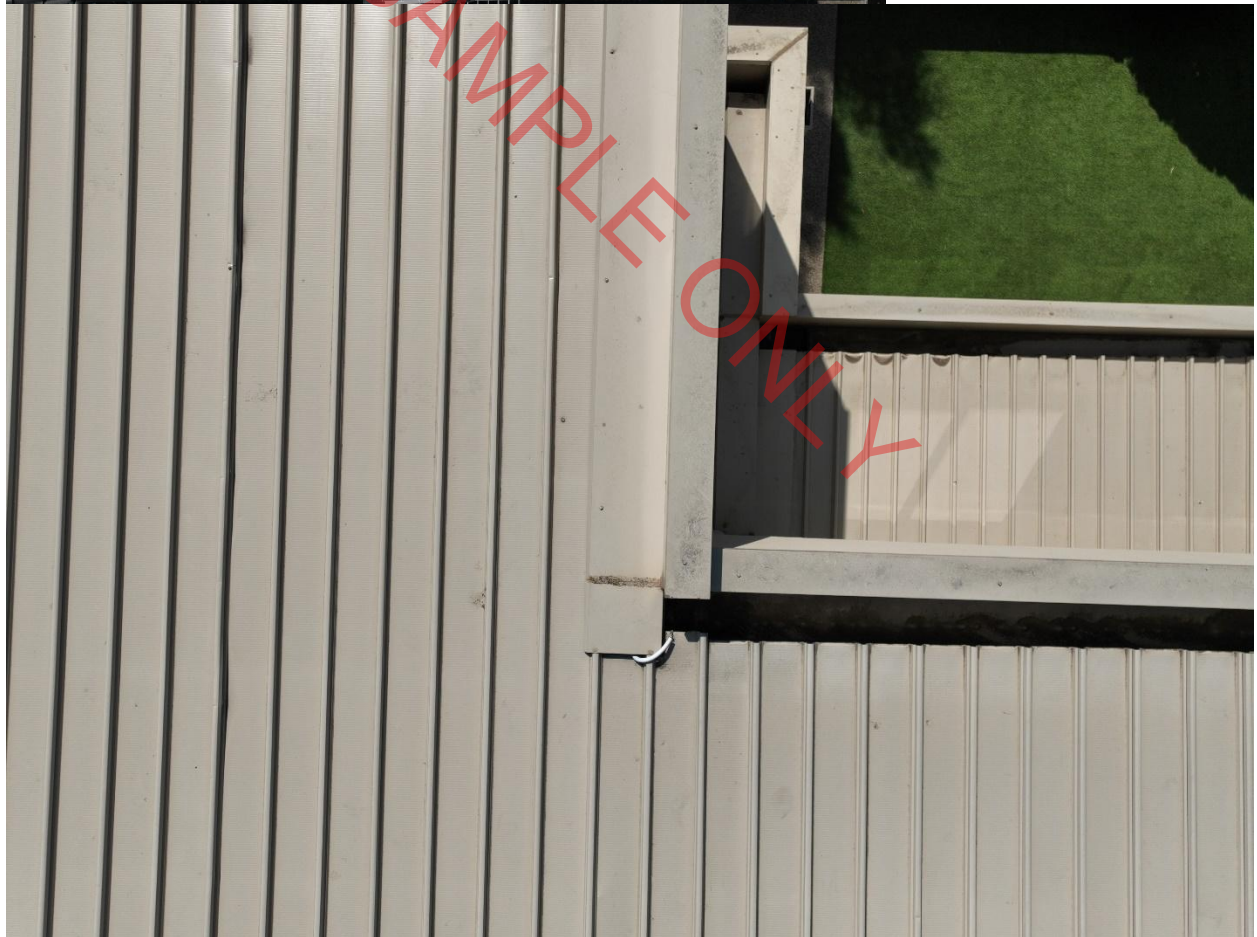
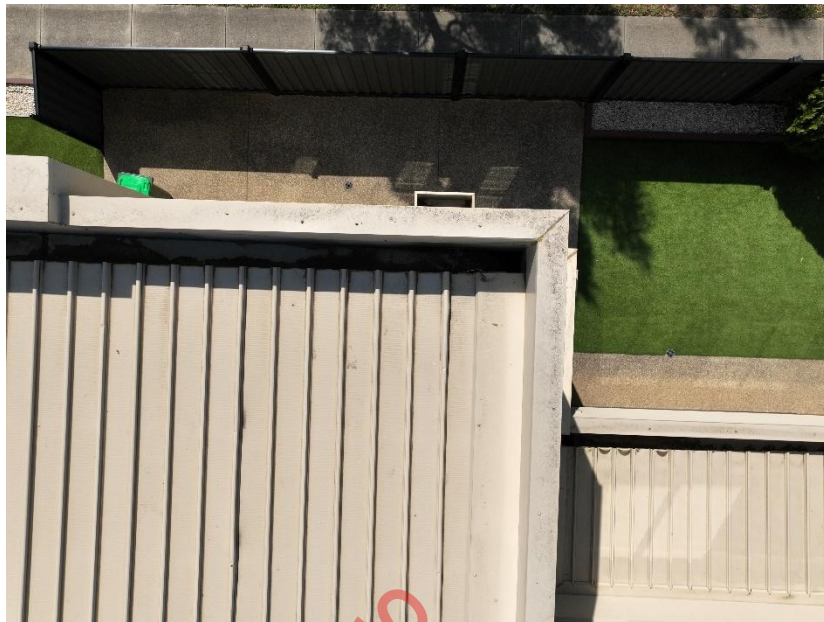
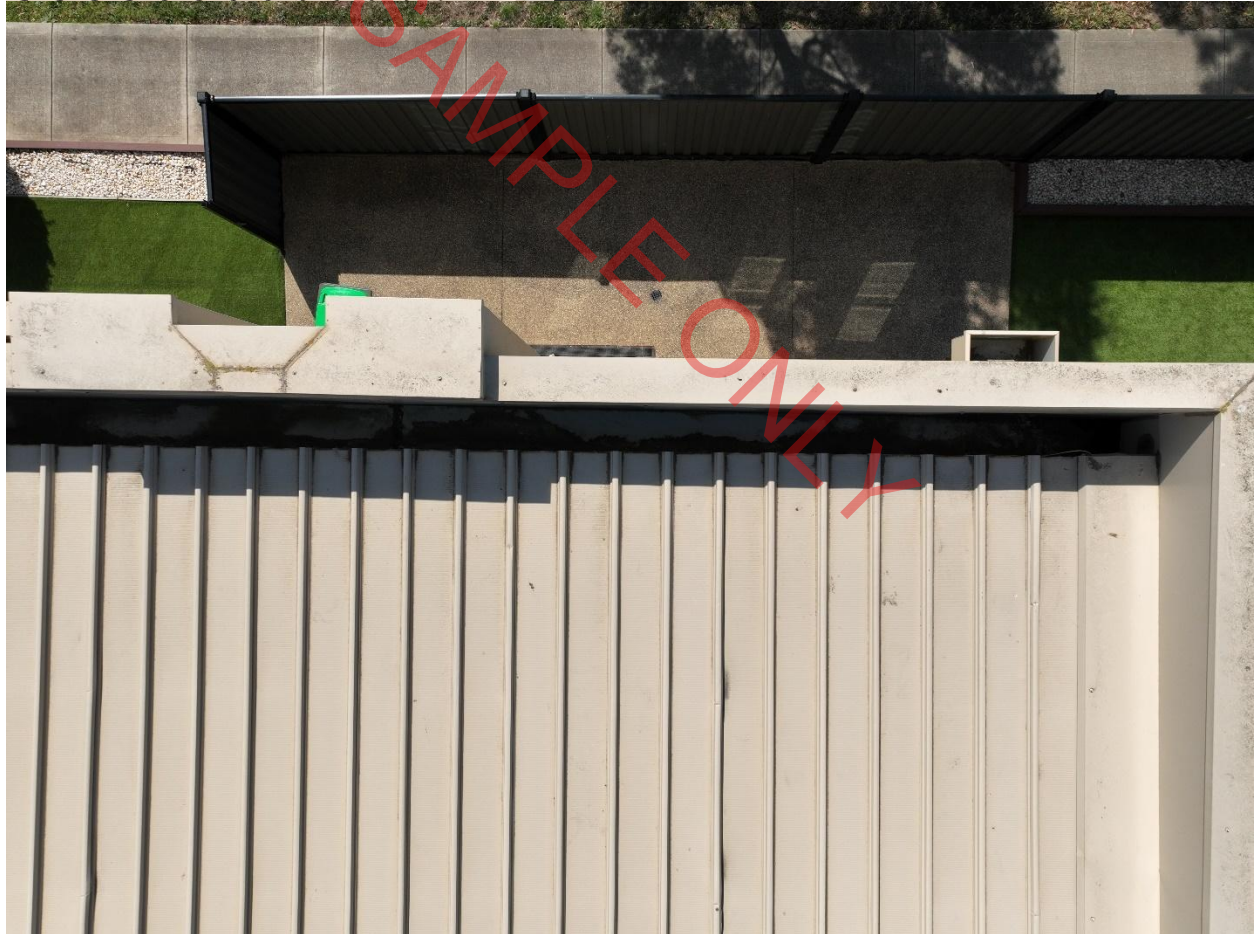
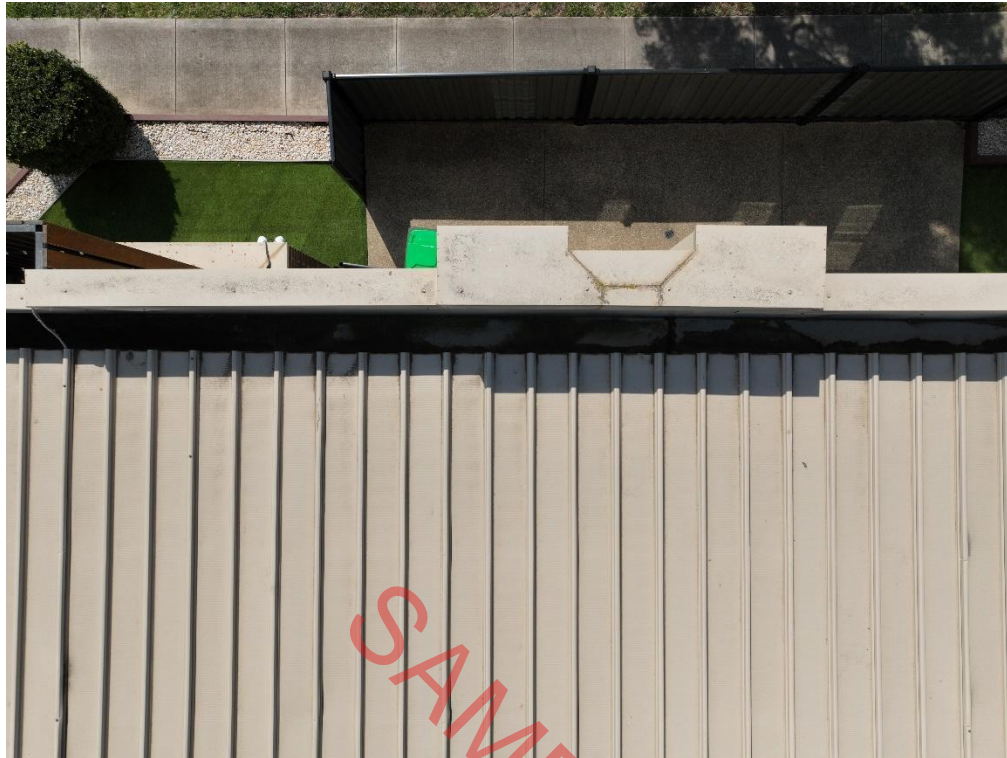
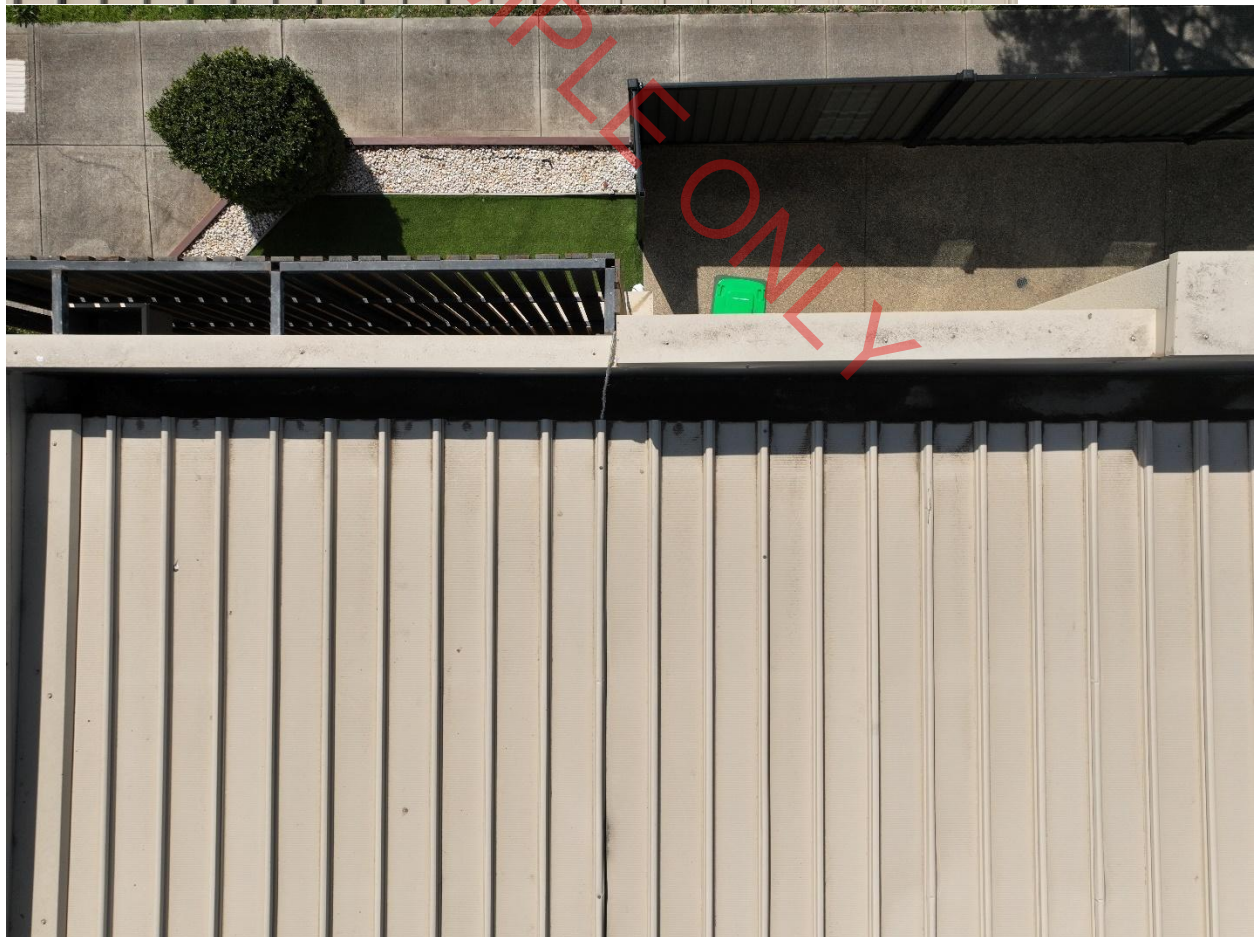
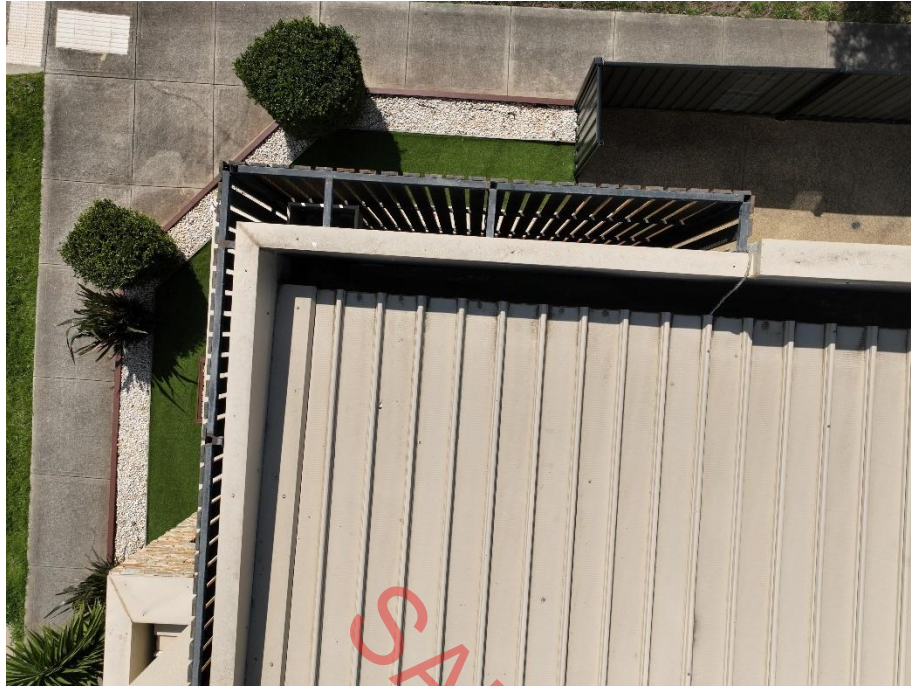
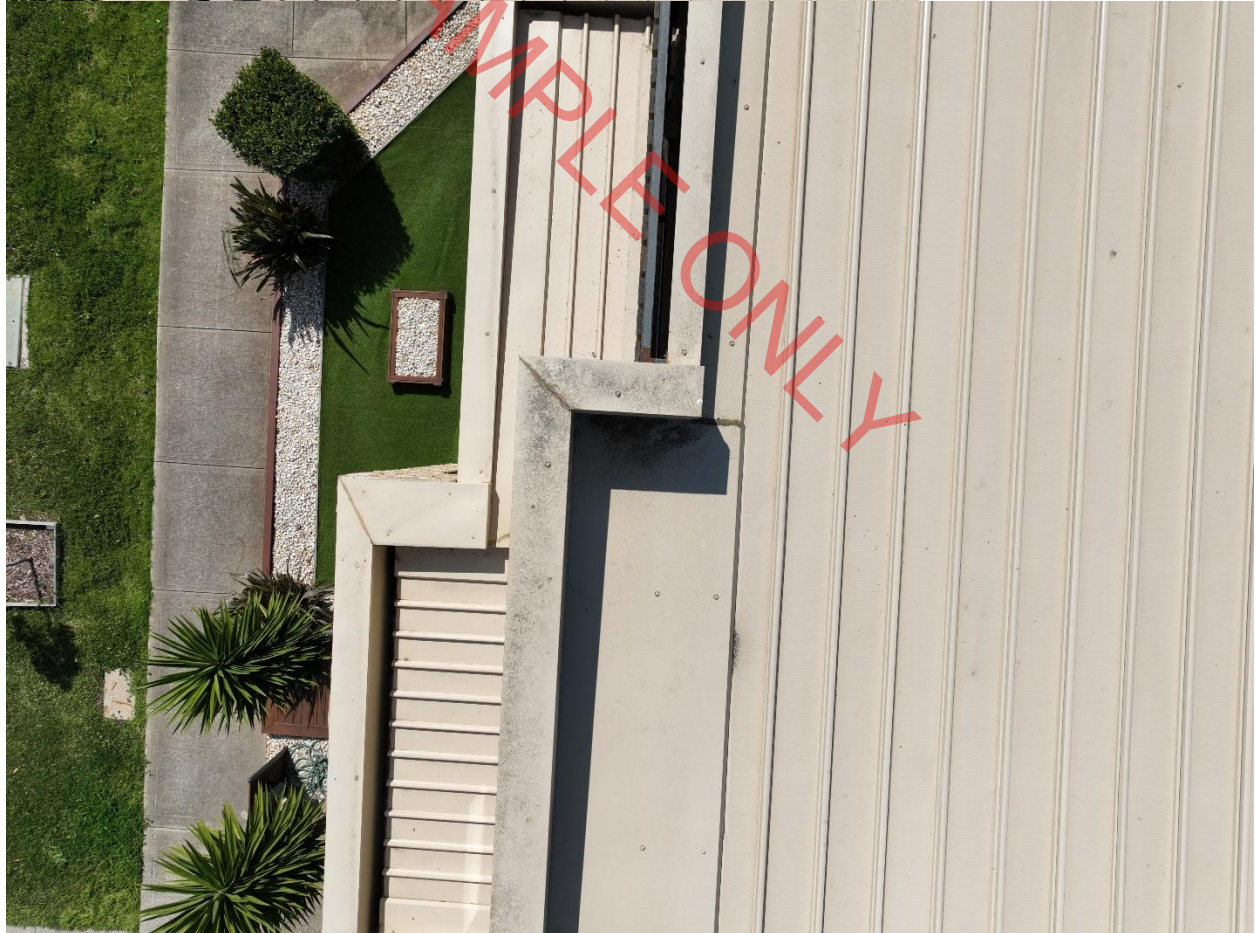
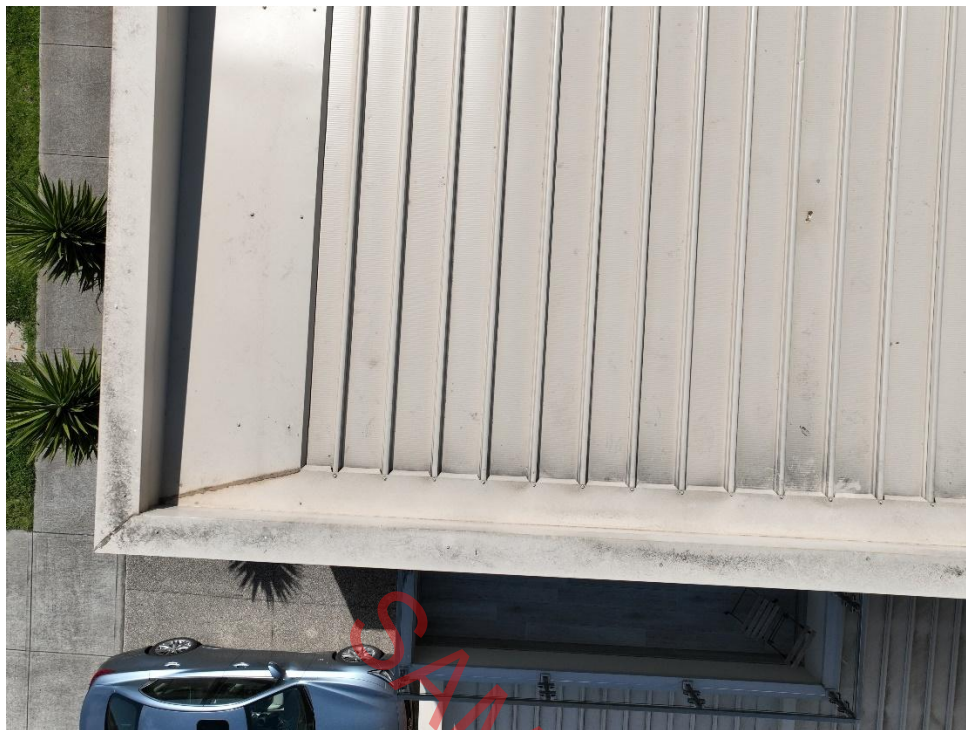
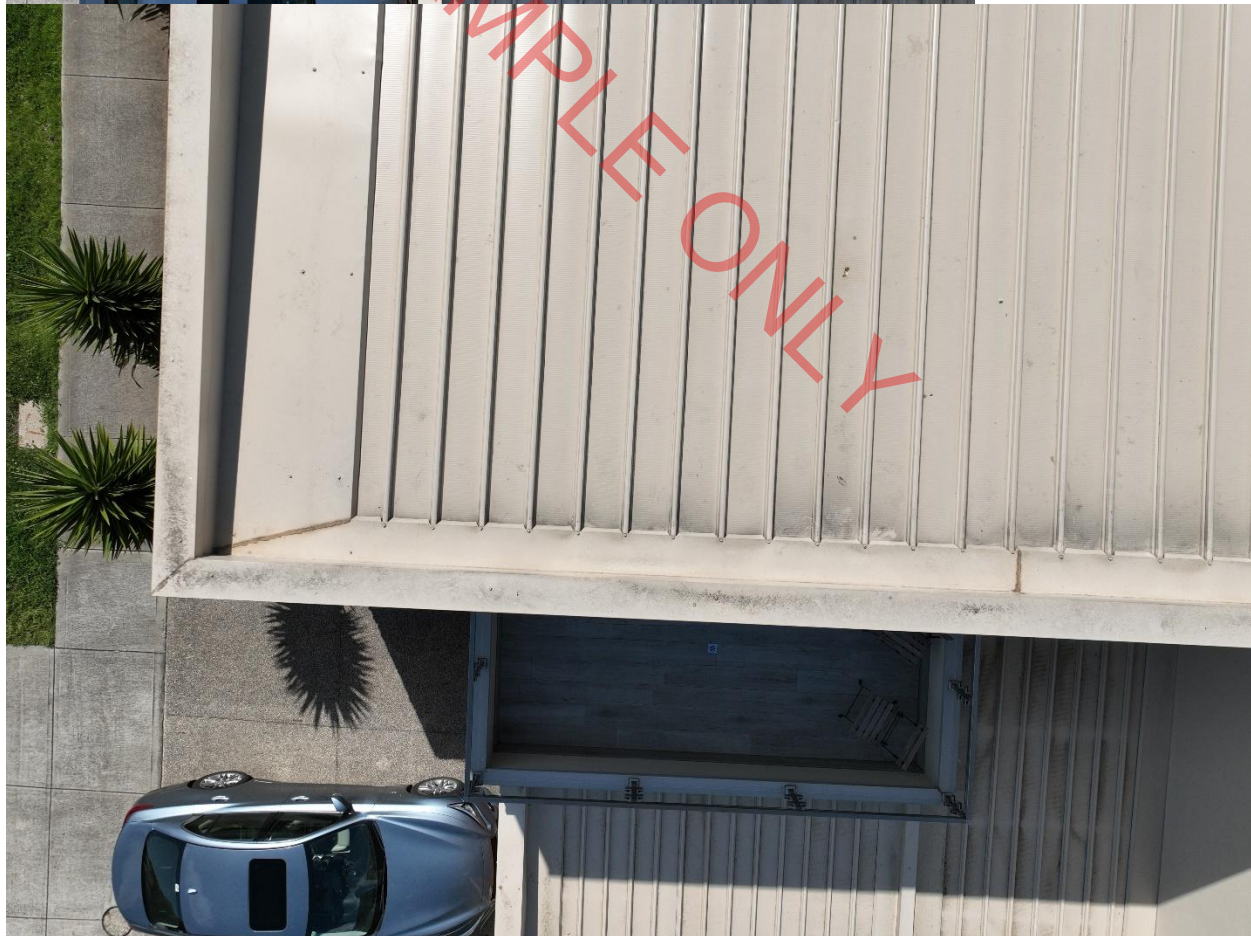
DEFECT: 1.0

Location: Finding:	Roof Inspection by Drone
Information:	<p>1. Roof Covering Condition: The roof covering appears to be in generally good condition. There are no visible signs of major damage such as cracks or missing tiles. Minor wear and tear consistent with the age of the roof was observed, but no immediate repairs are required.</p> <p>2. Box Gutters Observation: The box gutters were found to be holding some water, which may indicate poor drainage or slight sagging in some areas.</p> <p>Condition: The gutters are also filled with dirt and debris, which is likely contributing to the water retention issue.</p> <p>Recommendation: It is recommended to clean the gutters and check for any obstructions. If water pooling persists after cleaning, further inspection for slope and drainage problems should be conducted.</p> <p>3. Capping and Flashings:</p> <p>Observation: The capping and flashings are in good structural condition, with no signs of rust or damage.</p> <p>Condition: However, the silicone applied at joints and seams appears to be distorted in some areas.</p> <p>Recommendation: The distorted silicone should be checked and replaced where necessary to ensure a watertight seal and prevent potential water ingress.</p> <p>Overall Condition: Overall, the roof is in functional condition, but some minor maintenance tasks such as cleaning the gutters and addressing the silicone in the capping and flashings are recommended to maintain its integrity.</p> <p>Conclusion: While no significant issues were identified during this inspection, routine maintenance should be carried out to prevent small issues from developing into larger problems. Addressing the</p>
