Building and Timber Pest Inspection Report

Inspection Date: Wednesday, September 18, 2024
Property Address: Truganina 3029

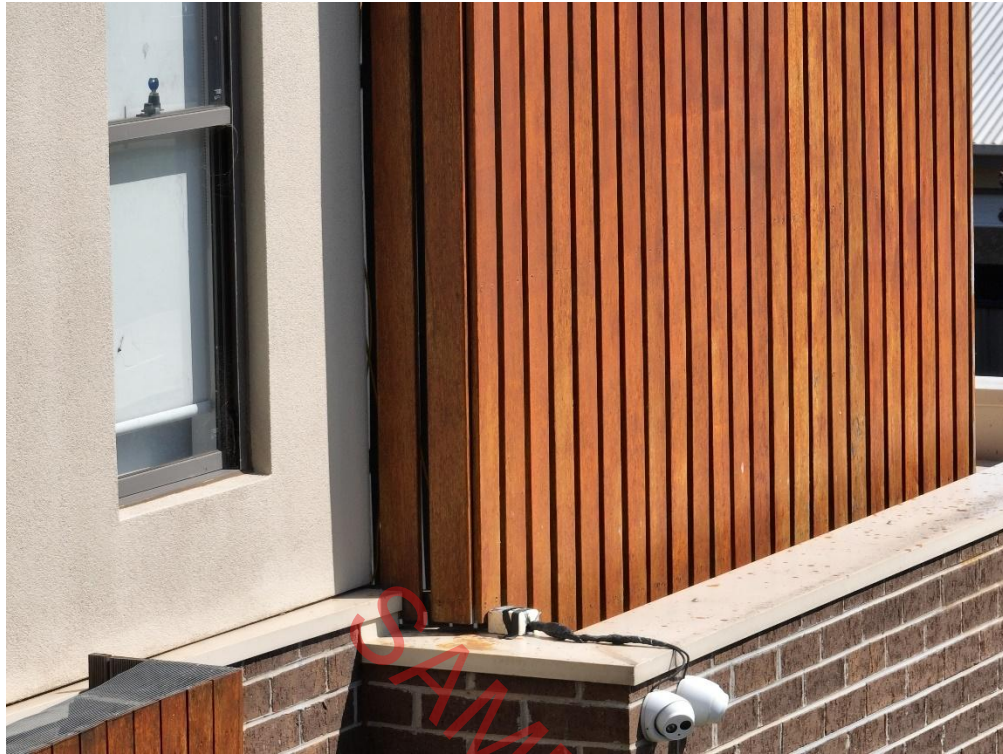
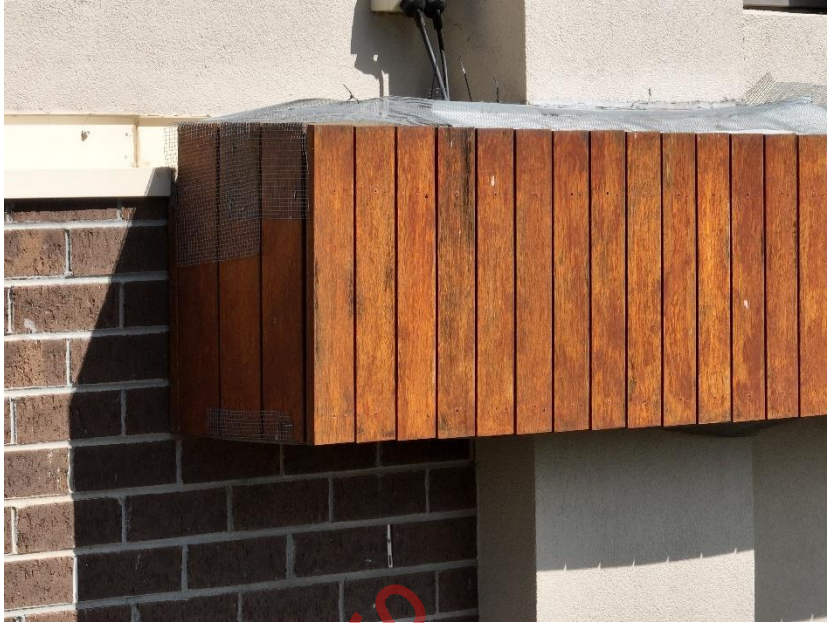
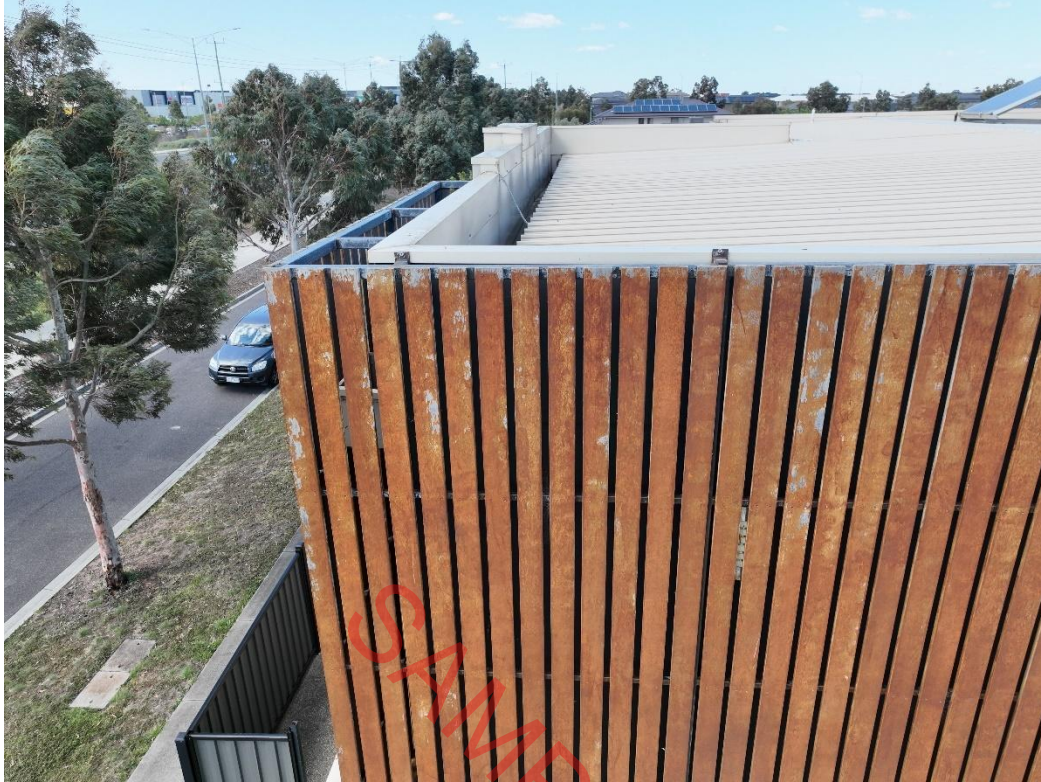
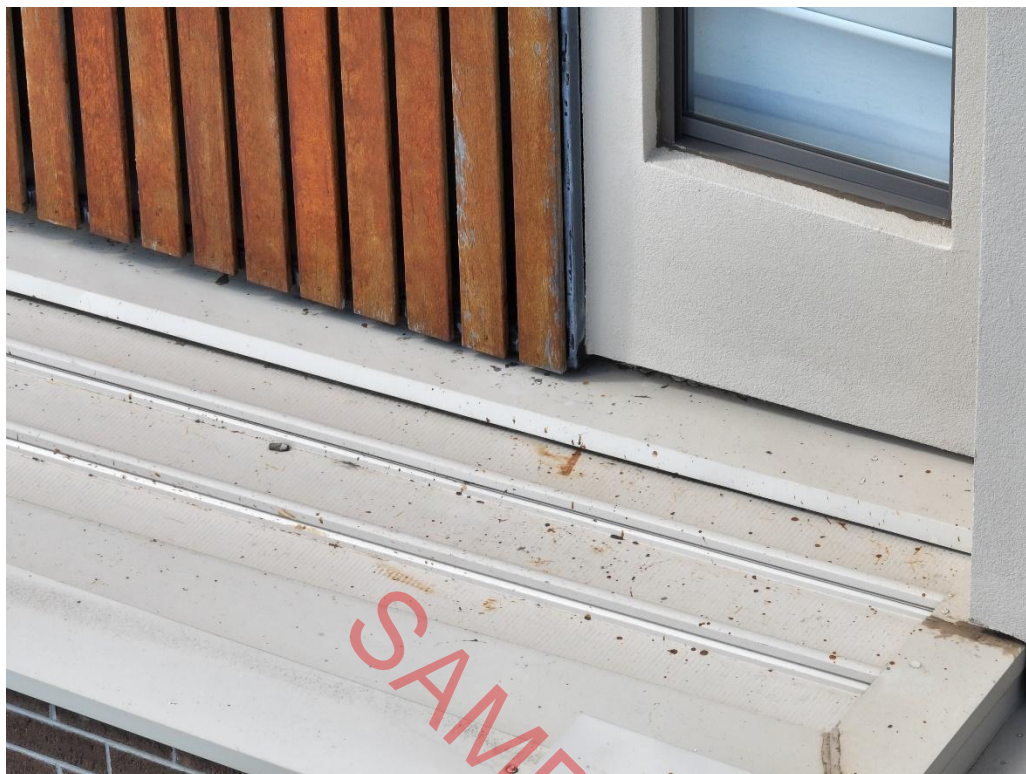
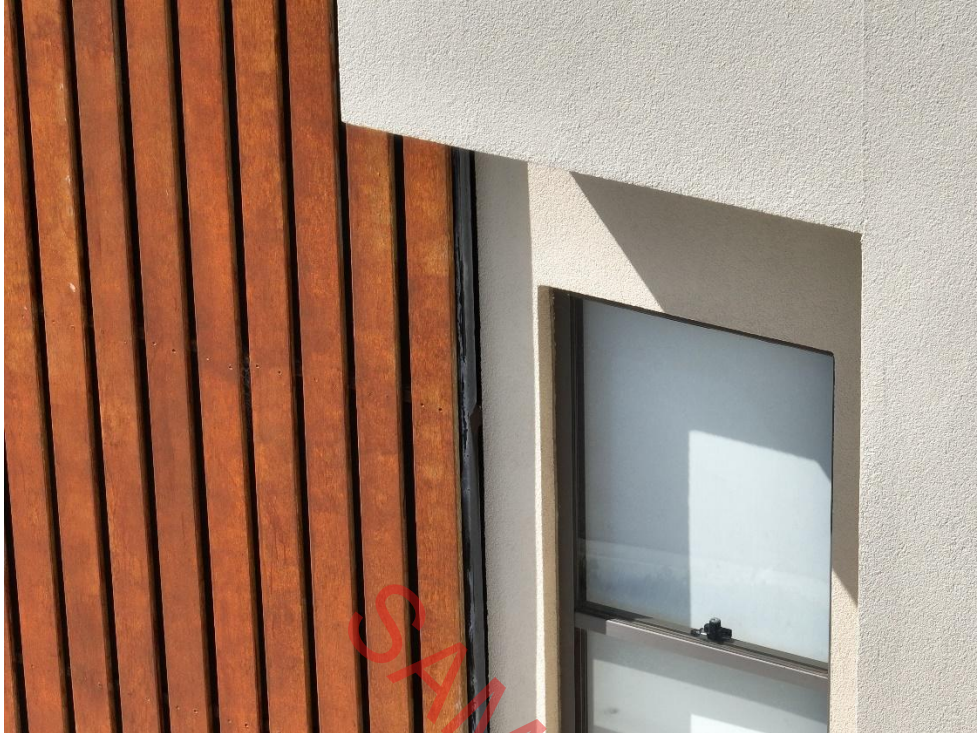
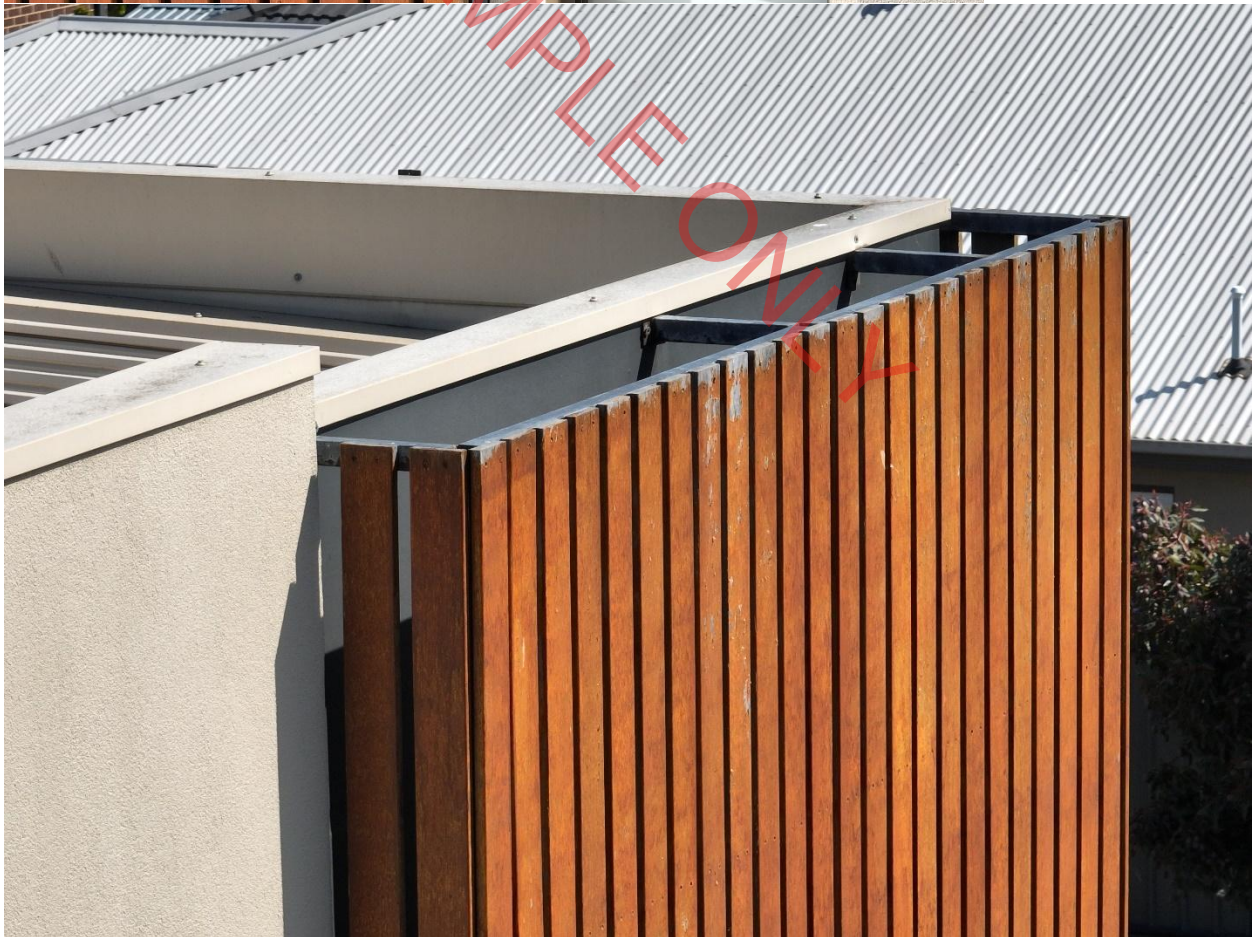
Findings: 2.0

Location: Finding:	Timber slats (Decking timber) on metal frame (Façade) – Drone inspection
Information:	<p>The drone inspection was conducted on a set of timber slats affixed to a metal frame. The purpose was to evaluate the integrity and overall condition of the structure due to observed issues of distortion and rotting at the end caps.</p> <p>2. Observations</p> <p>2.1 Timber Slats</p> <p>Distortion: Multiple timber slats have shown visible signs of distortion, particularly near the central sections and ends, likely caused by environmental exposure, moisture absorption, or lack of adequate protection.</p> <p>Extent: Approximately [50] % of the slats are affected.</p> <p>Possible Cause: This distortion may be a result of: Prolonged exposure to moisture without proper treatment. Changes in temperature causing expansion and contraction of the wood. Poor-quality wood or improper installation techniques.</p> <p>Condition of Wood: The wood's finish has faded or peeled, indicating a lack of maintenance or ineffective protective coatings.</p> <p>2.2 End Capping</p> <p>Rotting: The end caps of the timber slats are suffering from significant rot. This is likely due to constant exposure to moisture, which has penetrated the wood at its most vulnerable points—the exposed ends. These areas seem to lack proper sealing or protective capping.</p> <p>Extent of Rotting: The rot is present on [25] % of the end caps, affecting their structural integrity and potentially leading to further degradation.</p> <p>Possible Cause: Insufficient weatherproofing of the timber ends.</p> <p>2.3 Metal Frame</p> <p>Condition of Metal Frame: Despite the issues with the timber, the metal frame appears to be in fair condition, with no significant signs of rust or structural damage. However, there is minor surface rust at some junctions, which should be monitored and treated to prevent further corrosion.</p> <p>Fixings and Connections: The connections between the timber and the metal frame are secure in some areas, potentially few fixings have loosened due to the distortion of the slats.</p>

The timber slats on the metal frame show significant signs of wear, particularly in the form of distortion and end cap rotting. These issues are compromising the structural integrity and aesthetic appeal of the structure. Immediate action is recommended to replace affected components and apply protective measures to prevent further deterioration.

It is recommended that the distorted and cracked slats be replaced with treated, weather-resistant timber.

To prevent future distortion and moisture damage, all timber should be coated with a high-quality wood preservative and sealant.

All rotting end caps should be replaced with durable, weather-resistant material. Consider using plastic or metal caps instead of timber to ensure longer-lasting protection.

Light rust on the metal frame should be treated using a rust remover, followed by the application of a rust-inhibiting primer and paint.
